This document details the application of SOP 007 (Applicable to Lucy FRMU MK1 and MK2 Switchgear) issued by the Energy Networks Association.

7. SOP DETAILS

8. SOP HEADER

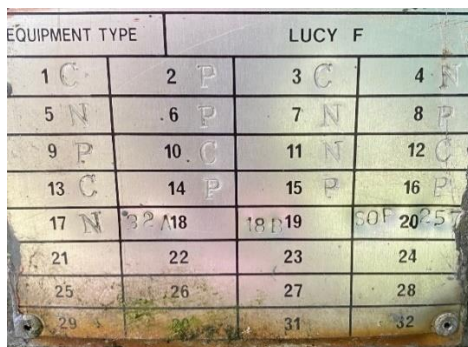
Figure 1: Modifications Plate

All units shall be checked for presence and completeness of plant modification plate like the example shown in Figure 1.

If there is not a modification plate fitted, **Report to Control Room, the SOP shall remain in force.**

The SOP shall remain in force until all checks have been completed via invasive maintenance and a new, appropriately stamped plate is fitted.

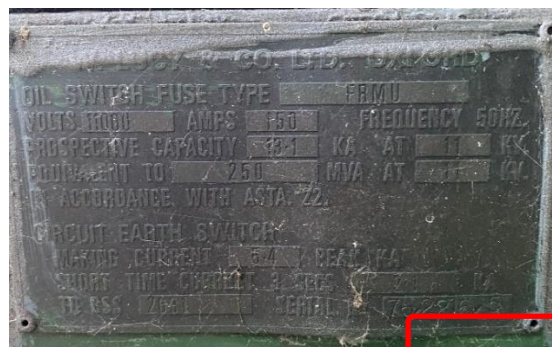
Figure 2: Rating Plate

The rating plate of the unit should be referenced to confirm the serial number and batch number of the units as shown in example in Figure 2.

Serial: 76/2216/5 Batch: 76/2216
