This document details the application of SOP 252 (Applicable to Siemens Type 8DA10 33kV Vacuum in SF6 extensible metal clad switchgear) issued by the Energy Networks Association.

7. SOP DETAILS

EQUIPMENT TYPE	Siemens Type 8DA10 33kV Vacuum in SF6 extensible metal clad switchgear
ORIGINATING COMPANY	Scottish & Southern
DATE	12/04/2000
NUMBER INSTALLED IN ENERGY NETWORKS NORTH	47
NUMBER INSTALLED IN ENERGY NETWORKS SOUTH	140
REASON	<p>An incident occurred in which a circuit was re-energised by the closure of the circuit breaker, after the apparent selection of the selector switch to EARTH. A clevis pin transmitting drive from the operating mechanism at the front of the switchgear had become displaced due to its retaining circlip being detached. The mimic diagram indicated that EARTH had been selected, but the selector switch contacts had not moved from the ON position. The switch linkage bell cranks are a true indication of the switch position.</p>
STATUS IN INITIATING COMPANY	<p>The following restriction to apply to all switchgear of the above type:</p> <p>Prior to any operation of the three position selector switch and again immediately after its operation, the position of the sw

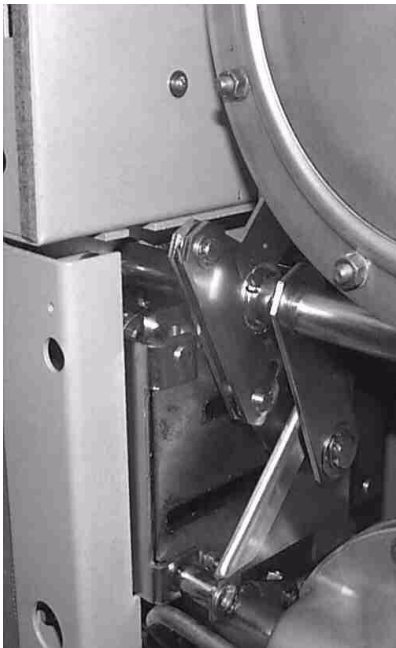
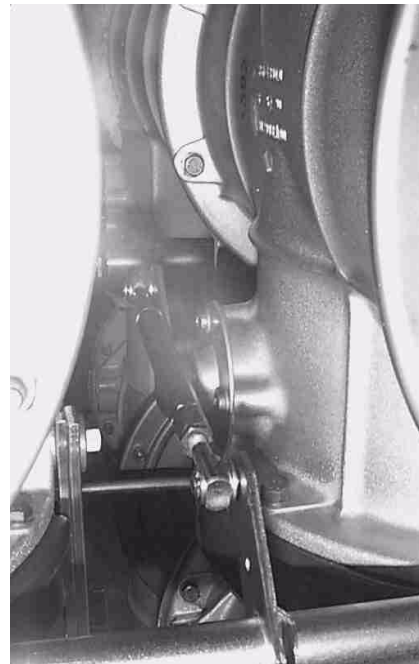
ON Position

The switch operating mechanism may be viewed from the rear of the switchgear. The drive linkage for the switch is the upper of the two horizontal rods, running from front to rear in the unit. The rod has three welded bell cranks, each with a drive link into its selector switch. The angular position of these bell cranks must be noted before operation of the selector switch mechanism, and their change of position noted after operation of the switch mechanism. Photographs of the position of these bell cranks are shown below in Figures 1-6. They show the correct position in each of the switch locations - ON, OFF, EARTH. The correct position of the switch contacts must be confirmed by inspection of the bell cranks before the circuit breaker is closed.
