This document details the application of SOP 429 (Applicable to British Thomas Houston (BTH) MF36 RMUs) issued by the Energy Networks Association.

7. SOP DETAILS

8. SOP HEADER

9. APPENDIX 1 - DEFECT INSPECTION PROCEDURE

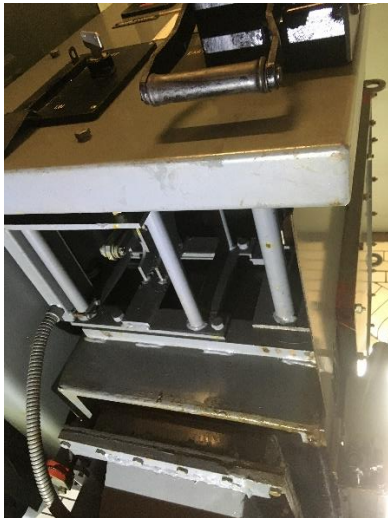
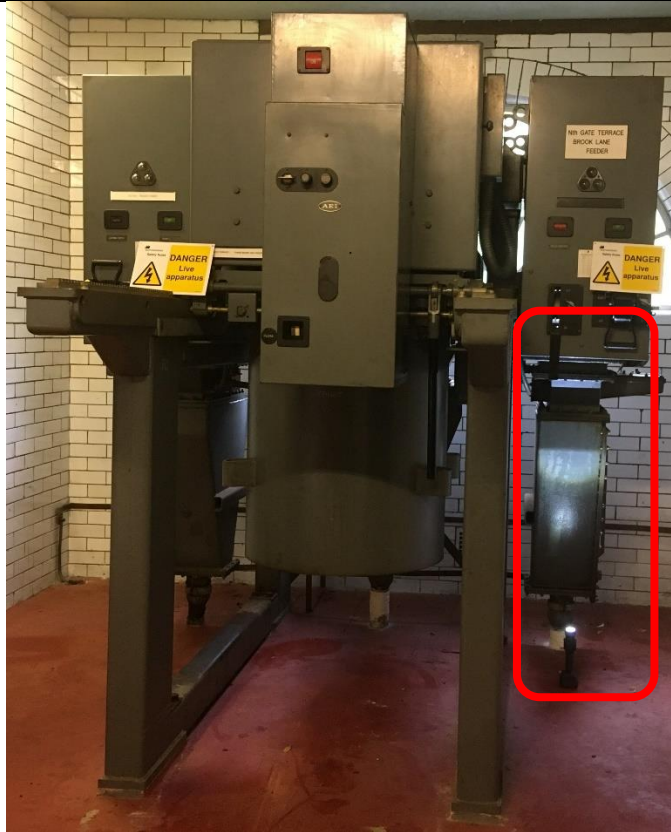
Place a torch under the RSW to be examined.

This should point up into the open cubicle where the switch mechanism is contained (as below).

The component to be inspected is at the top of the cubicle

The drive crank should be painted (yellow in this case).

If the drive crank is not painted, immediately report to control.

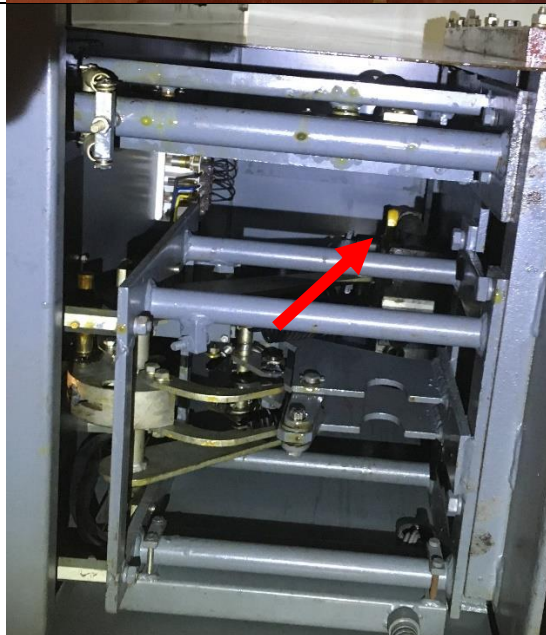
It is essential to focus in on the drive crank (typically yellow or red) to assess the units.

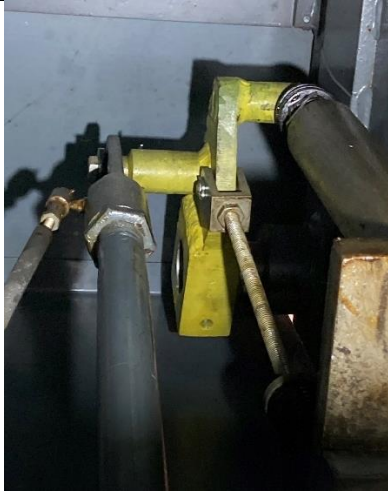
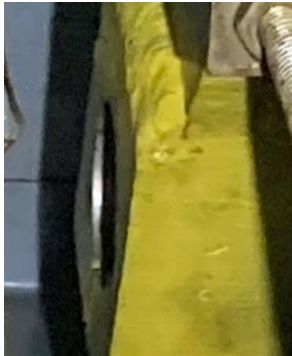
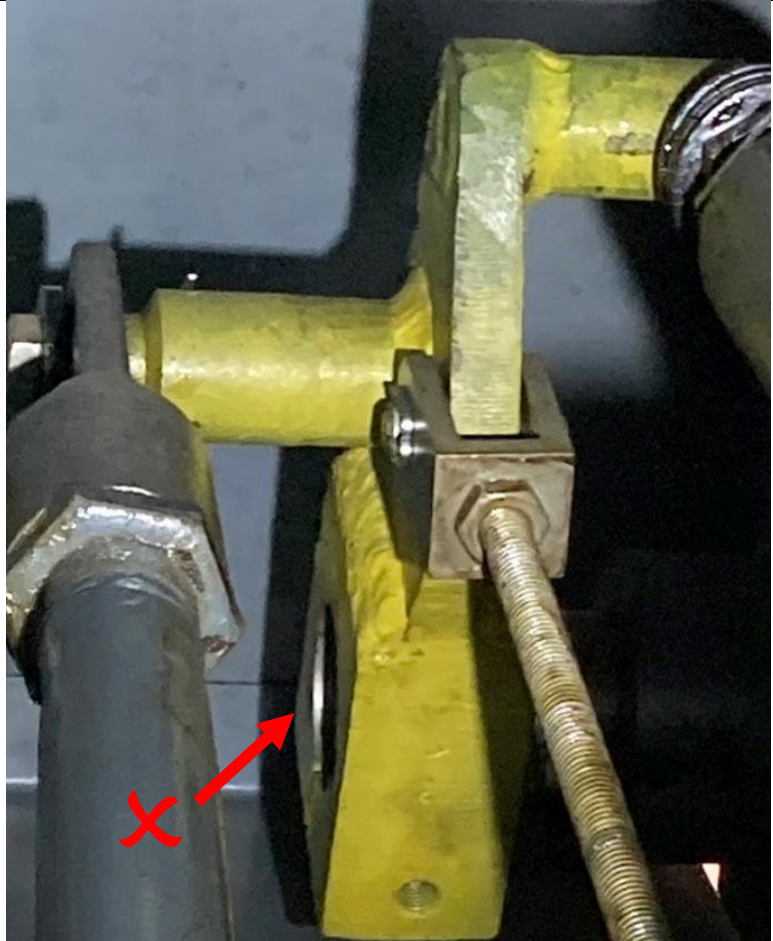
Equipment **not acceptable** to operate

See the hole where the **X**
operating shaft should fully enter
(flush to the end) / protrude
through the yellow/red drive
crank

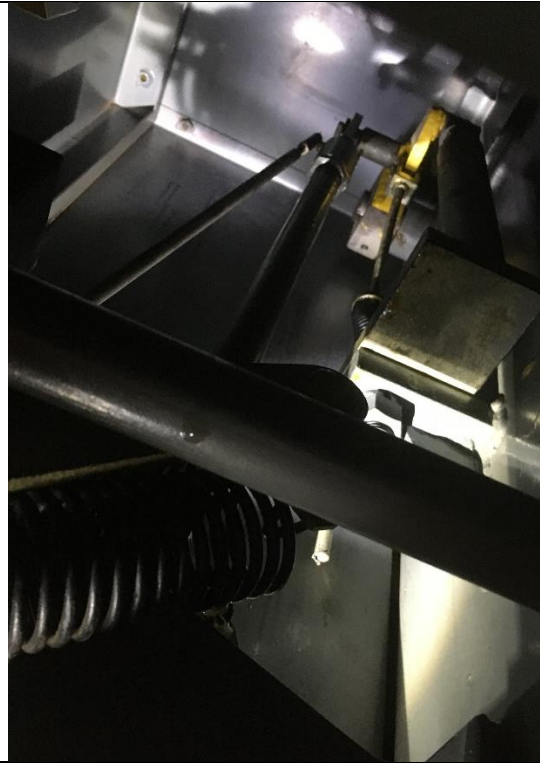
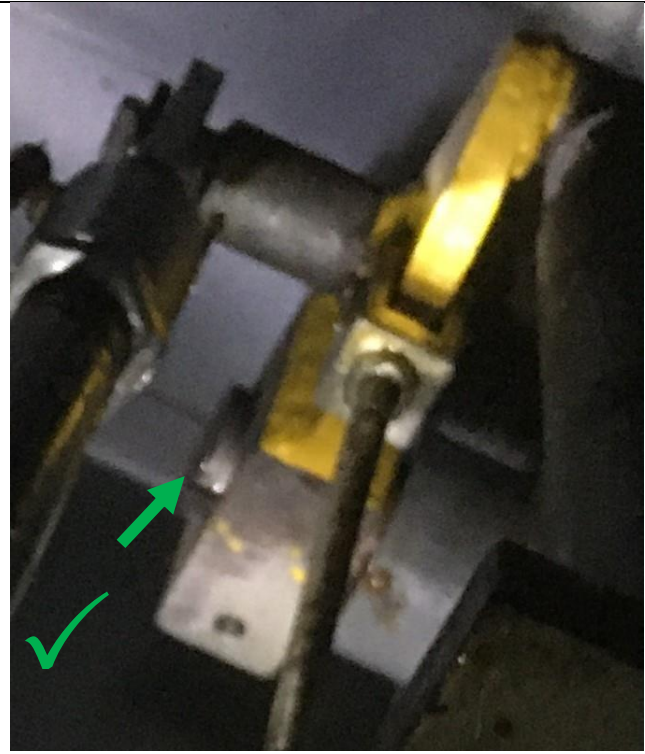
Equipment acceptable to operate

See where the operating shaft protrudes through the hole in the yellow drive crank

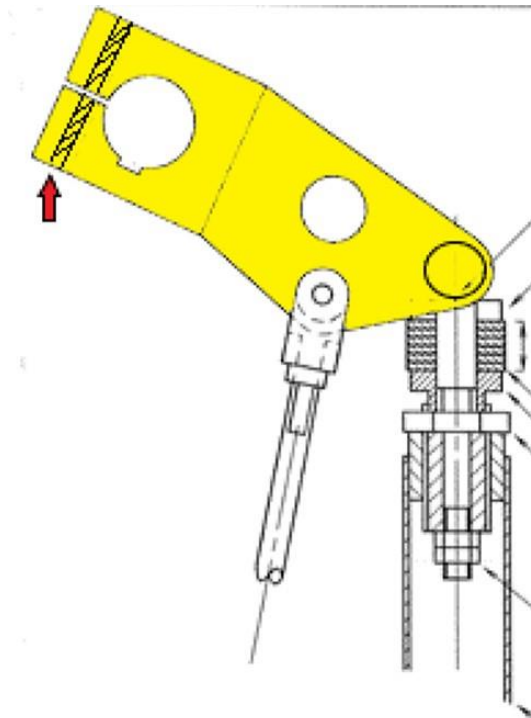
The drive crank component that needs to be secured is shaded yellow in the drawing below. In some regions this has been painted other colours. There is a threaded hole that runs through the drive crank as indicated by the red arrow. The drive crank is secured to the operating shaft using a bolt

When the drive crank is seated in the correct position, it should be secured with the bolt and spring washer.

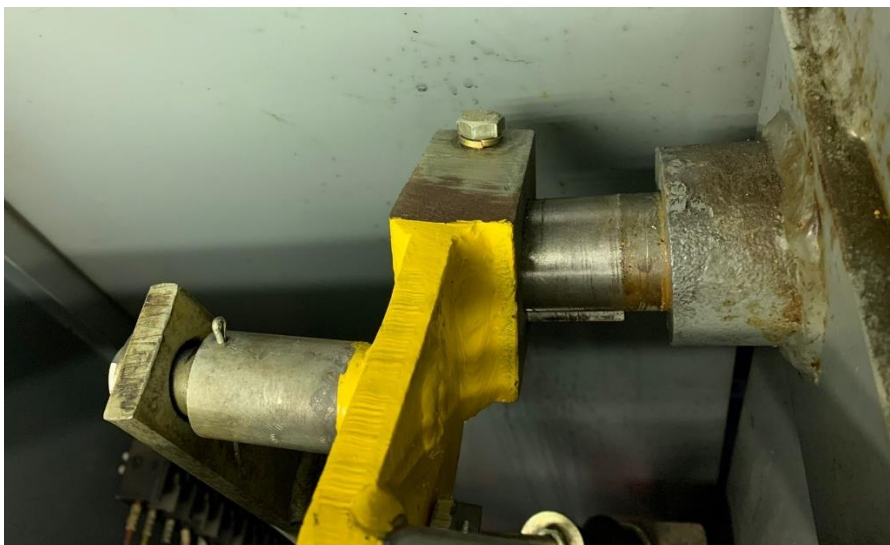
Under the head of the bolt is spring washer. The arrangement below shows an example of where the drive crank has detached from the operating shaft.

Under permit for work conditions, with the top cover of the RMU removed, the associated assembly should be positioned so that the drive crank is lined up to the end of keyed portion on the bottom of the operating shaft (red arrow in picture below).

The switch should be then operated five times and then again inspected to confirm that the drive crank has not moved. If there is any movement, the drive crank must be repositioned and tightened in place and again operated five times to check and ensure that it is secure.

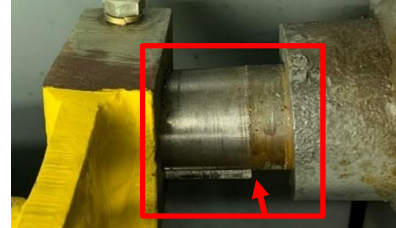
The metal surface of the operating shaft will be cleaner in the position the drive crank should be seated if it has moved in position.

See the area marked by the red box, with arrow showing where drive crank was initially located.
