This document details the application of SOP 437 (Applicable to ABB / Hitachi Energy VUBB On-load Tap Changers fitted on primary transformers manufactured by ABB / Hitachi Energy Dudullu factory in Turkey) issued by the Energy Networks Association.

7. SOP DETAILS

Inspection of VUBB

PREPARED 2023-12-12 Anton Bergström	STATUS Draft	SECURITY LEVEL Internal		
APPROVED	DOCUMENT KIND Inspection and test instruction			
TITLE Inspection of VUBB				
OWNING ORGANIZATION	DOCUMENT ID 1ZSC030598	REV. A	LANG. en	PAGE 1/8

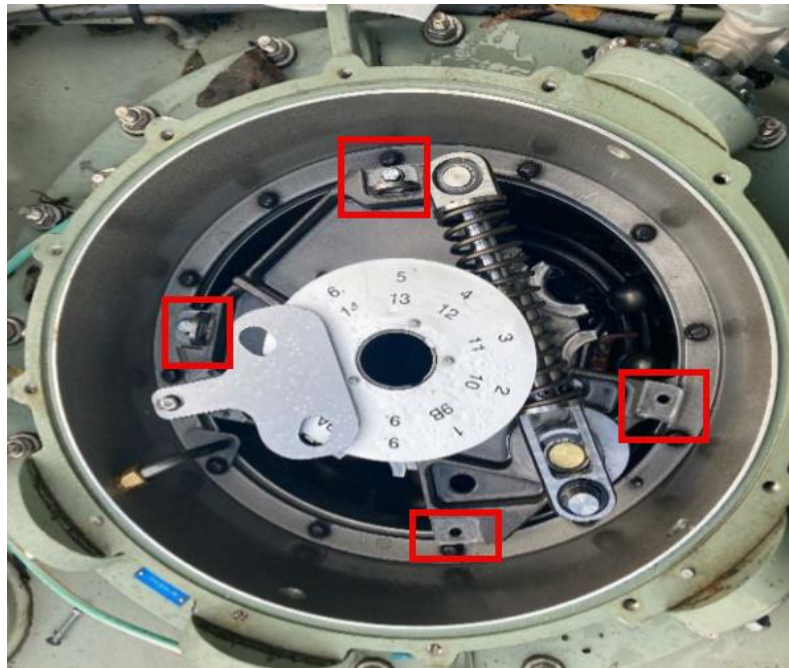
Figure 4: Photo of VUBB with top cover removed, two lifting lugs missing.

If one or more lifting lugs are missing, the bolts have sheared off and the threads have been damaged to some degree. This might require a special mitigation beginning with:

If one or more lifting lugs are missing together with their bolts, continue to section 3.7.

- Drainage of full oil volume
- Lifting of selector switch insert
- Removal of lifting lugs from the OLTC bottom.
- Clean the housing (after corrective actions on the threads)
- Inspect the OLTC for arcing damages in proximity to moving contacts.
 - *Here it is valuable to have a DGA taken before maintenance work begins.*

If actions described in 3.6 is not enough, tap-changer should remain in fixed tap position until arrangements are done to repair the threads. The DGA will be valuable for knowing if full or parts of the tap-changer need to be replaced.

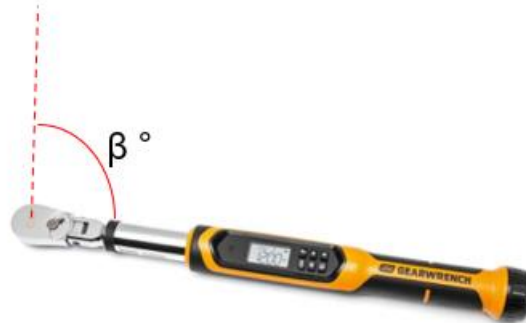
Take notice of the angle β required to reach set torque. This is valuable information for the continuing investigation.

Figure 5: Illustration of tightening angle

With the calibrated torque wrench, re-tighten the bolts to the stipulated torque. [24Nm]
