**PROPOSED REINFORCEMENT TO THE ELECTRICAL DISTRIBUTION
SYSTEM**

132kV OVERHEAD LINE BETWEEN LEGACY AND OSWESTRY

**ENVIRONMENTAL STATEMENT VOLUME 4:
APPENDICES 15C – 18E**

Route for proposed 132kV Line Legacy to Oswestry Ornithological Assessment July 2012

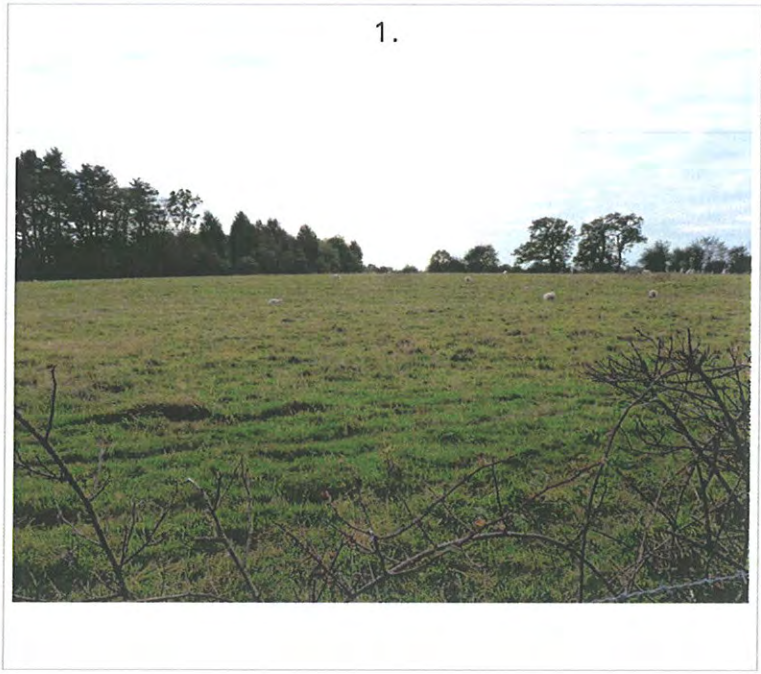
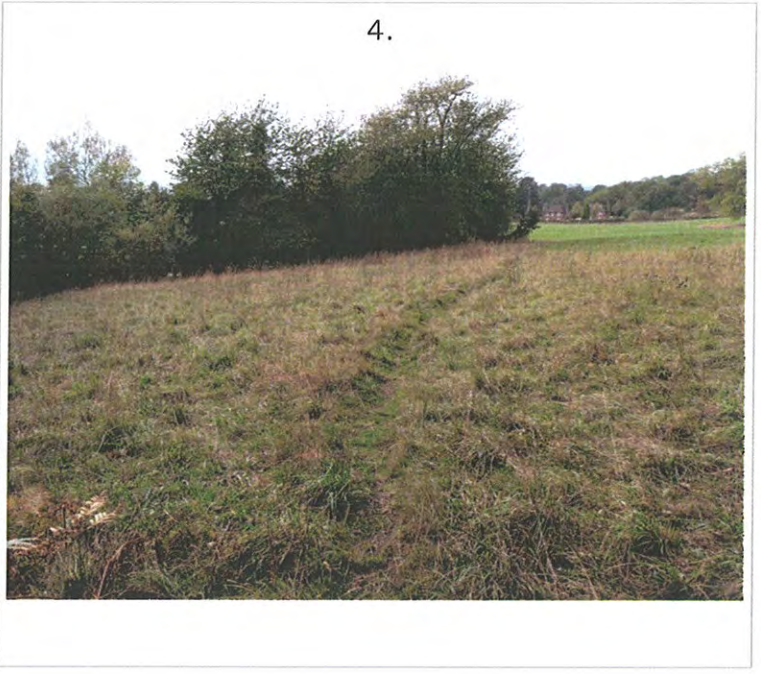
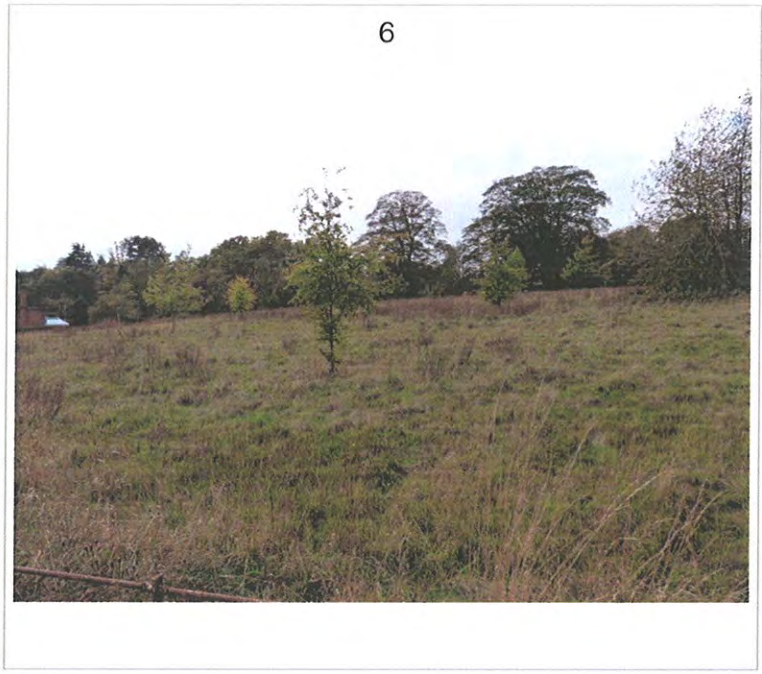
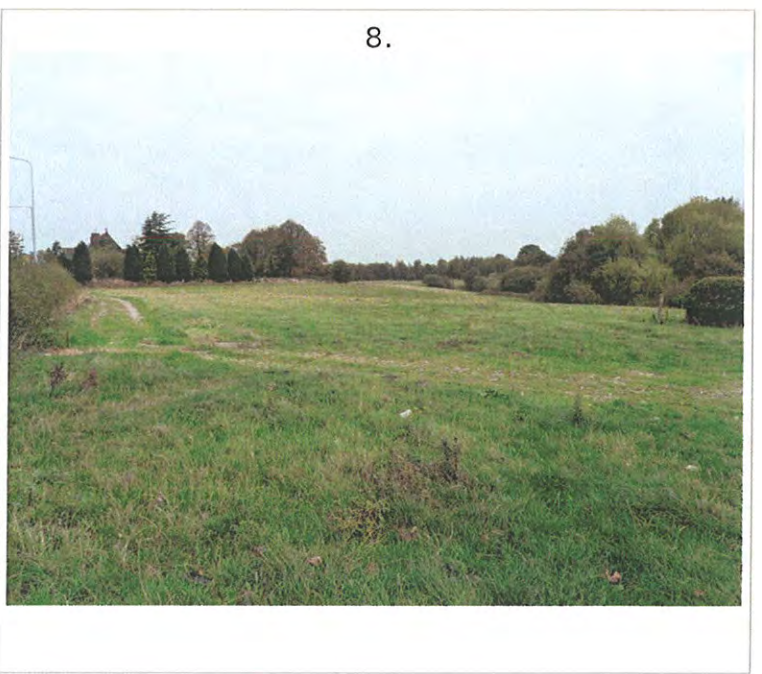
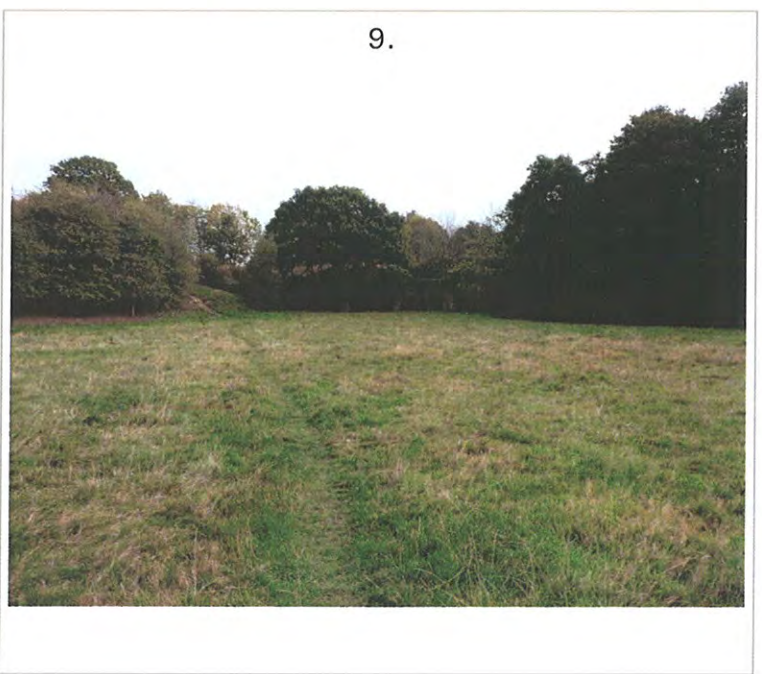
1. View of sheep grazed pasture field adjacent to substation (SJ2948)
2. Pylons and overhead lines present in area (SJ2948).
3. Field of bare earth, ploughing took place at time of survey (SJ2948).
4. Small rough grassland area north of Brook (SJ3047).
5. Building with potential for barn owl (SJ3047).
6. Area of rough grassland adjacent to crematorium (SJ3047 & SJ3048).
7. View of arable fields (SJ3048).
8. Area of pasture habitat within SJ3148.
9. View of pasture habitat adjacent to Brook within SJ3148.

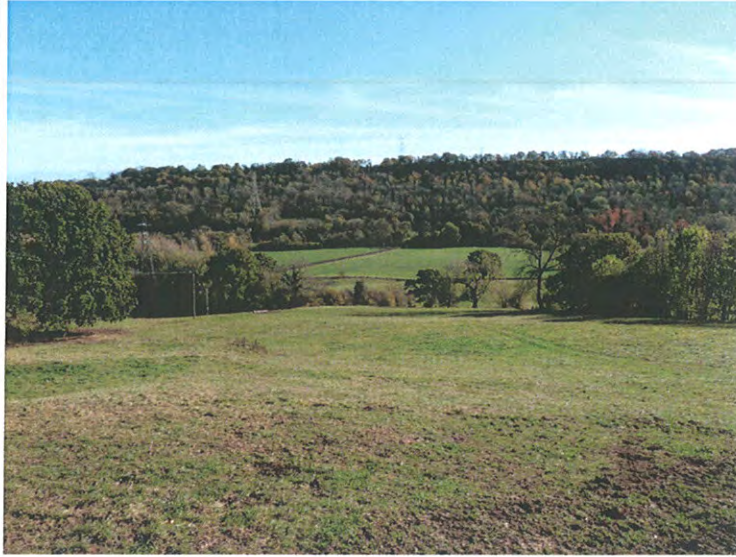
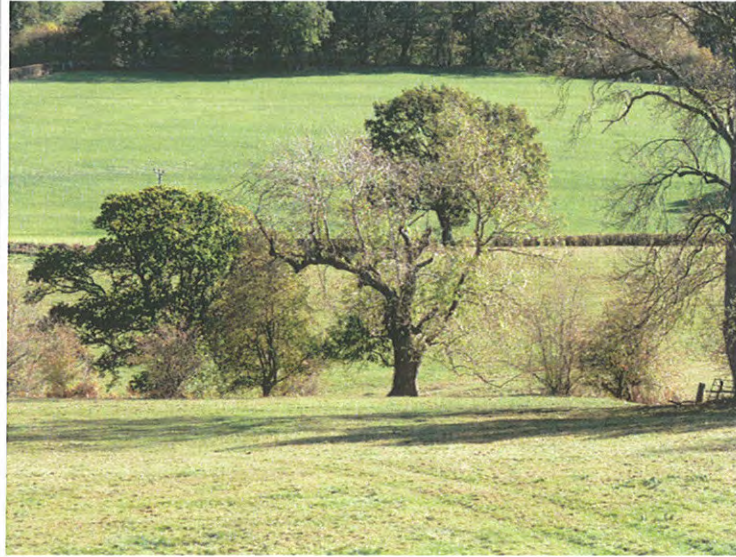
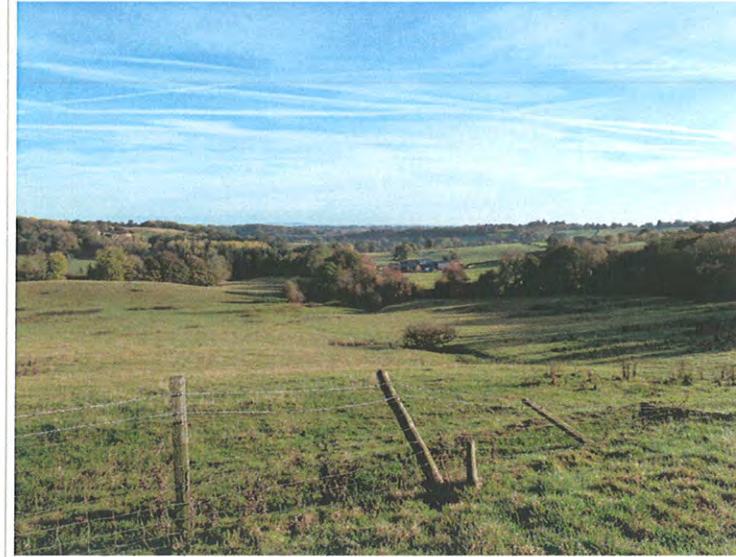
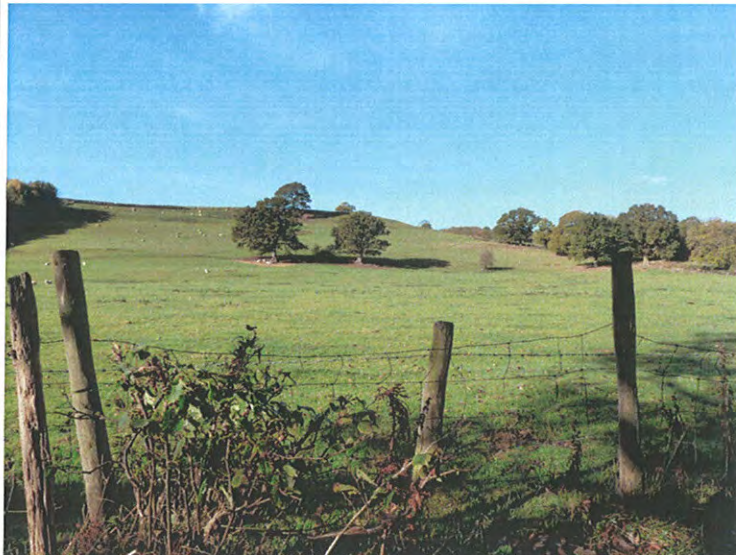
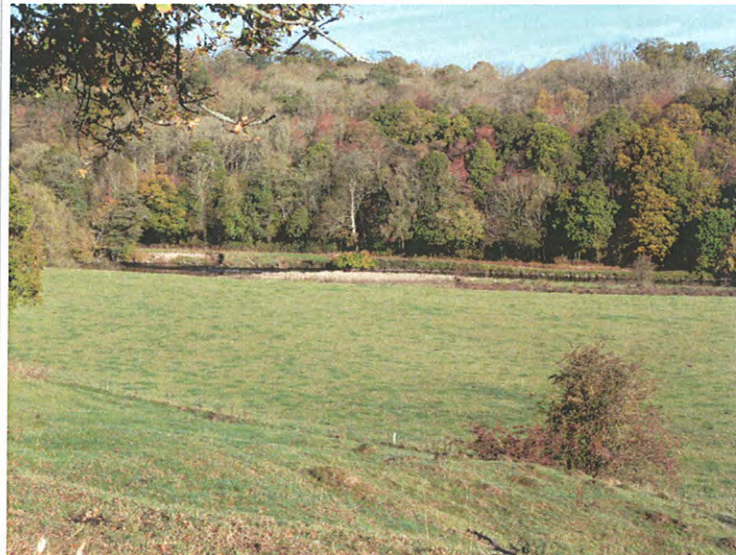
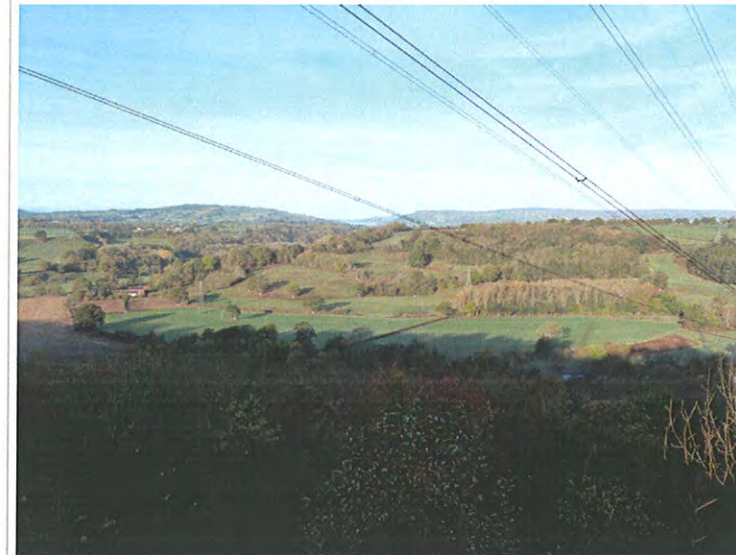
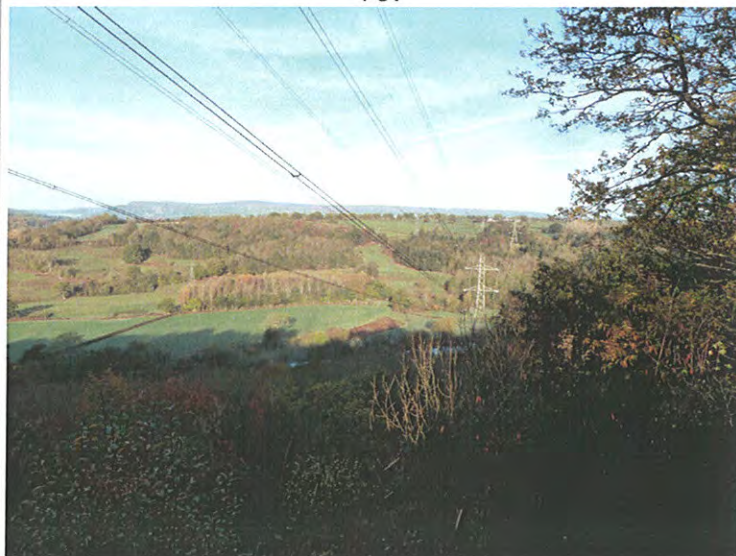
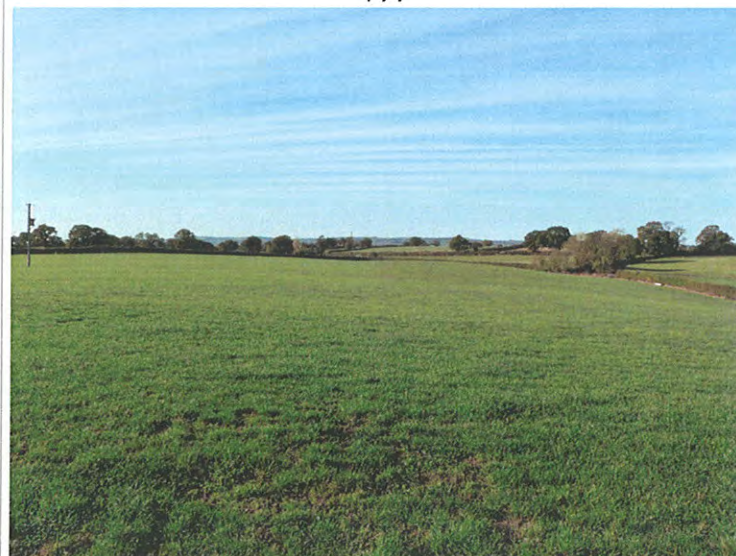
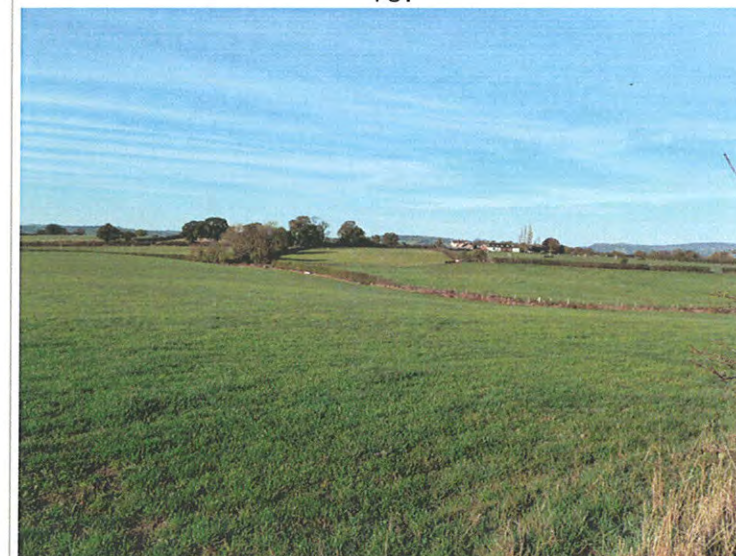
- 10. View of wooded valley of the River Dee (SJ3140)
- 11. Mature tree identified as potential barn owl nest site 500 metres to East of proposed OHL.
- 12. Area of pasture near Flannog Farm in the Southeast corner of SJ3141.
- 13. Steep-sided slopes of pasture (SJ3139).
- 14. Area of flat pasture along the River Dee with exposed sand banks showing in the background.
- 15. View of fields at base of Dee valley (SJ3239).
- 16. View of fields at base of Dee Valley (SJ3239).
- 17. Area of pasture habitat within SJ3239.
- 18. View Area of pasture habitat within SJ3239.

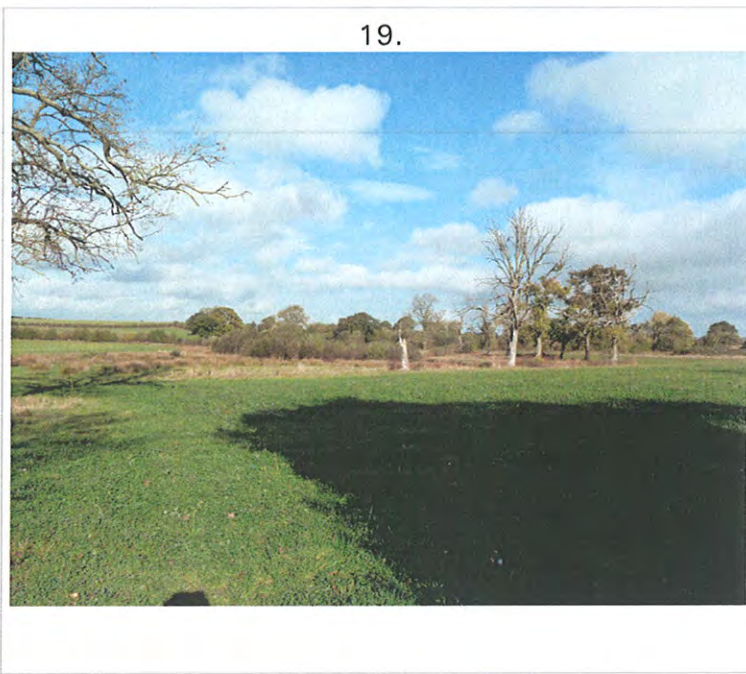
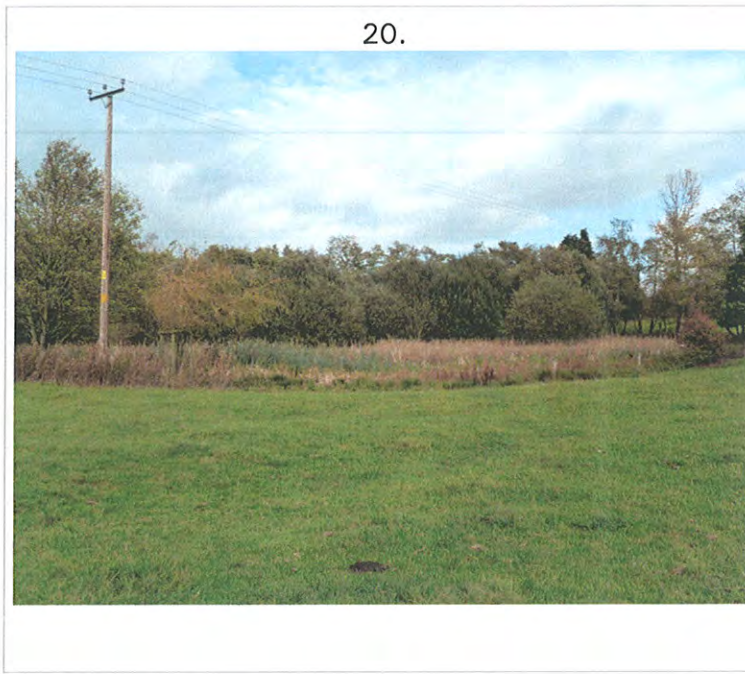
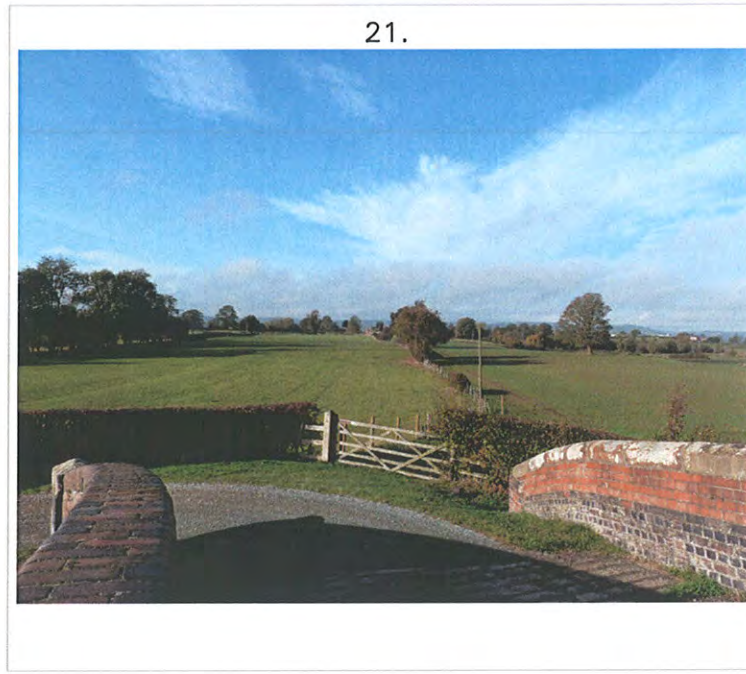
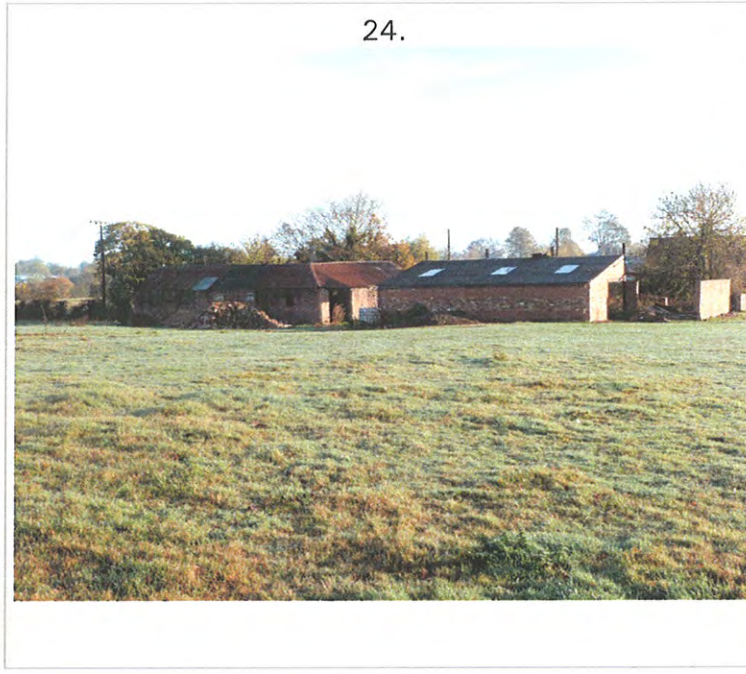
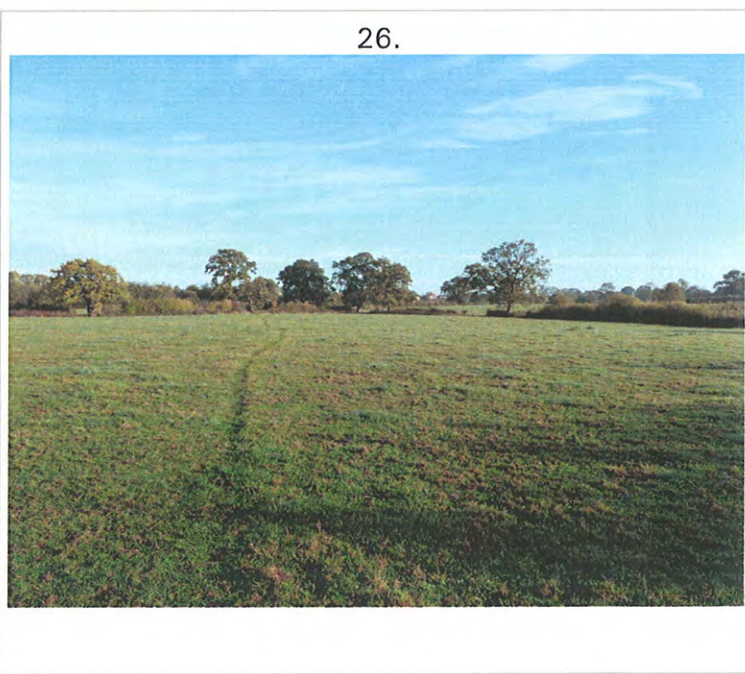
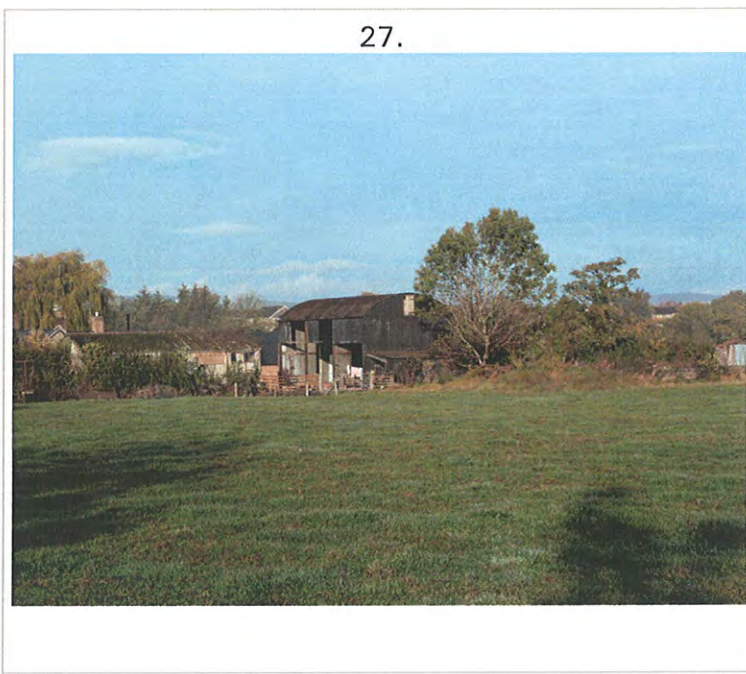
Title
 Photographic Reference sheet - Bird Habitat Assessment Area 3

- 19. Wet flush and marshy grassland in Northeast quarter of SJ3134.
- 20. Small wet flush in Southwest quarter of SJ3134.
- 21. View from New Marton Bridge looking West across typical habitat (SJ3234).
- 22. Large dead tree with suitable cavities for barn owl (SJ3235).
- 23. Rush dominated pasture provides prime breeding habitat for waders (SJ3235).
- 24. Farm building with barn owl nesting potential 1km west of proposed overhead line route (SJ3236).
- 25. Group of trees suitable for nesting barn owl located 200 metres west of proposed overhead line route (SJ3236).
- 26. Pasture fields within SJ3236.
- 27. Pasture fields and typical farm outbuildings within SJ3236.
