**Glenmuckloch to
Glenglass
Reinforcement Project
Appendix 7.3: Peat
Survey Report**

Final report
Prepared by Kaya Consulting/LUC/SPEN
January 2023

Project Number
10191

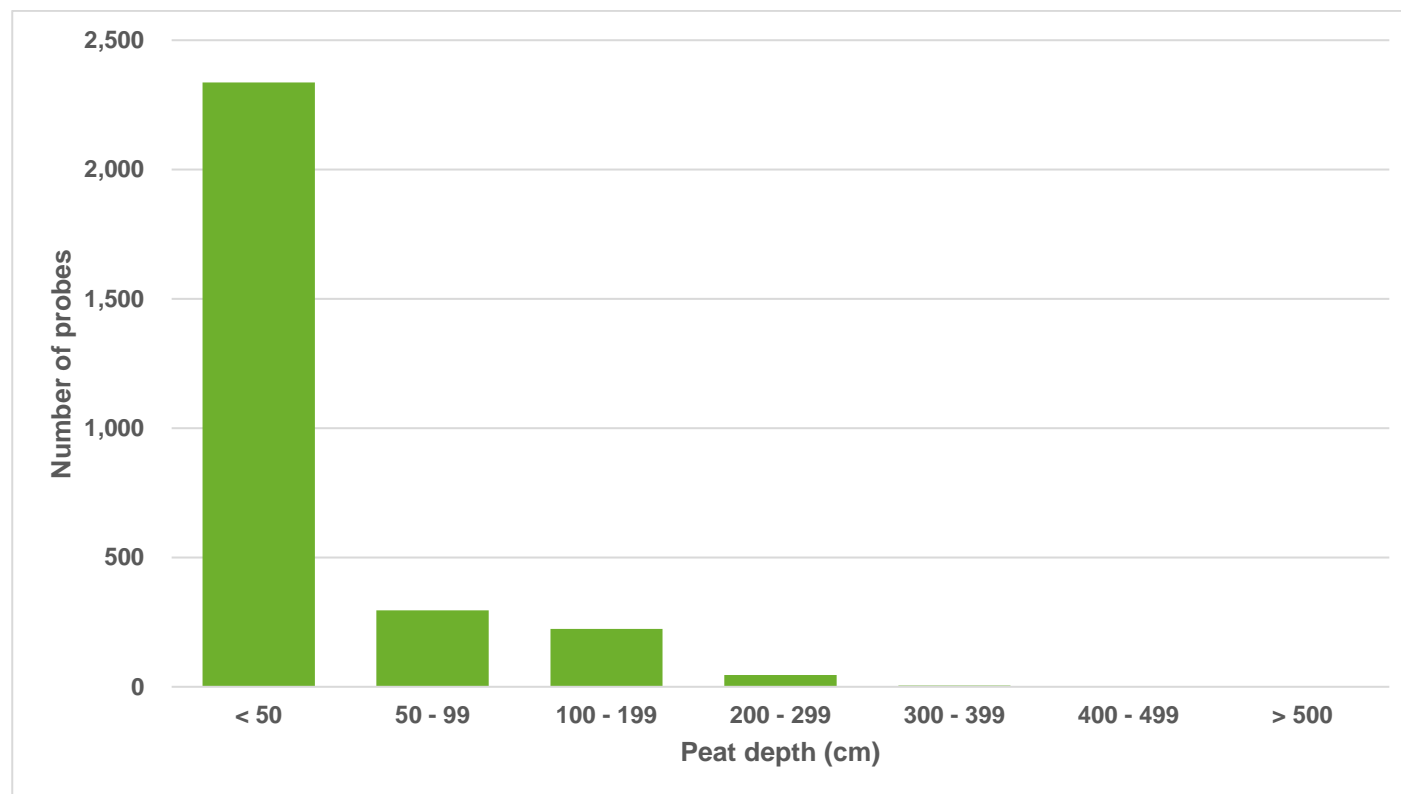
Figure 1: A histogram showing the peat depth measurements for the site

1.13 **Table 1** and **Figure 1** shows the range of results obtained during the peat survey. A total of 2,908 probes were collected across the survey period.

Peat depth range (cm)	Number of probes	Percentage of total probes
< 50	2,337	80.4%
50 - 99	296	10.2%
100 - 199	224	7.7%
200 - 299	46	1.6%
300 - 399	5	0.2%
400 - 499	0	0.0%
> 500	0	0.0%
Total	2,908	100%

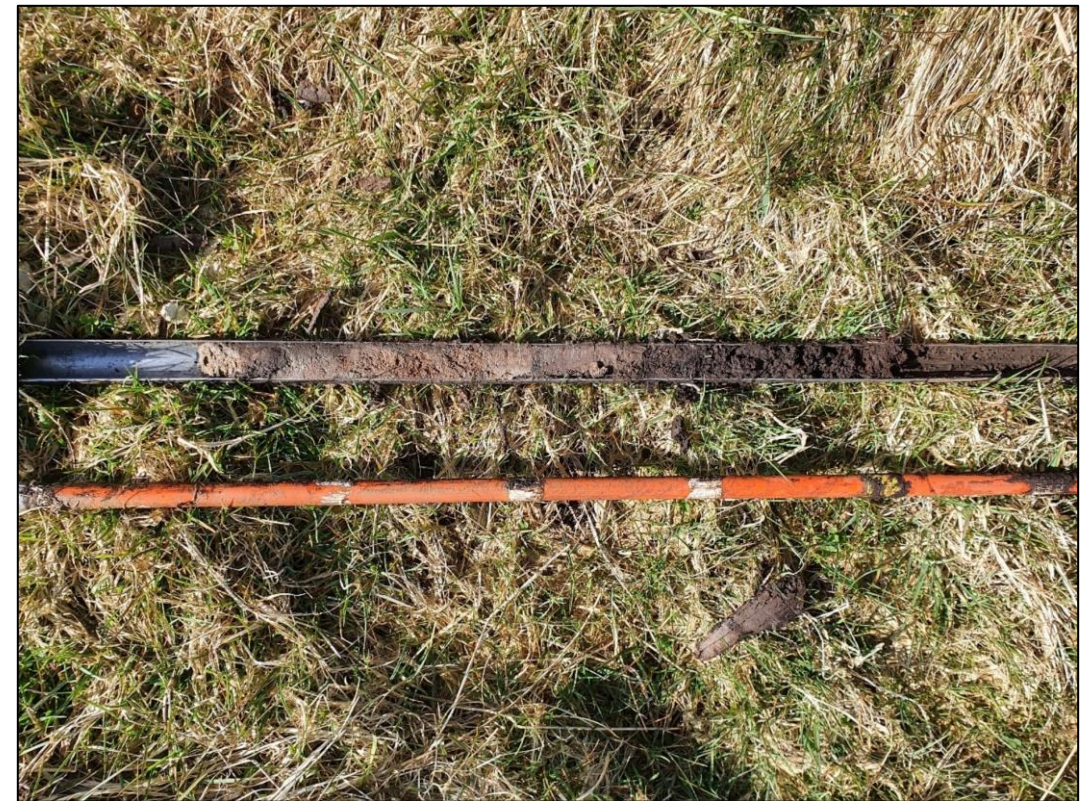
Photo 1: An example of a clay bottom to a peat core

1.17 Generally, the substrate material was mixed with cores containing peat having either a clay, rock/gravel or bedrock base. An example of the peat core with a clay base is evident in **Photo 1**. A general close-up of a peat core is shown in **Photo 2**.

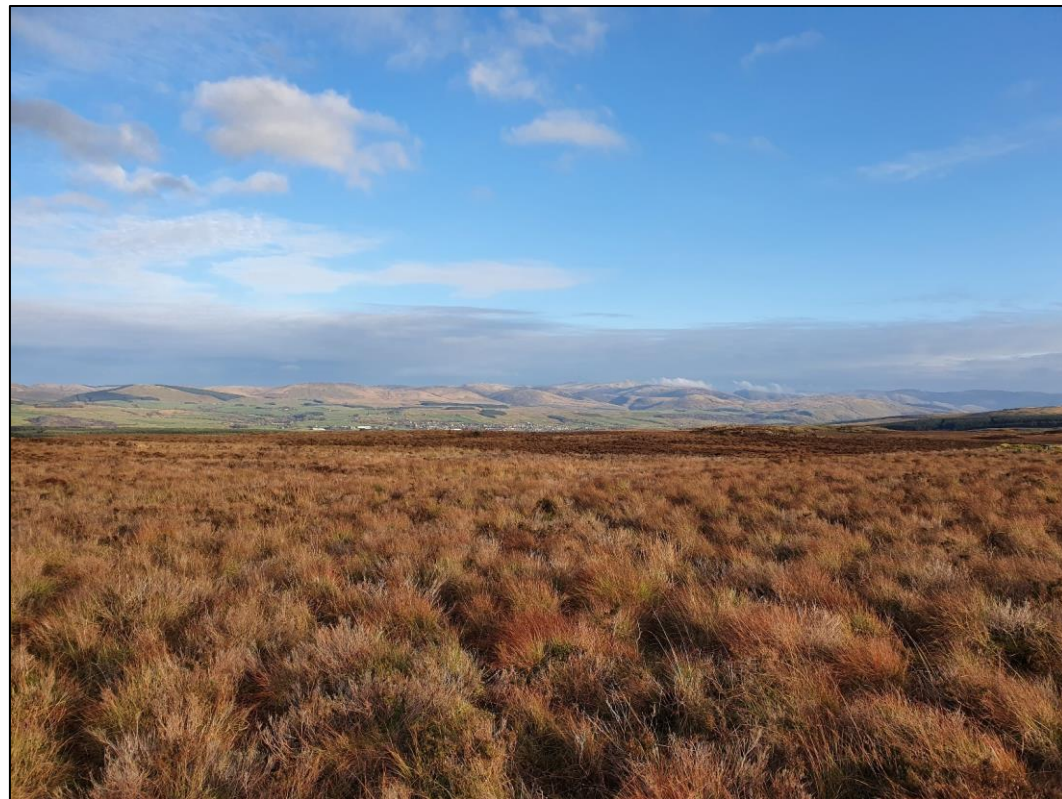
Photo 3: Typical upland vegetation on Barr Moor in the southern part of the route

1.18 The entire site appeared to have been influenced by recent or historic human activity. Along the route there were areas of peat with a depth greater than 100cm; these were predominantly concentrated in the southern part of the route on Barr Moor (see **Photo 3**). A small area in the northern part of the route, near Rigg Farm, was also found to have deep peat; this area was well constrained with the peat located in a topographic hollow (see **Photo 4**) and was avoided during route design iterations.

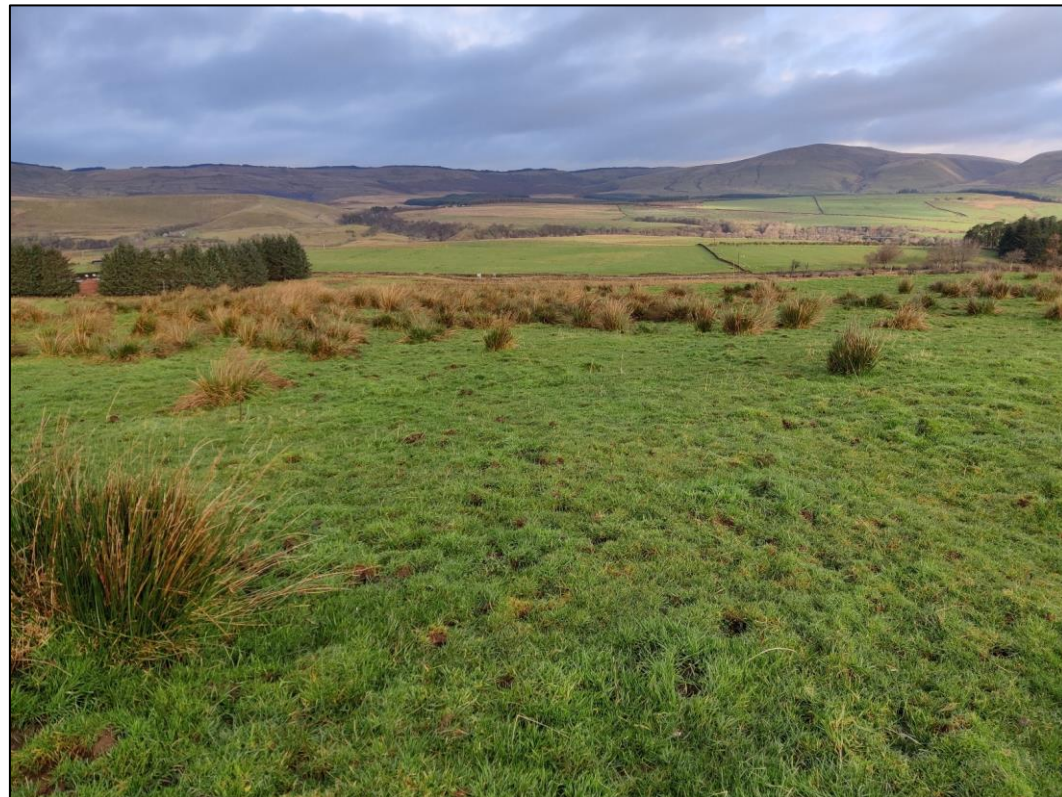
Photo 7: Improved grassland in the northern part of the route

1.20 Areas of improved grassland in the northern part of the route (see **Photo 7**) were predominantly mineral soil with only isolated pockets of peat.

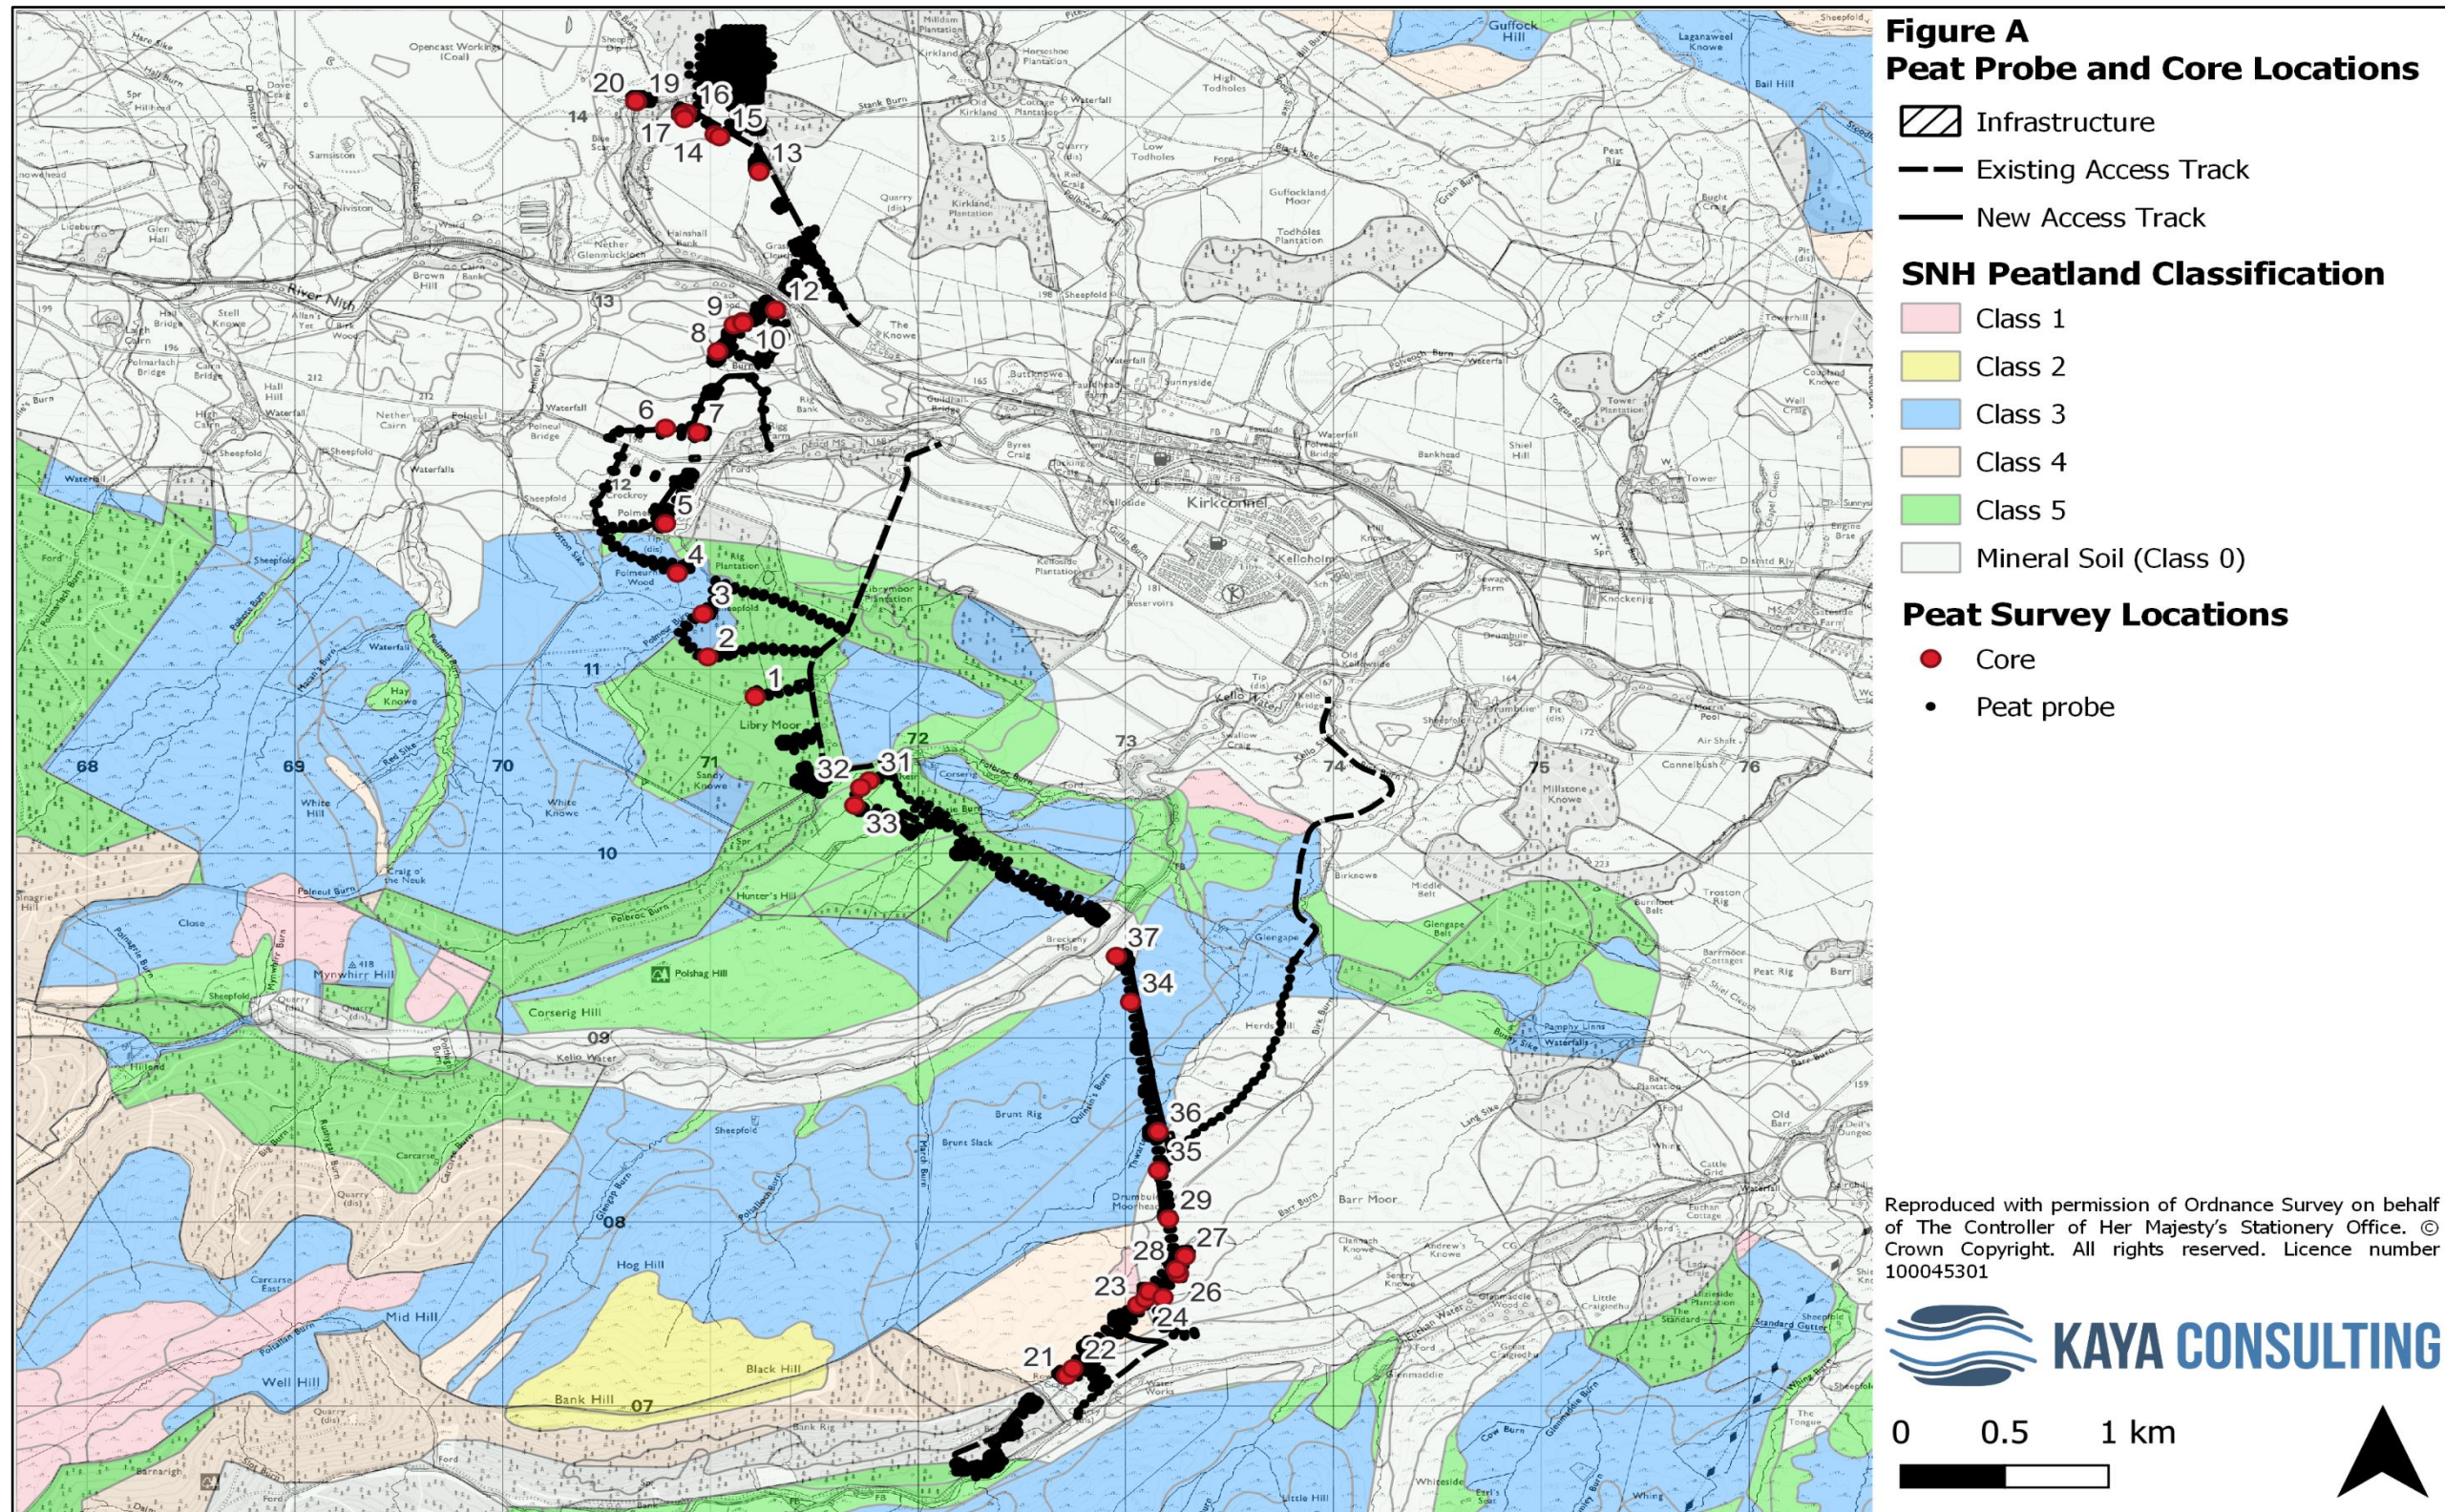
1.3 **Figure A** (see end of document) shows the extent of the route and survey. The survey covers the OHL route, Glenmuckloch Substation and access tracks. The route is comprised of a mix of upland heath, bog, improved grassland, and a commercial conifer plantation forestry.

1.7 The Carbon and Peatland map for the route is shown in **Figure A**. The central and southern part of the route is predominantly comprised of Class 3 and Class 5 peatland with small areas of Class 4 peatland and mineral soil. There is a small area of Class 1 peatland just west of the route in the upper catchment of the Barr Burn, but this was avoided during early design iterations. The northern part of the route is marked as mineral soil.

- A total of 2,908 sampling points were surveyed. The peat depth data was fed back iteratively to the design team to inform constraints mapping and the layout was revised to avoid deep peat areas where possible. Therefore, multiple iterations of the route alignment were surveyed with some areas sampled not carried forward in the final development plan. The extent of the peat survey is illustrated in **Figure A**.

- Peat cores were taken using a gouge auger (20mm diameter) to confirm the existence and composition of peat. Cores were taken at representative locations across the site. The locations of the cores are shown in **Figure A**.
