**Glenmuckloch to
Glenglass
Reinforcement Project
Appendix 7.3: Peat
Survey Report**

Final report
Prepared by Kaya Consulting/LUC/SPEN
January 2023

Project Number
10191

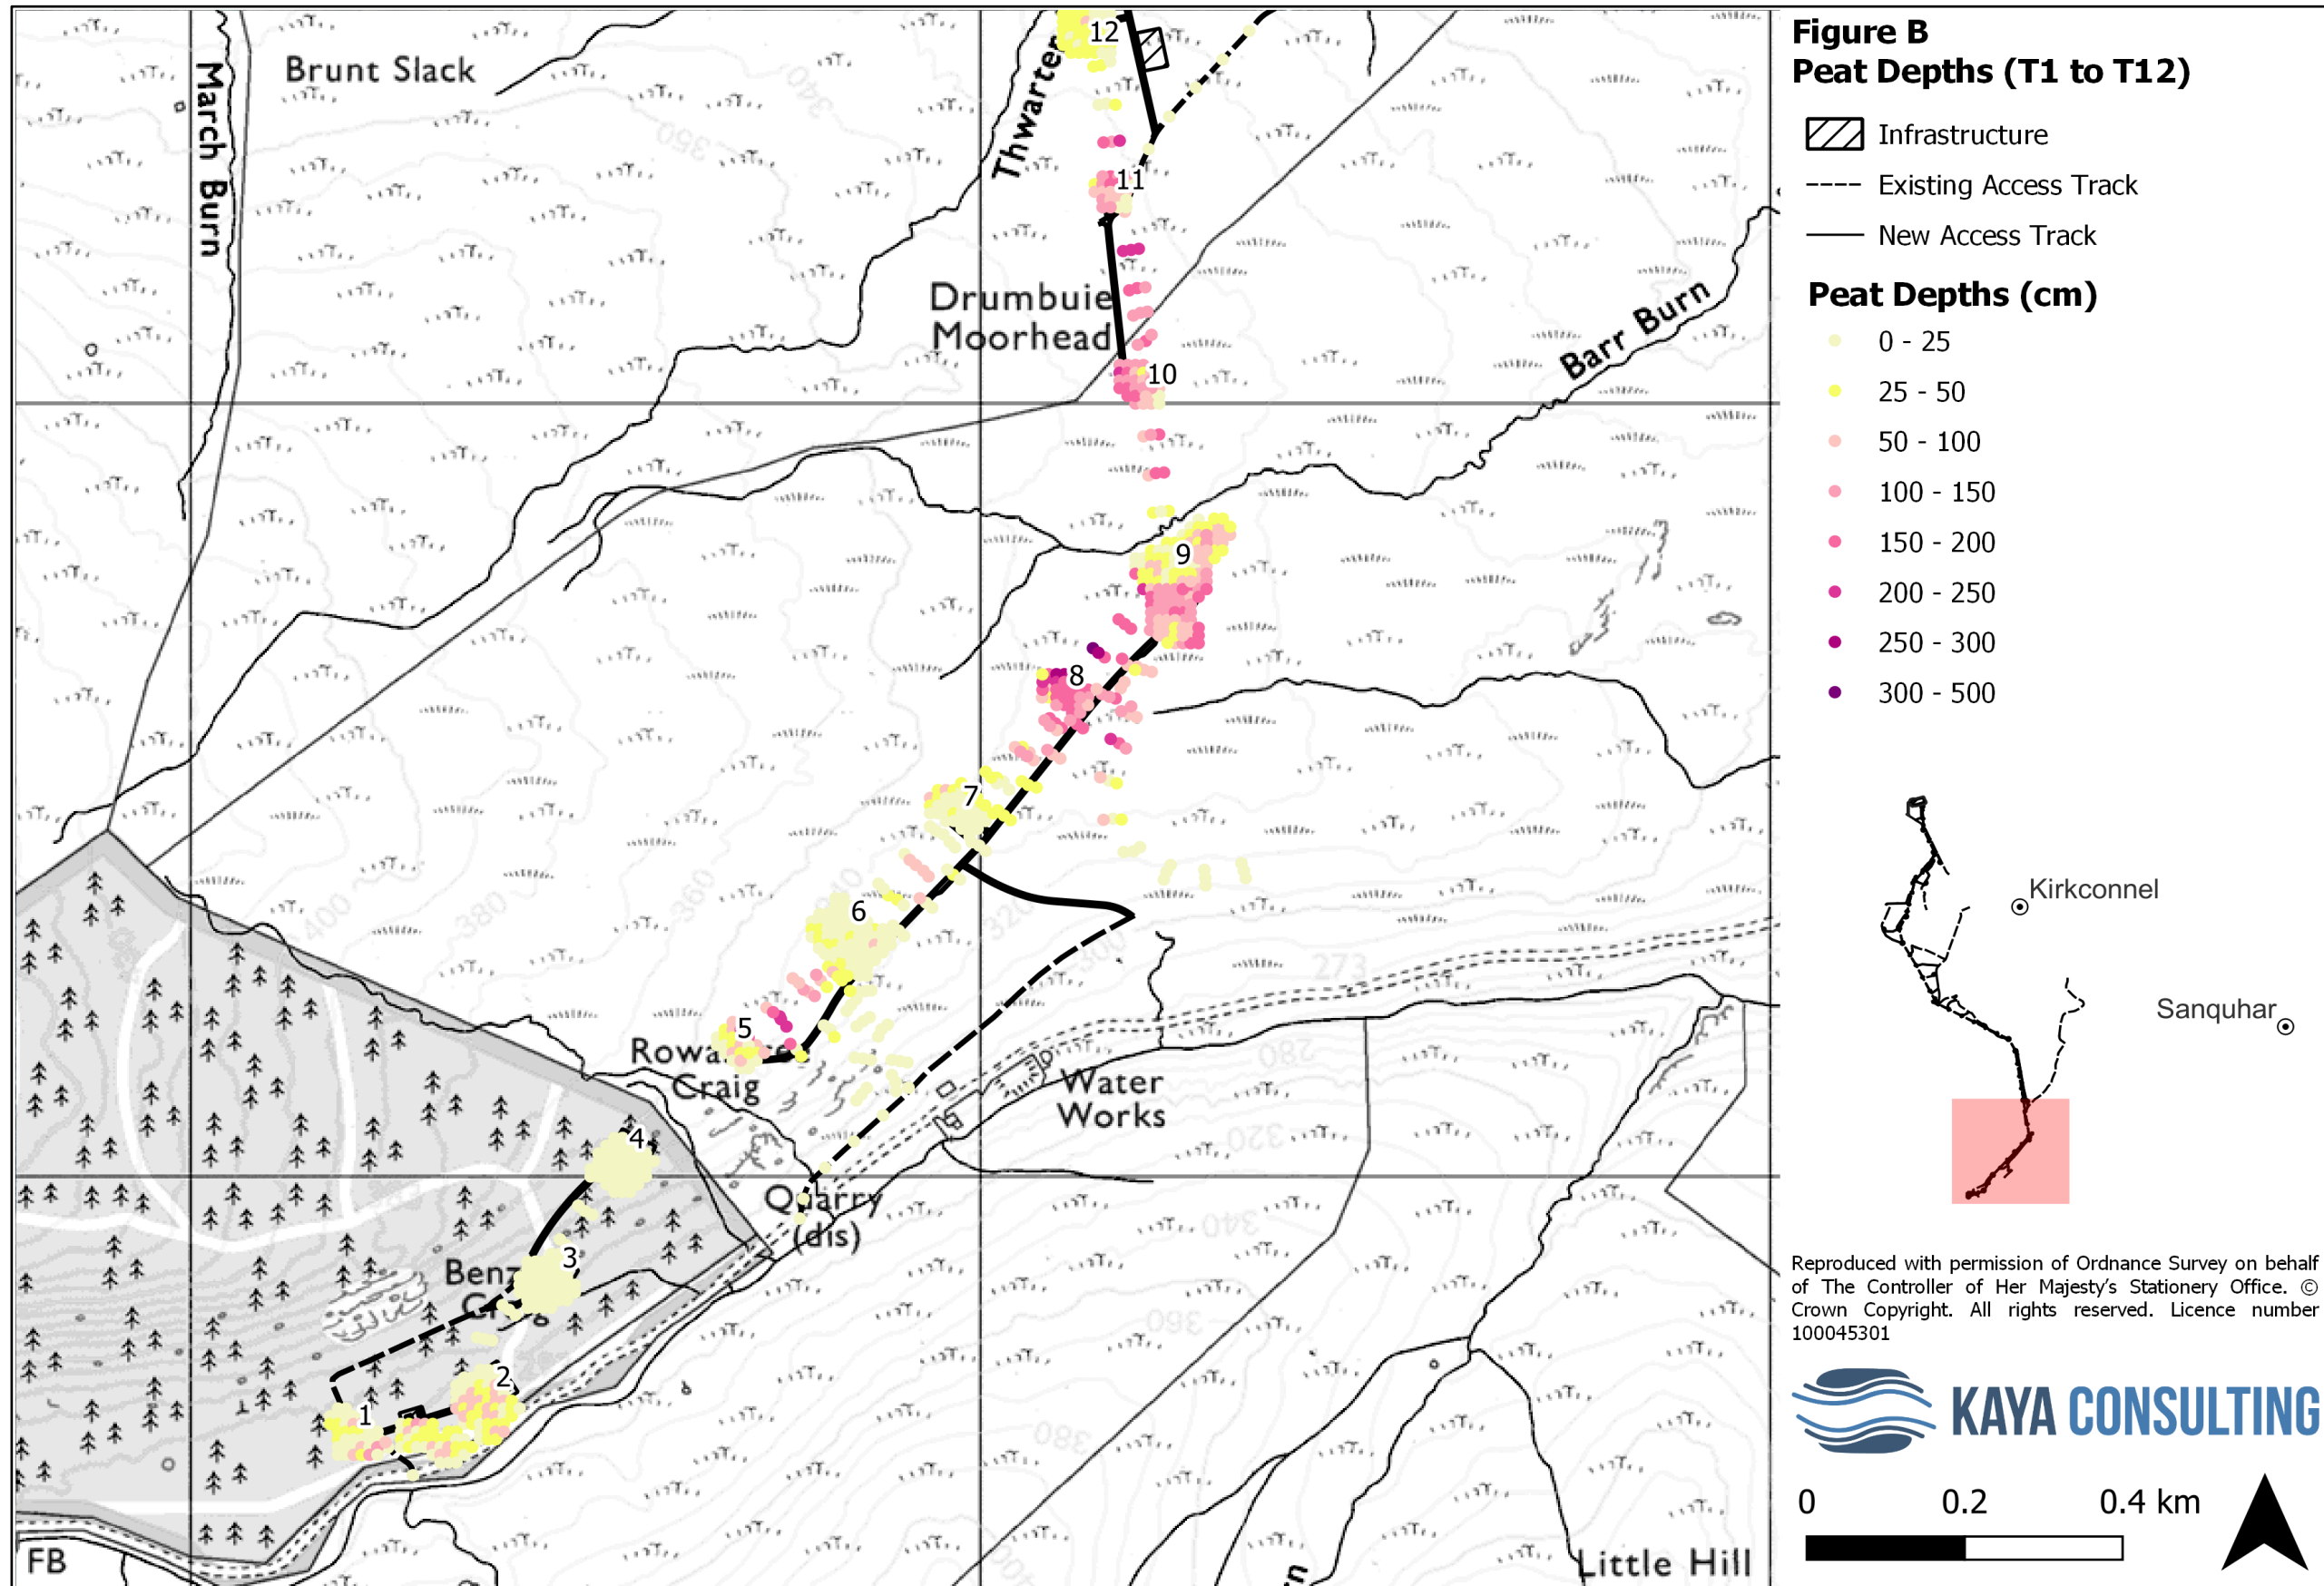
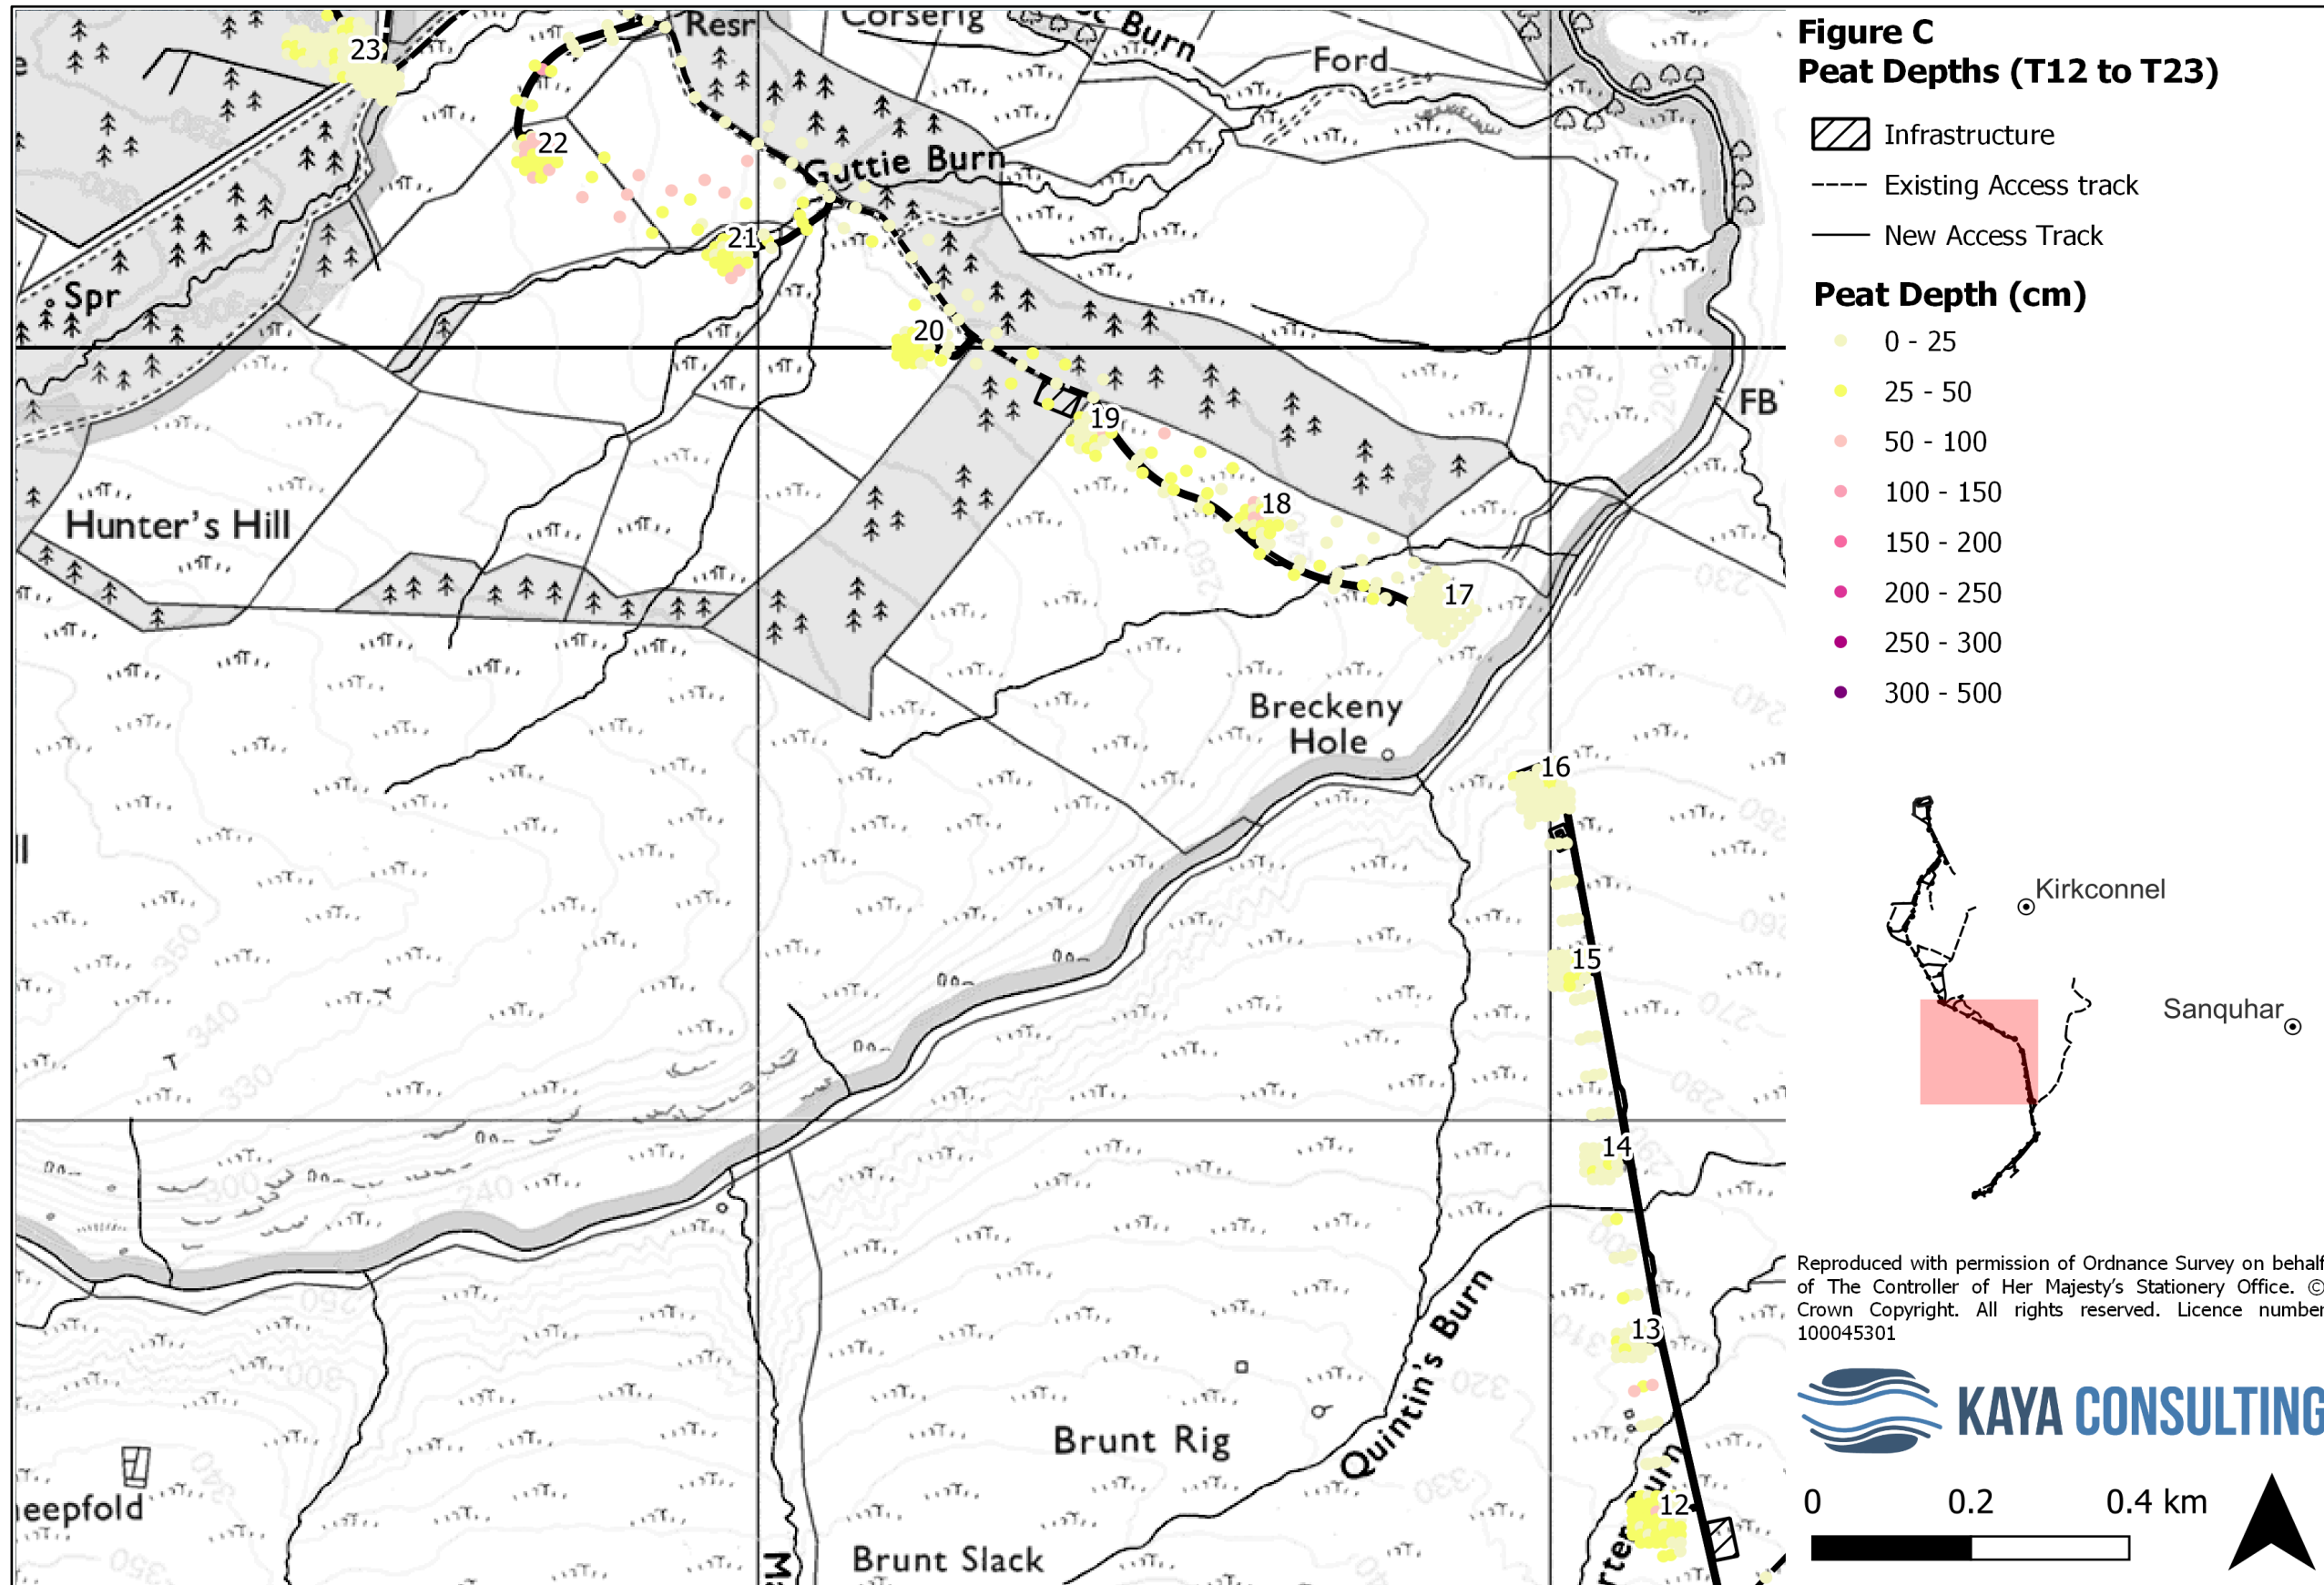
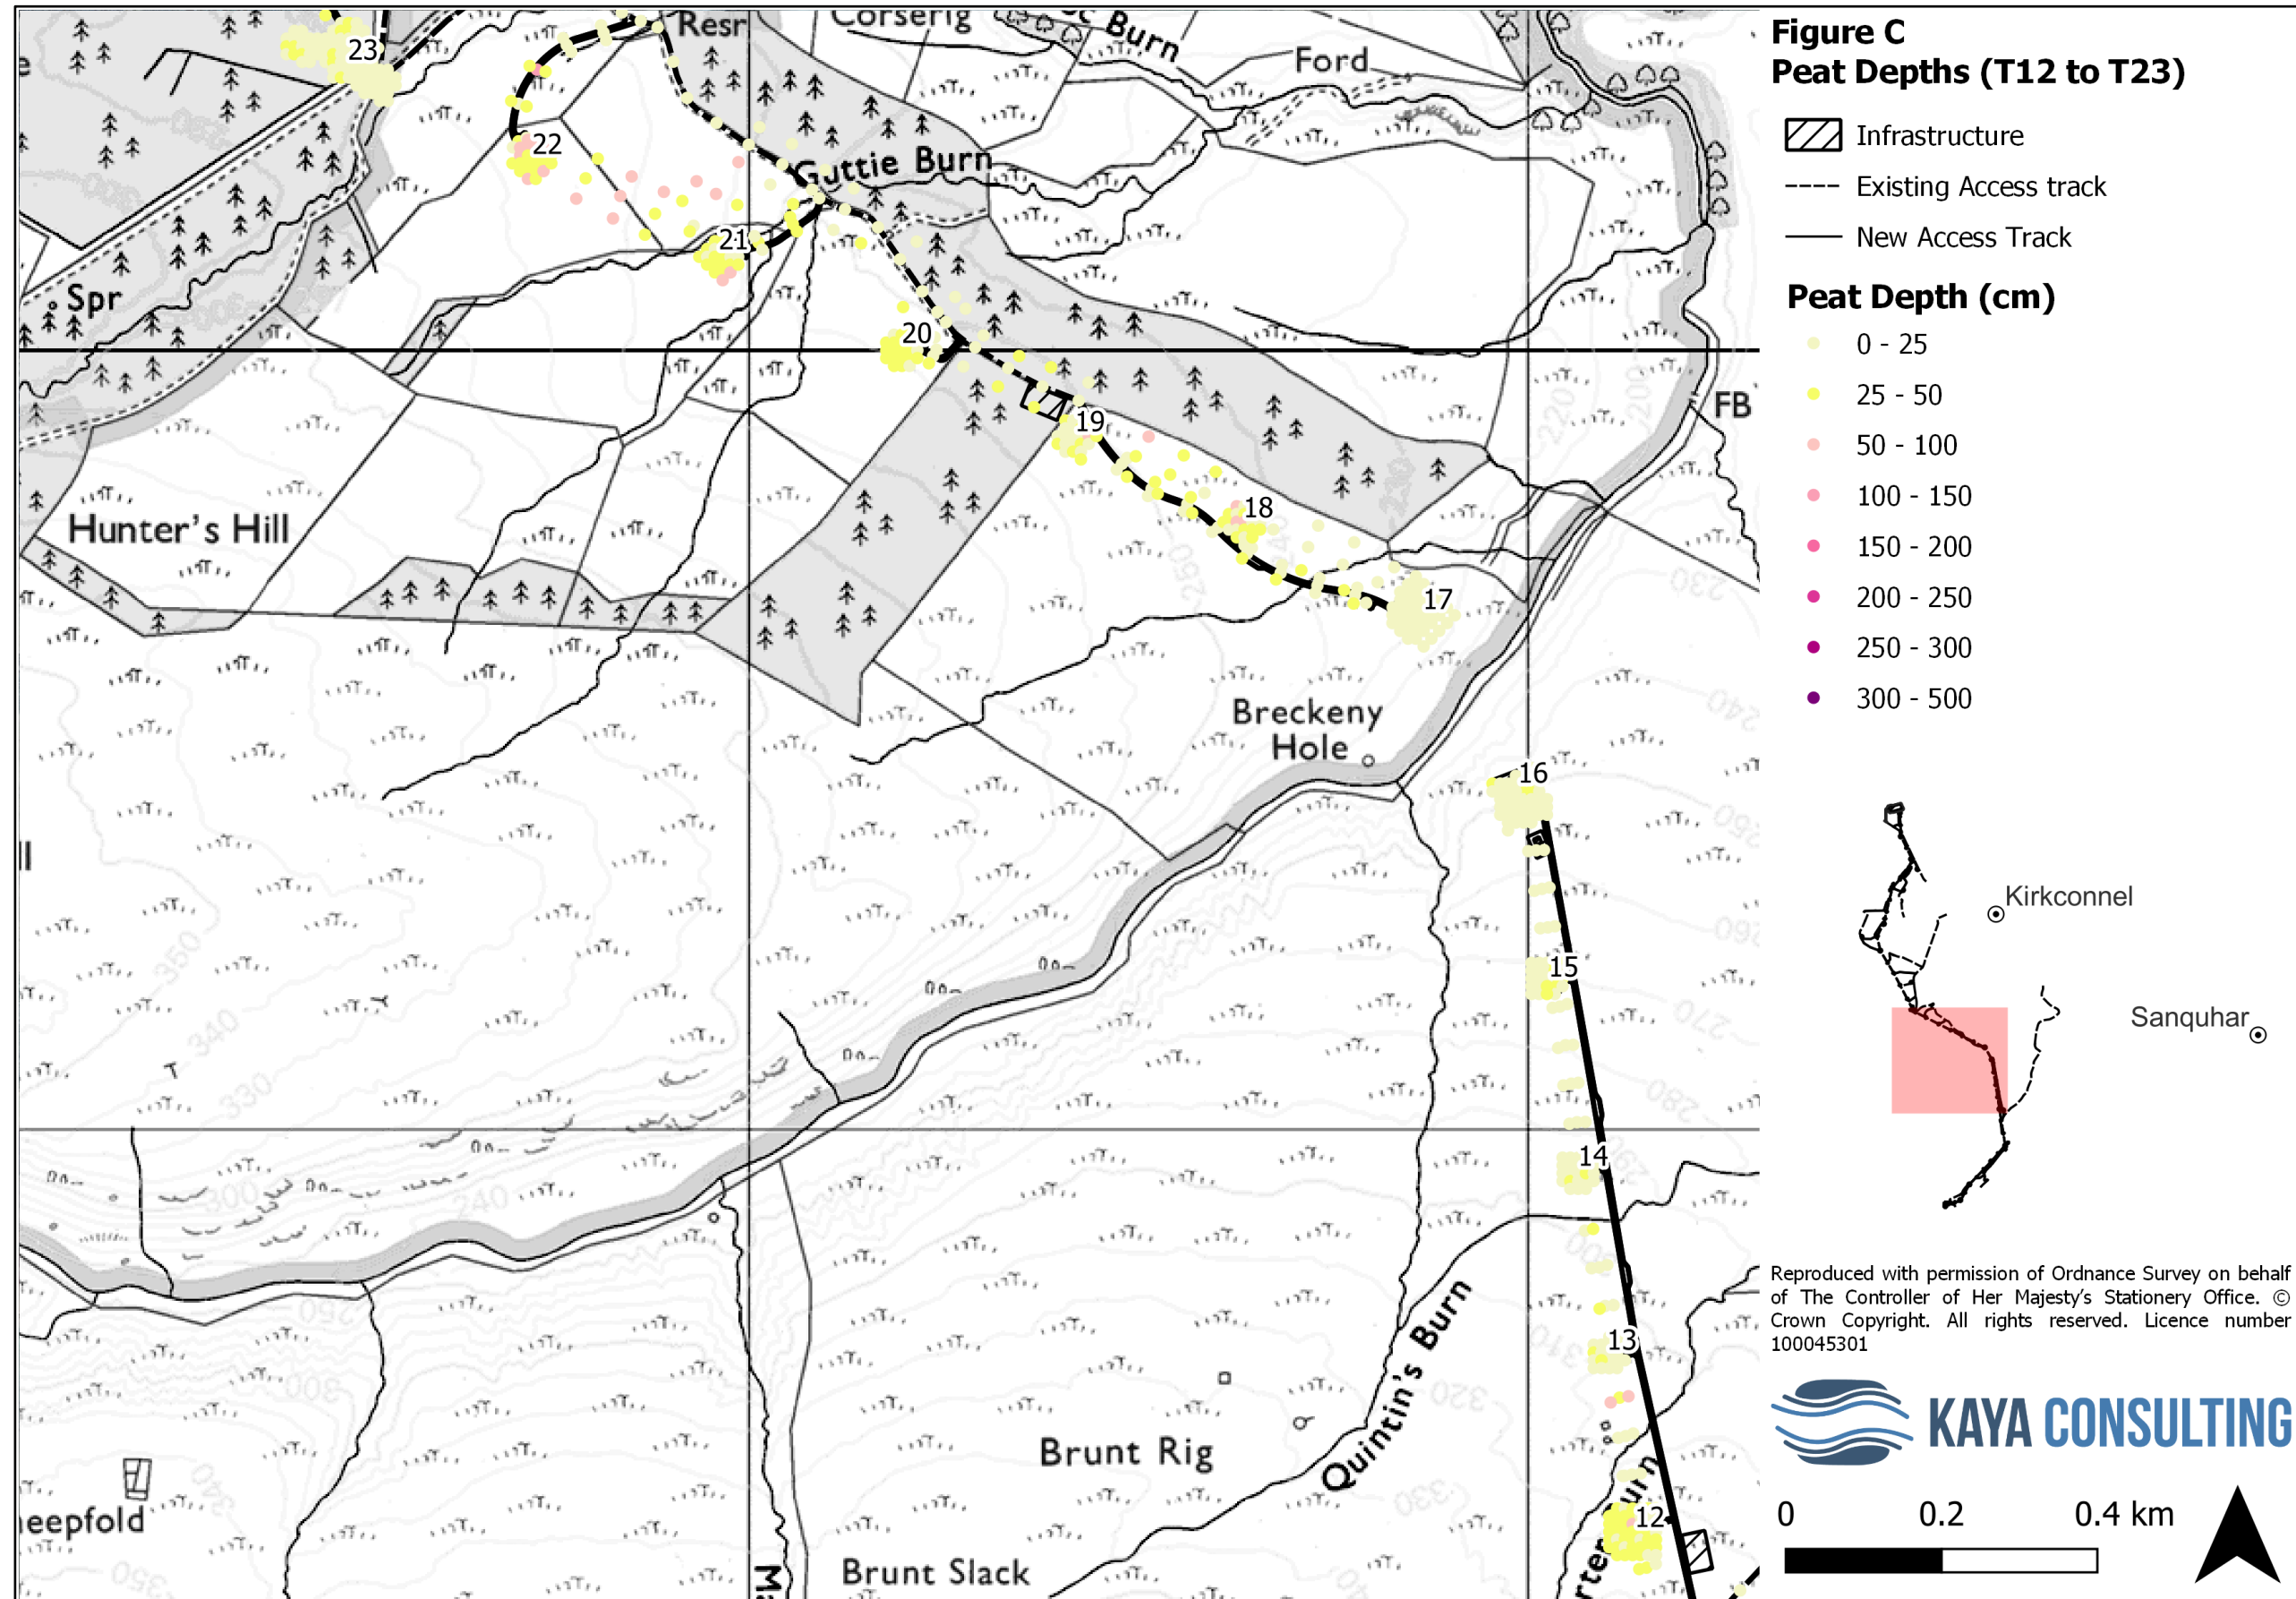
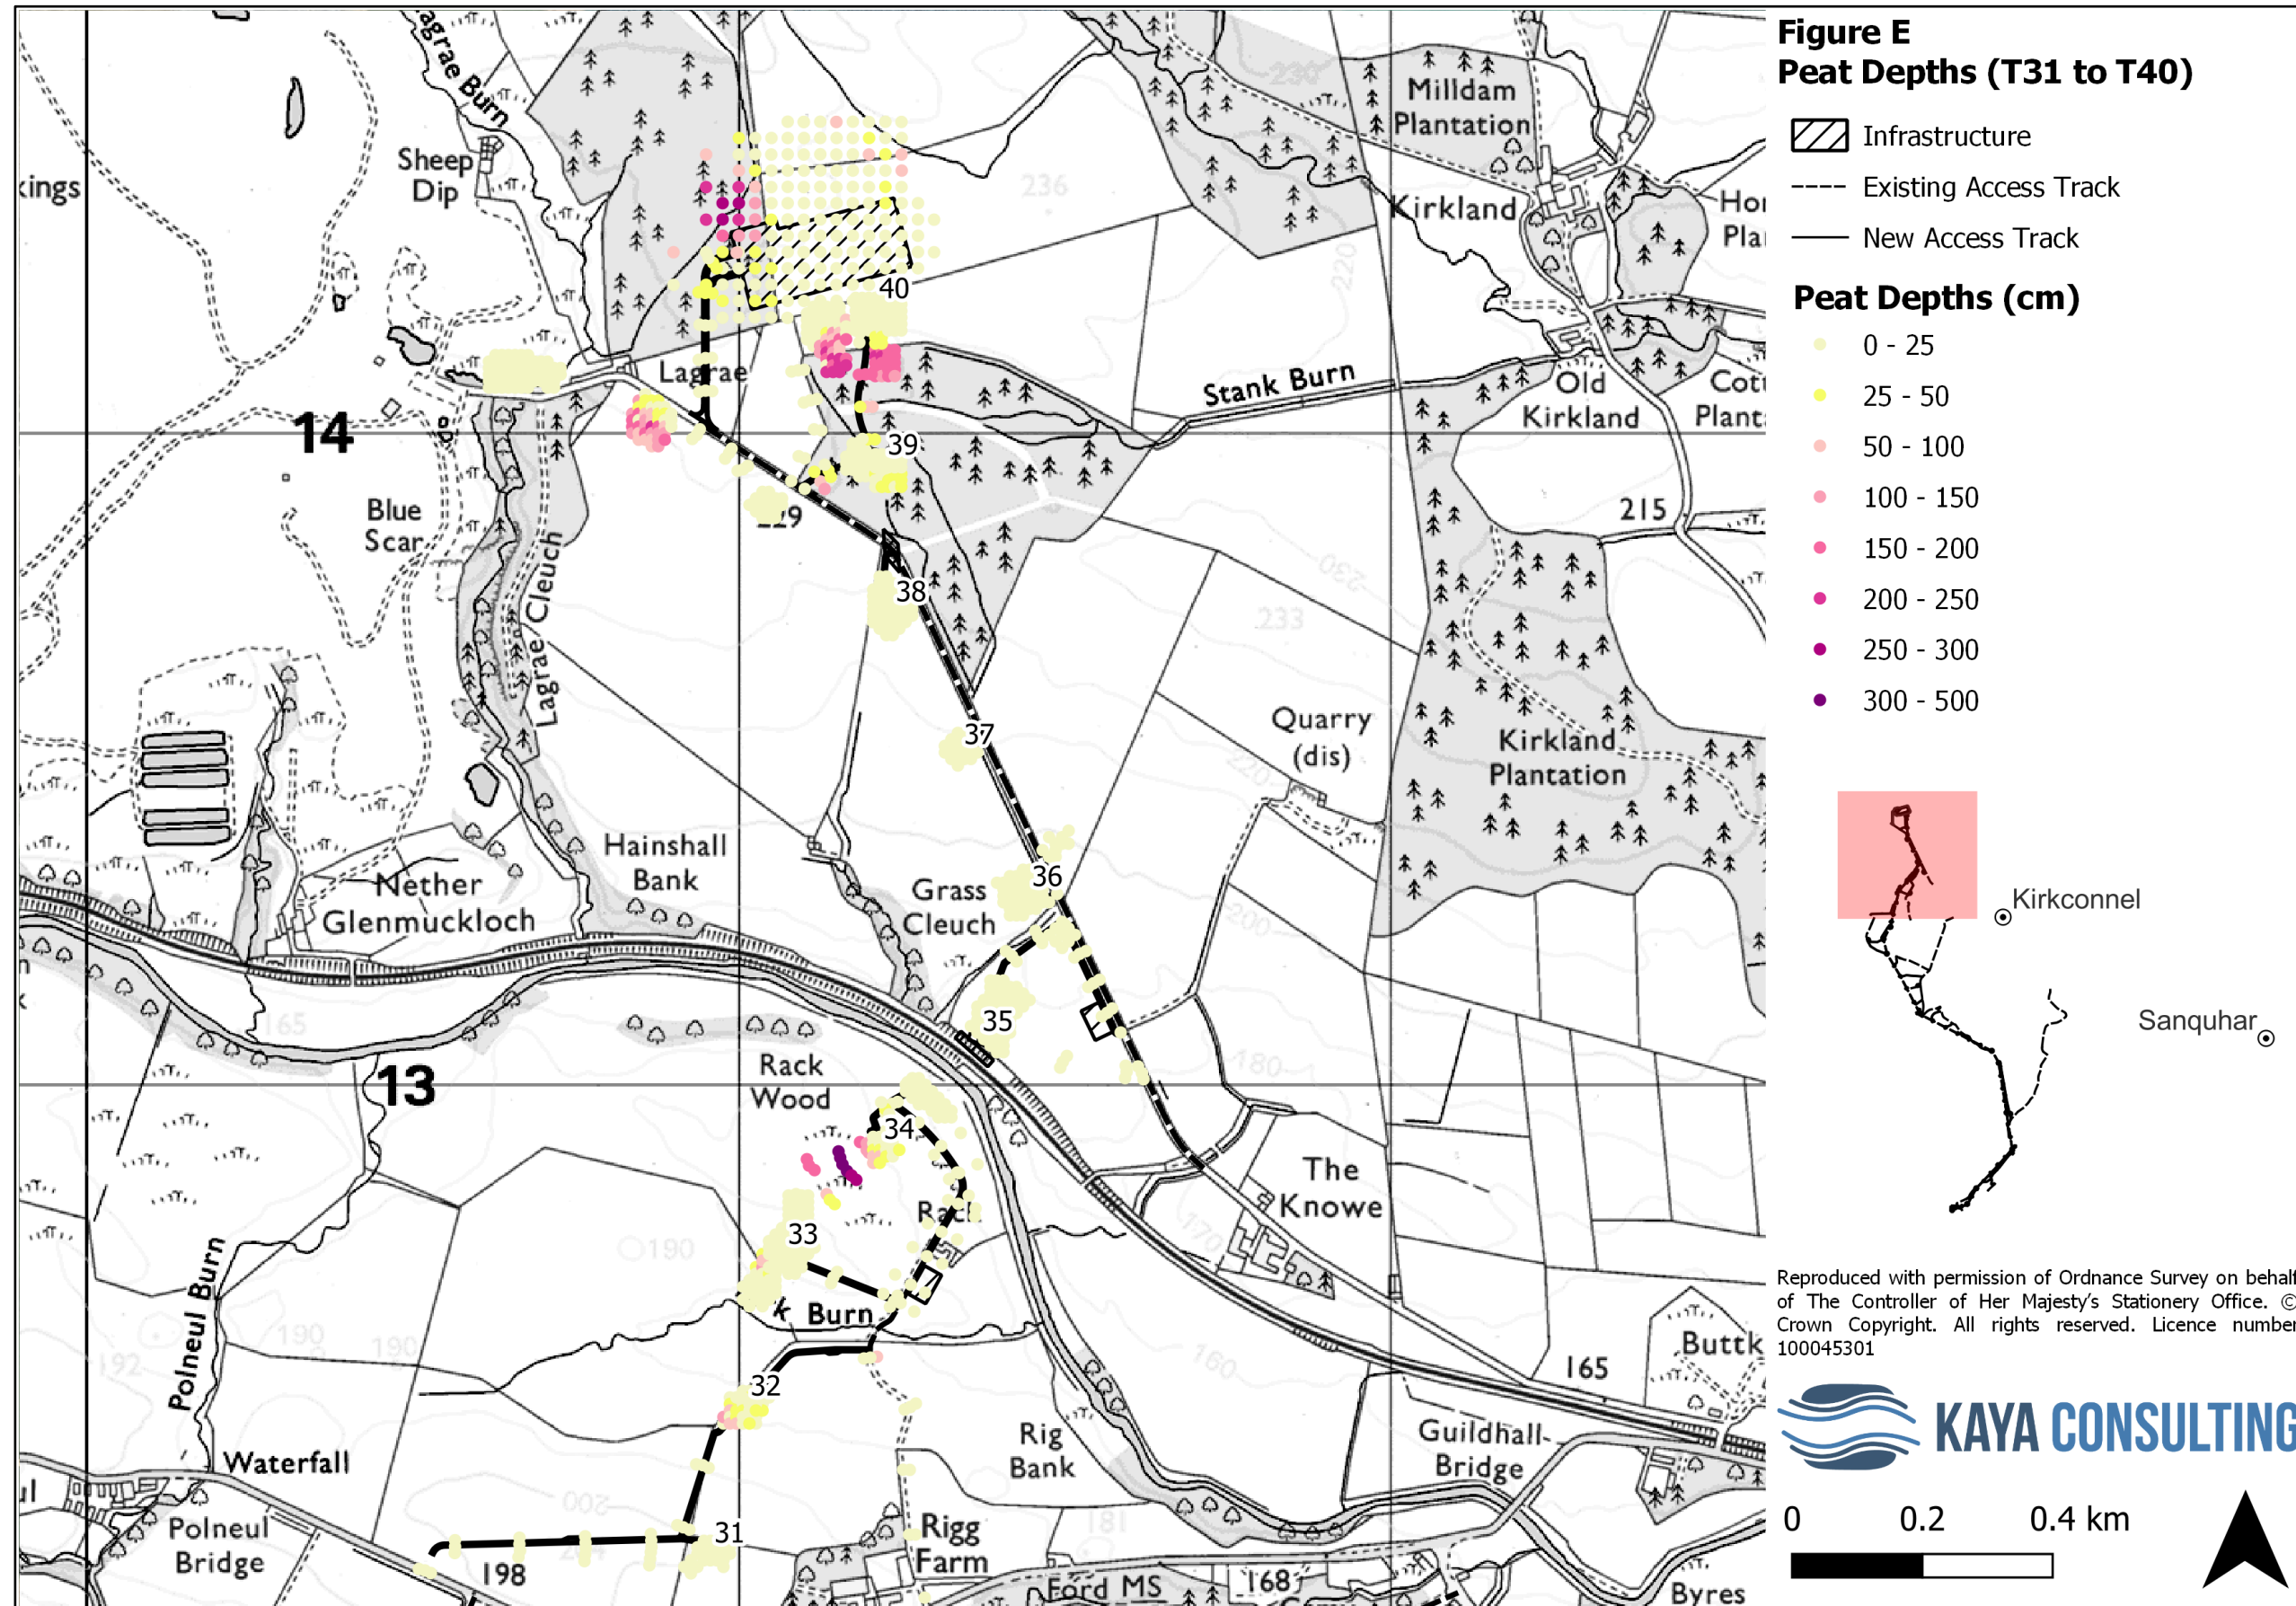
1.15 **Figures B to E** (see end of document) show the spatial distribution of the peat depths from the peat survey data. 80.4% of probes were recorded as having a peat depth of less than 50cm across the peat survey. These probes are classified as organo-mineral soils and not formally considered to be peat. 90.5% of probes were recorded as having a peat depth of less than 100cm across the peat survey. 9.5% of the probes were recorded as having a peat depth of over 100cm across the peat survey. These probes are classified as ‘deep-peat’.
