Appendix 7.1

Watercourse Crossings and Buffers

Appendix 7.1: Glenmuckloch to Glenglass Reinforcement Project (GGRP) Watercourse Crossings and Buffers

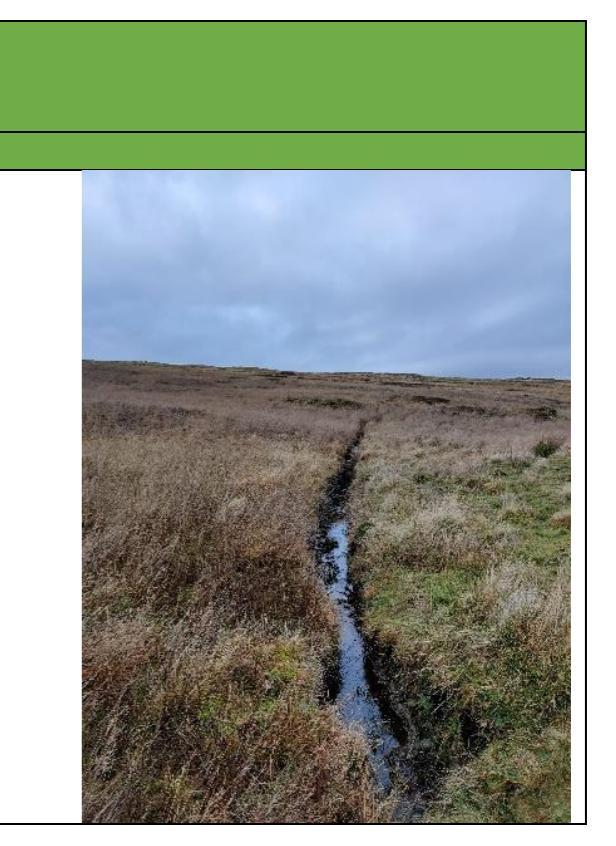
ID	Name	Easting	Northing	Width (m)	Sediment	Slope	Erosion	Crossing Type	Field Notes/ Comments	Catchment (km²)	Minor Watercourse (yes/no) ²	CAR Engineering Authorisation Required (yes/no)	Photo
Exist	ing Track Cro	ssings											
37	Unnamed	272982	607177	<1	Silt to cobble	Gentle	Unknown	Existing	Land drain (crossing 1) (viewed ~150m upstream of 37 crossing location)	0.08	Yes	No

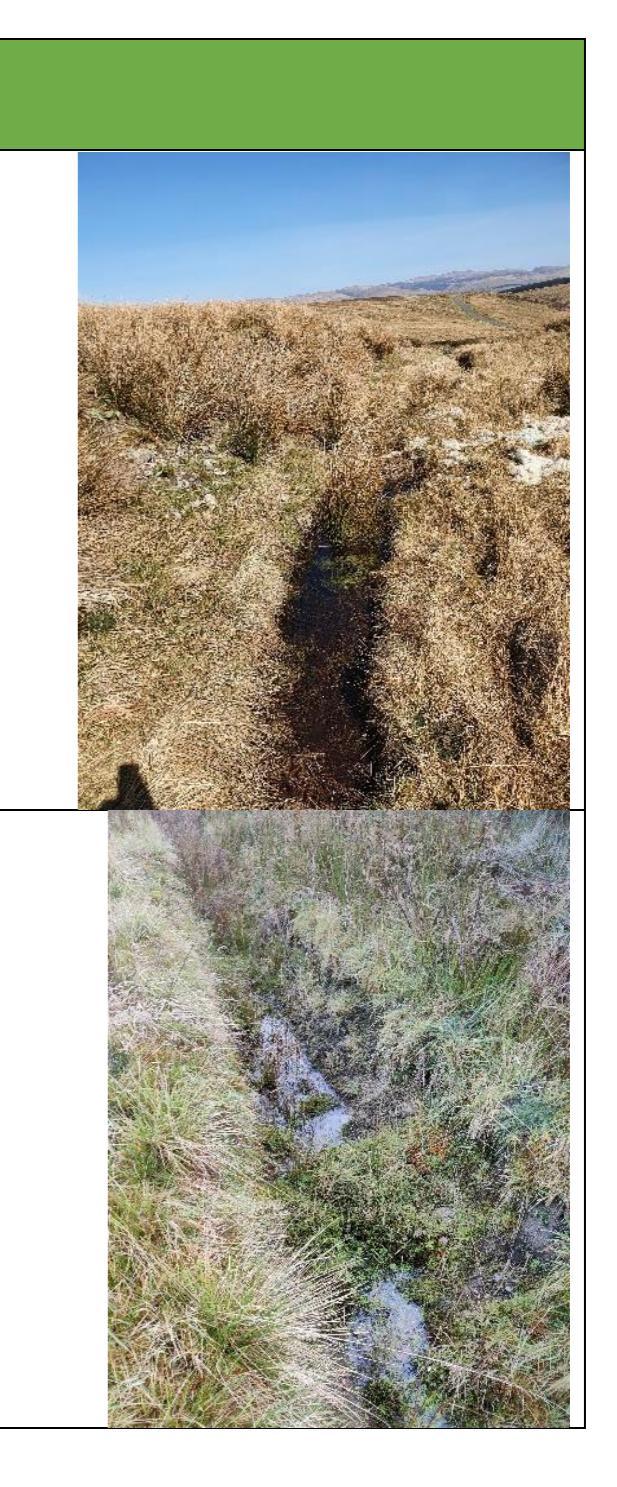
ID	Name	Easting	Northing	Width (m)	Sediment	Slope	Erosion	Crossing Type	Field Notes/ Comments	Catchment (km²)	Minor Watercourse (yes/no) ²	CAR Engineering Authorisation Required (yes/no)	Photo
38	Unnamed	273140	607307	0.8	Soil to cobble	Gentle	Not observed	Existing	Peat drain (crossing 2) (viewed ~500m upstream of 38 crossing location)	0.05	Yes	No	
13	Unnamed	272446	609892	0.7	Silt/soil	Gentle	None observed	Existing	Drains alongside track and then under in an assumed 300mm culvert	0.01	Yes	No

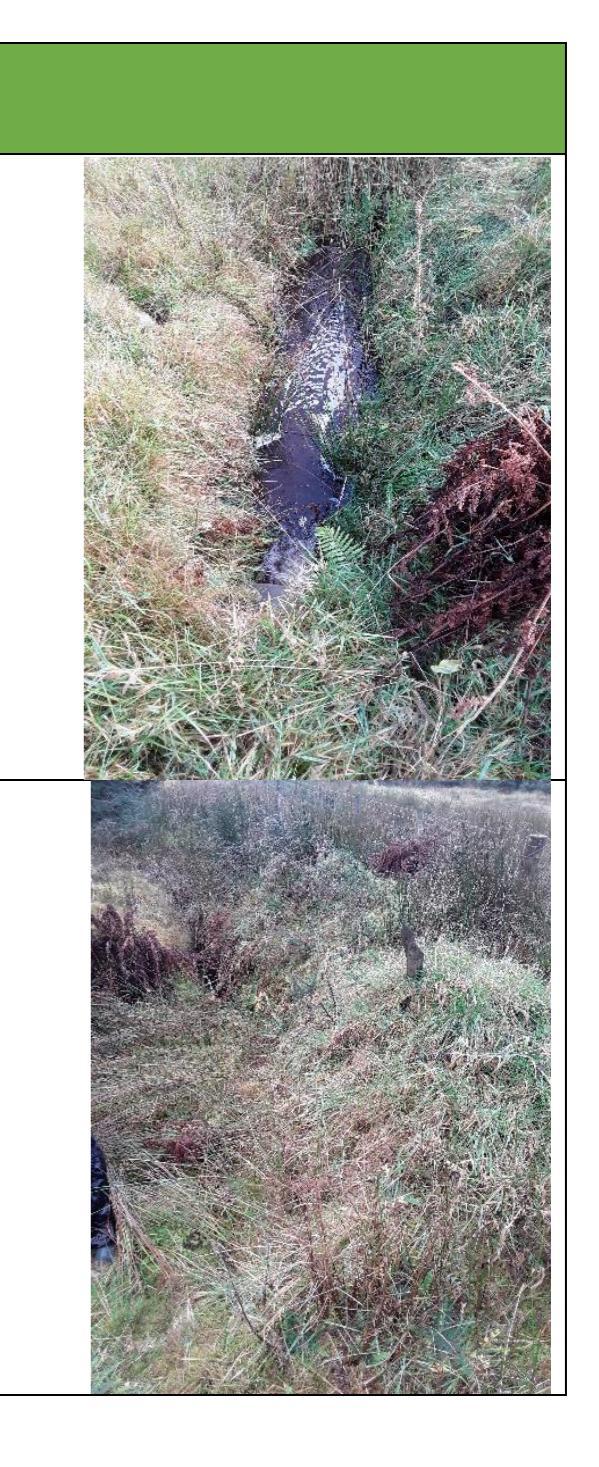
ID	Name	Easting	Northing	Width (m)	Sediment	Slope	Erosion	Crossing Type	Field Notes/ Comments	Catchment (km²)	Minor Watercourse (yes/no) ²	CAR Engineering Authorisation Required (yes/no)	Photo
14	Unnamed	272421	609937	1	Silt/soil	Gentle	None observed	Existing	Re-routed forest drainage channel	0.01	Yes	No	
15	Unnamed	272288	610007	0.3	Silt/soil	Gentle	None observed	Existing	Forest drainage channel	0.03	Yes	No

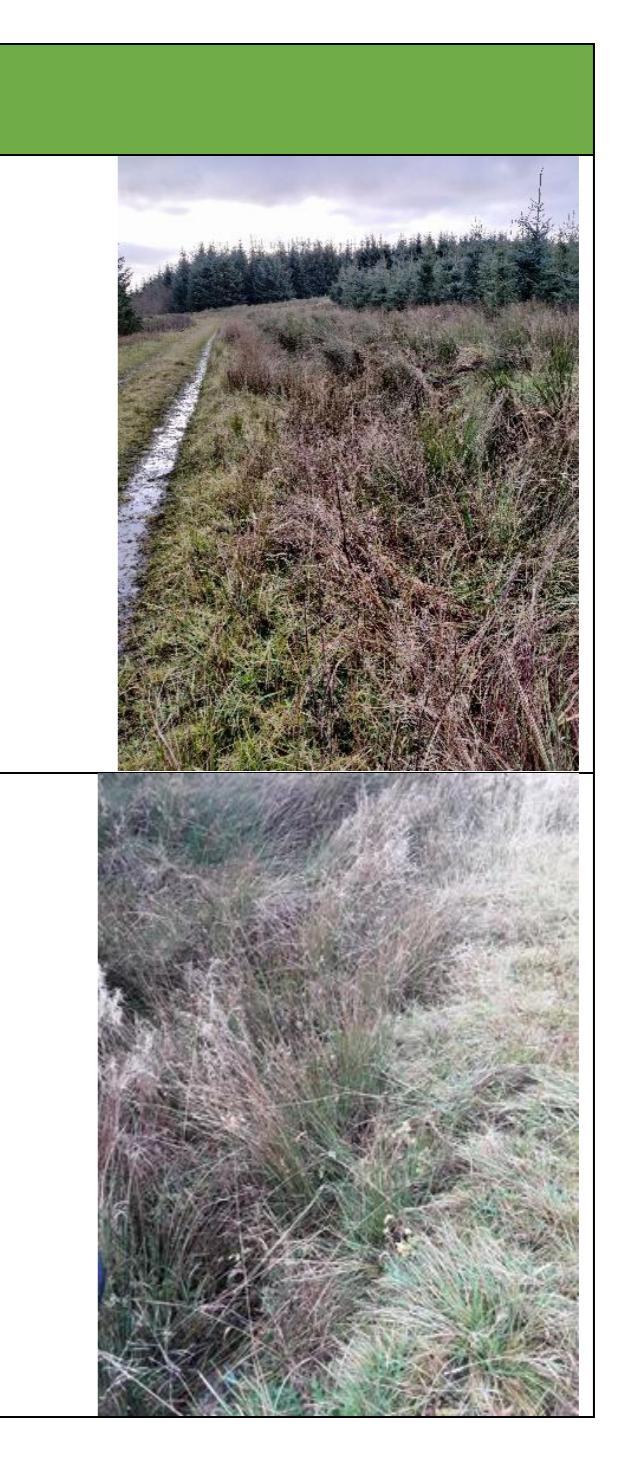
ID	Name	Easting	Northing	Width (m)	Sediment	Slope	Erosion	Crossing Type	Field Notes/ Comments	Catchment (km²)	Minor Watercourse (yes/no) ²	CAR Engineering Authorisation Required (yes/no)	Photo
16	Unnamed	272240	610048	1.0	Silt/soil	Gentle	None observed	Existing	Drain at side of existing track, drains alongside of track	0.03	Yes	No	
17	Unnamed	272191	610122	2.5	Silt/soil	Gentle	None observed	Existing	Forest drainage channel	<0.01	Yes	No

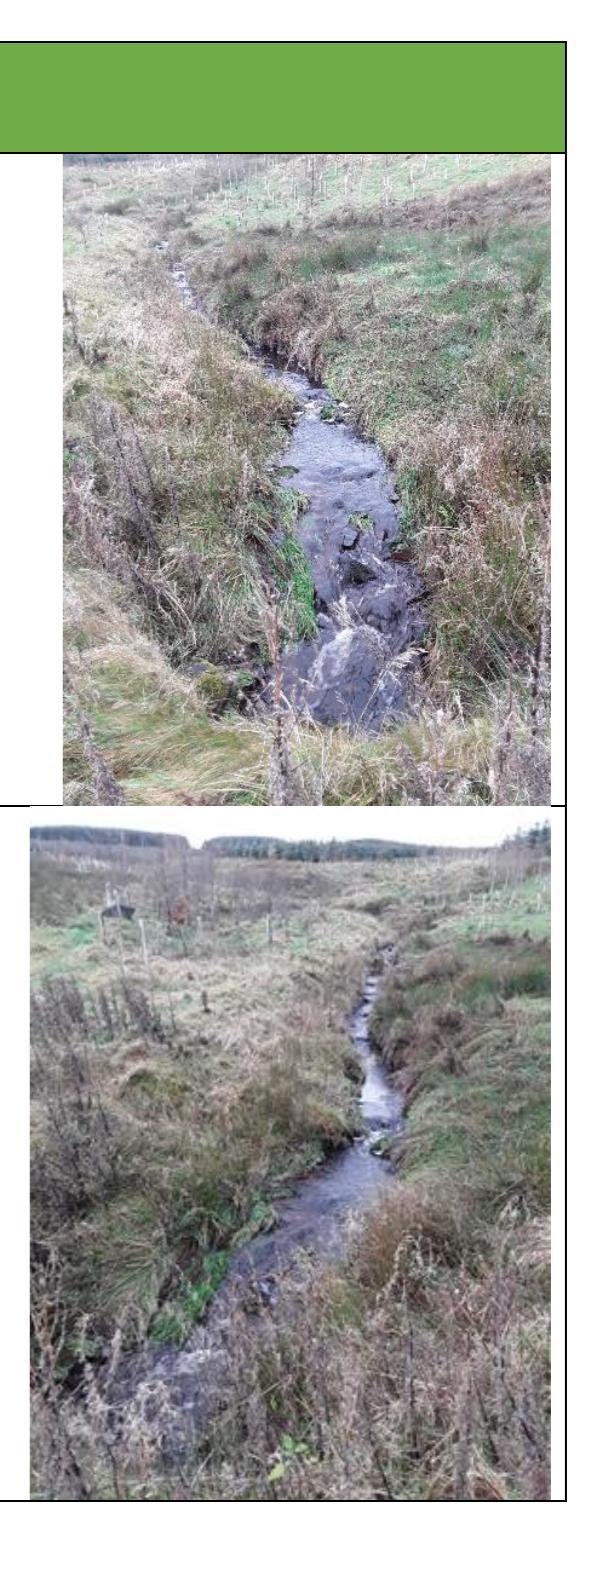
ID	Name	Easting	Northing	Width (m)	Sediment	Slope	Erosion	Crossing Type	Field Notes/ Comments	Catchment (km²)	Minor Watercourse (yes/no) ²	CAR Engineering Authorisation Required (yes/no)	Photo
19	Unnamed Tributary of Guttie Burn	272089	610193	0.6	Pebble to cobble	Moderate	None observed	Existing	Joins Guttie Burn immediately upstream of track crossing	0.56	No	Possible if upgrade required	
20	Guttie Burn	272096	610195	1.4	Gravel to cobble	Moderate	Erosion US of existing crossing	Existing	-	0.75	No	Possible if upgrade required

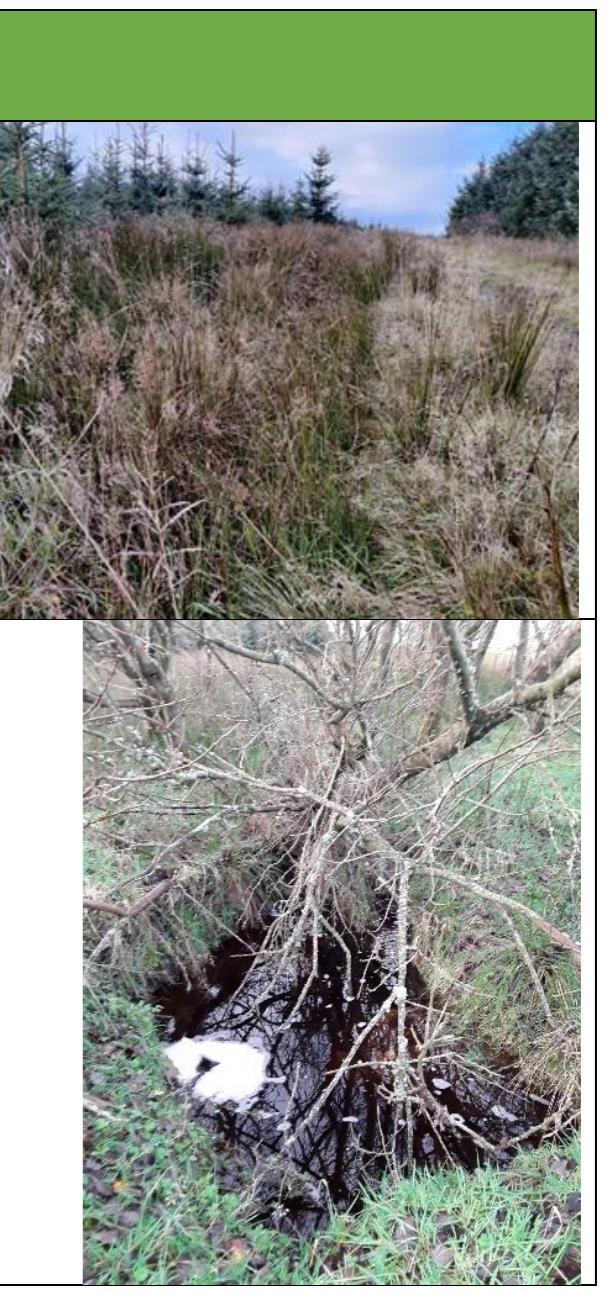
ID	Name	Easting	Northing	Width (m)	Sediment	Slope	Erosion	Crossing Type	Field Notes/ Comments	Catchment (km²)	Minor Watercourse (yes/no) ²	CAR Engineering Authorisation Required (yes/no)	Photo
21	Unnamed	272000	610262	0.7	Silt/soil	Gentle	None observed	Existing	Forest drainage channel	<0.01	Yes	No	
22	Unnamed	271878	610418	1.6	Silt/soil	Gentle	None observed	Existing	Wider area of marsh/bog upstream	0.03	Yes	No

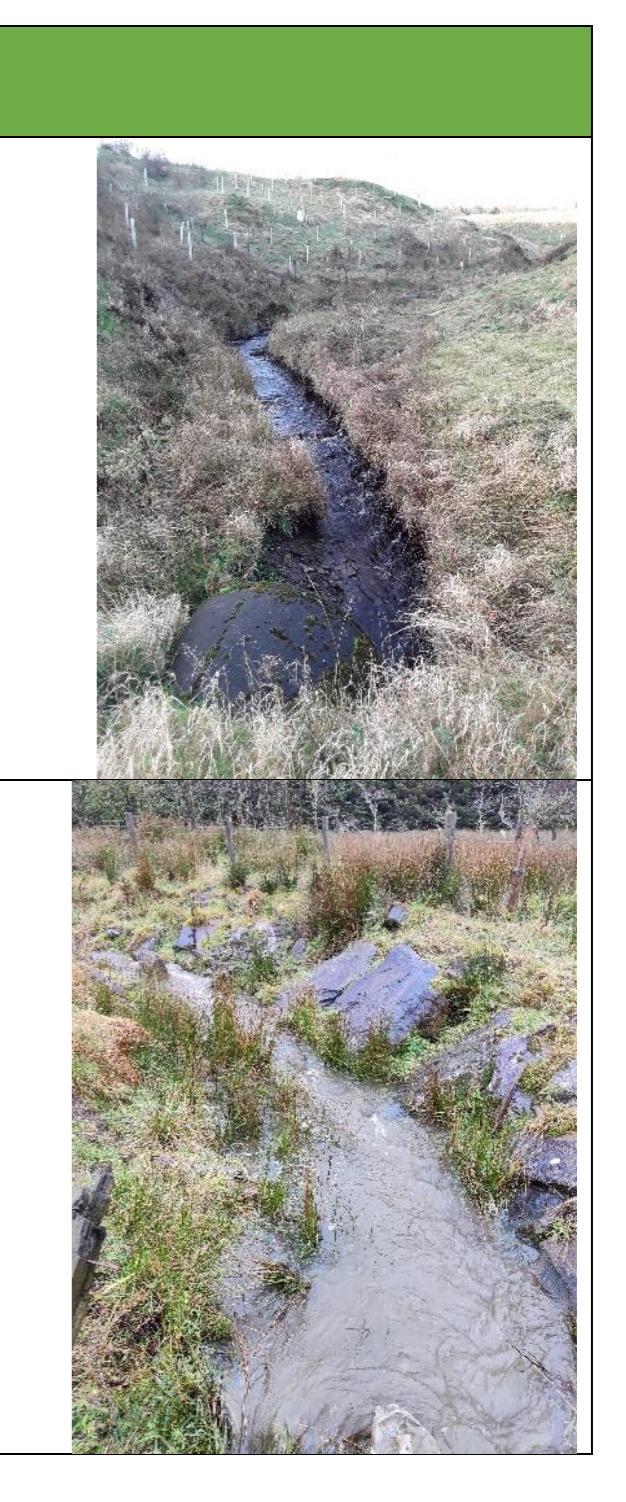
ID	Name	Easting	Northing	Width (m)	Sediment	Slope	Erosion	Crossing Type	Field Notes/ Comments	Catchment (km²)	Minor Watercourse (yes/no) ²	CAR Engineering Authorisation Required (yes/no)	Photo
24	Polbroc Burn	271823	610455	1.4	Gravel to cobble	Moderate	None US, bank erosion DS	Existing	Existing access track crossing	1.2	No	Possible if upgrade required	
29	Unnamed	271289	611395	3.2	Silt/ soil with boulders at edge	Gentle	Not observed	Existing	Larger forest drain channel with many sub- catchments of forest drains joining adjacent to access track upstream	<0.01	Yes	No

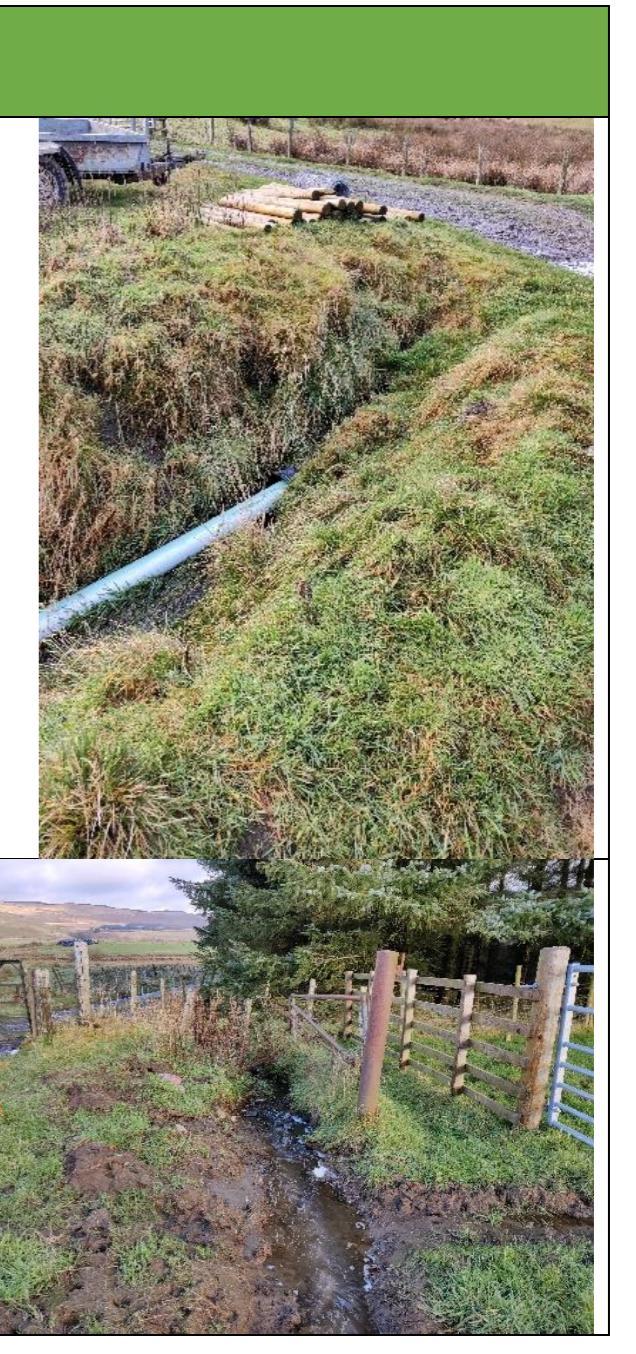
ID	Name	Easting	Northing	Width (m)	Sediment	Slope	Erosion	Crossing Type	Field Notes/ Comments	Catchment (km²)	Minor Watercourse (yes/no) ²	CAR Engineering Authorisation Required (yes/no)	Photo
31	Unnamed	270454	611909	1.3	Silt/soil	Gentle	Not observed	Existing	Field drain	0.02	Yes	No	
32	Unnamed	270547	612101	0.7	Gravel/ pebble/ silt	Gentle	Not observed	Existing	Ford into field through gate. Field drain	0.08	Yes	No

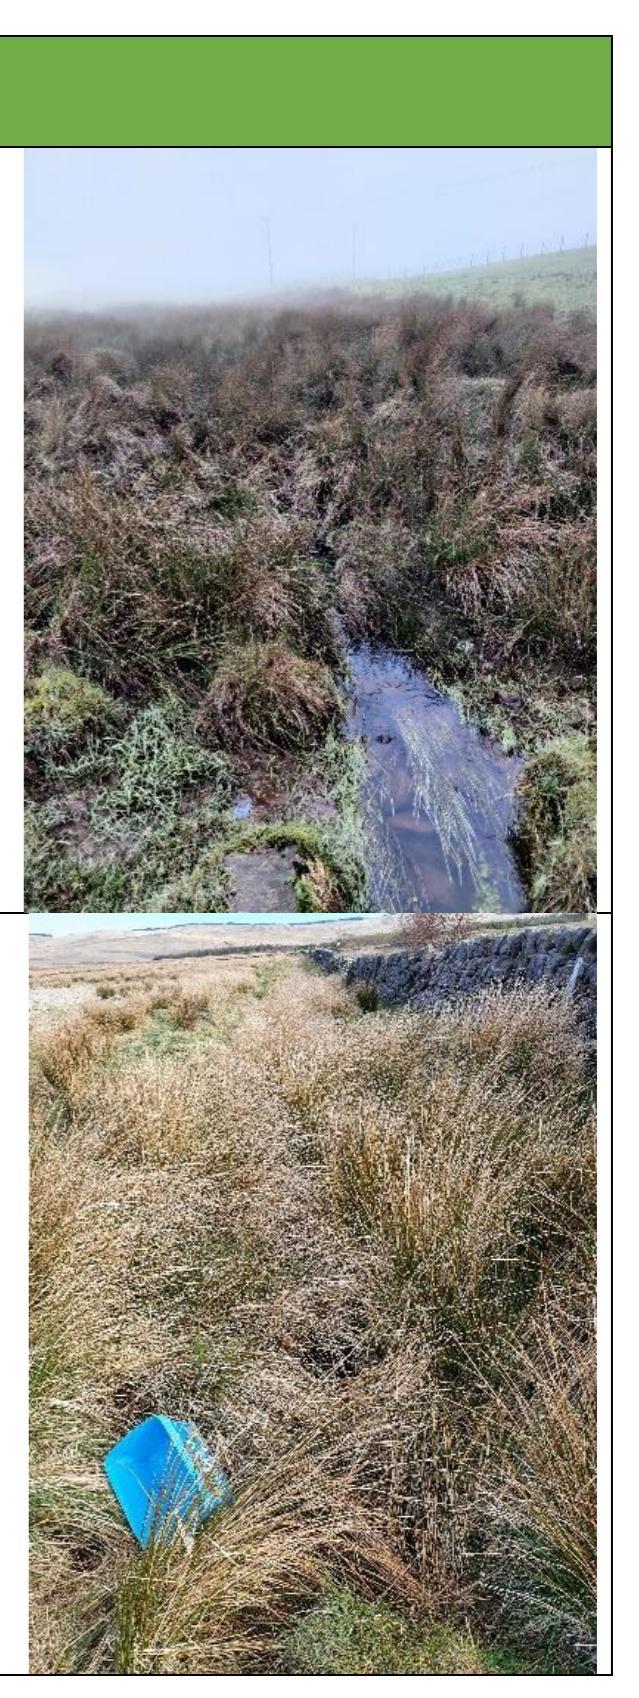
ID	Name	Easting	Northing	Width (m)	Sediment	Slope	Erosion	Crossing Type	Field Notes/ Comments	Catchment (km²)	Minor Watercourse (yes/no) ²	CAR Engineering Authorisation Required (yes/no)	Photo
33	Birk Burn	271214	612628	0.75	Silt to cobble	Gentle	Not observed	Existing	Existing farm track	0.22	No	Possible if upgrade required	
34	Unnamed	271483	613292	2	Silt/soil	Moderate	None	Existing	Field drainage ditch	0.10	Yes	No

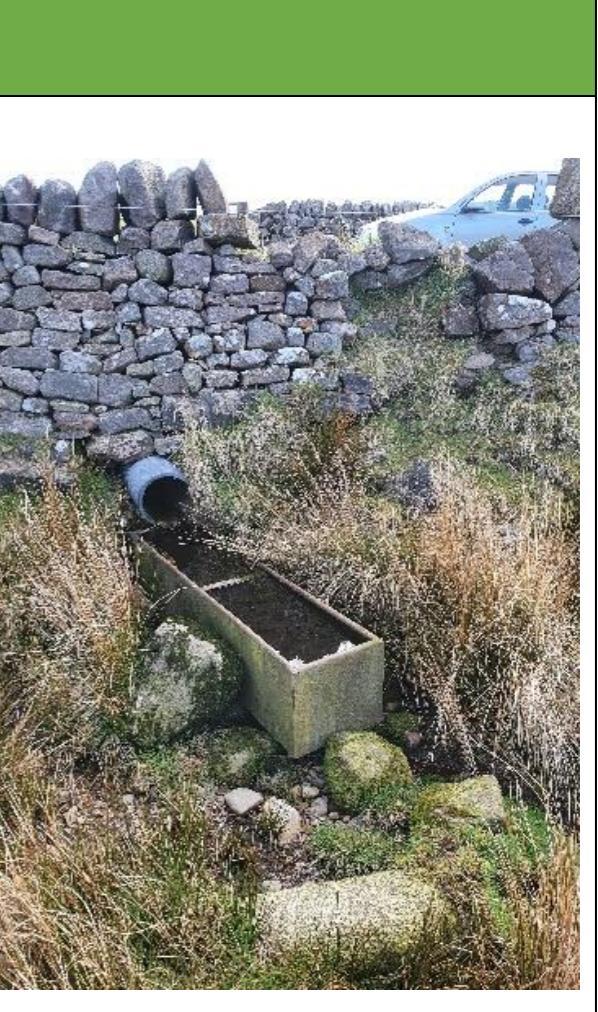
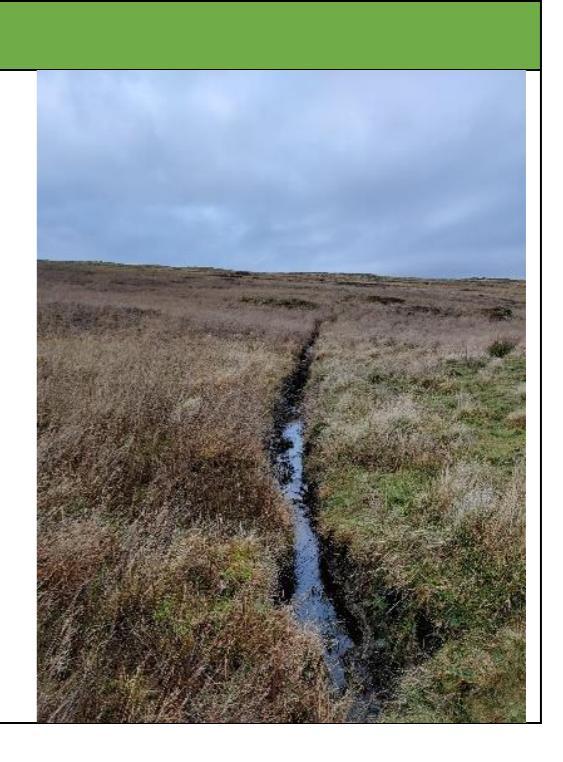
ID	Name	Easting	Northing	Width (m)	Sediment	Slope	Erosion	Crossing Type	Field Notes/ Comments	Catchment (km²)	Minor Watercourse (yes/no) ²	CAR Engineering Authorisation Required (yes/no)	Photo
35	Unnamed	271374	613542	250mm culvert	Silt/soil	Moderate	None	Existing	Road and field drain	0.04	Yes	No	
				1					New Cross	ings			
0	Unnamed	272802	607201	0.6	Silt/soil	Gentle	None, incised channel	New	Land drain in peat	0.02	Yes	No

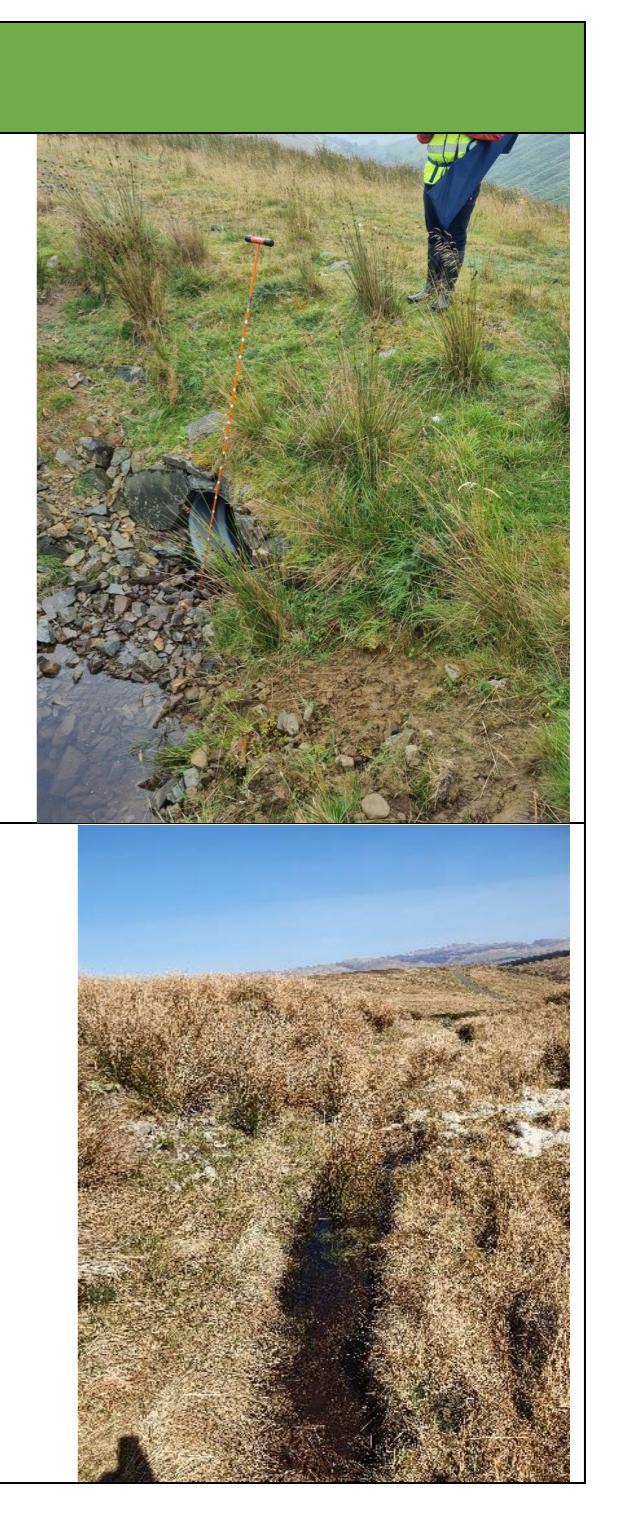
ID	Name	Easting	Northing	Width (m)	Sediment	Slope	Erosion	Crossing Type	Field Notes/ Comments	Catchment (km²)	Minor Watercourse (yes/no)²	CAR Engineering Authorisation Required (yes/no)	Photo
1	Unnamed	272820	607231	0.45	Silt to cobble	Gentle	Incision into bed	New	Land drain, existing 750mm culvert 30m downstream	0.07	Yes	No	
2	Unnamed	272861	607298	0.8	Soil to cobble	Gentle	None	New	Partially blocked peat drain	0.03	Yes	No

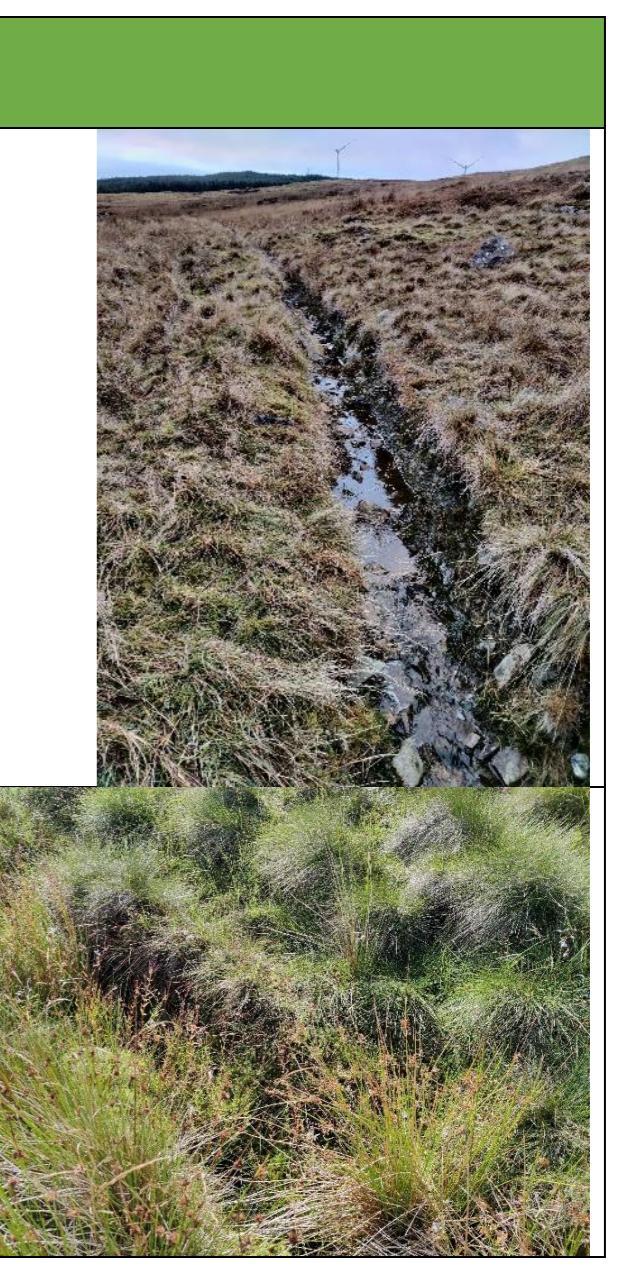
ID	Name	Easting	Northing	Width (m)	Sediment	Slope	Erosion	Crossing Type	Field Notes/ Comments	Catchment (km²)	Minor Watercourse (yes/no) ²	CAR Engineering Authorisation Required (yes/no)	Photo
3	Unnamed	272928	607354	0.95	Silt to cobble	Gentle	Not observed	New	Land drain	<0.01	Yes	No	
4	Unnamed	273162	608229	0.5	Sand/Silt	Moderate	None	New	Artificial Drain	0.10	Yes	No

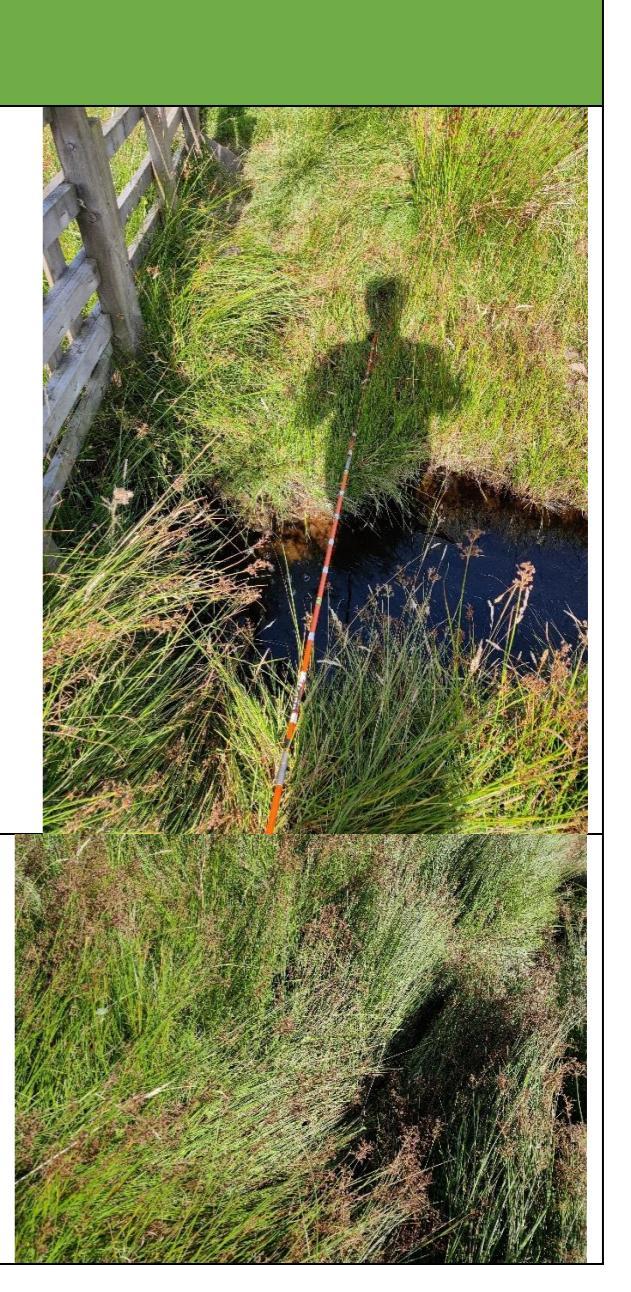
ID	Name	Easting	Northing	Width (m)	Sediment	Slope	Erosion	Crossing Type	Field Notes/ Comments	Catchment (km²)	Minor Watercourse (yes/no) ²	CAR Engineering Authorisation Required (yes/no)	Photo
5	Thwarter Burn	273163	608622	1.3	Cobble	Gentle	None	New	-	0.28	No	No	
6	Unnamed	273132	608765	0.5	Sand/Silt	Gentle	None	New	Empty Drain	0.02	Yes	No

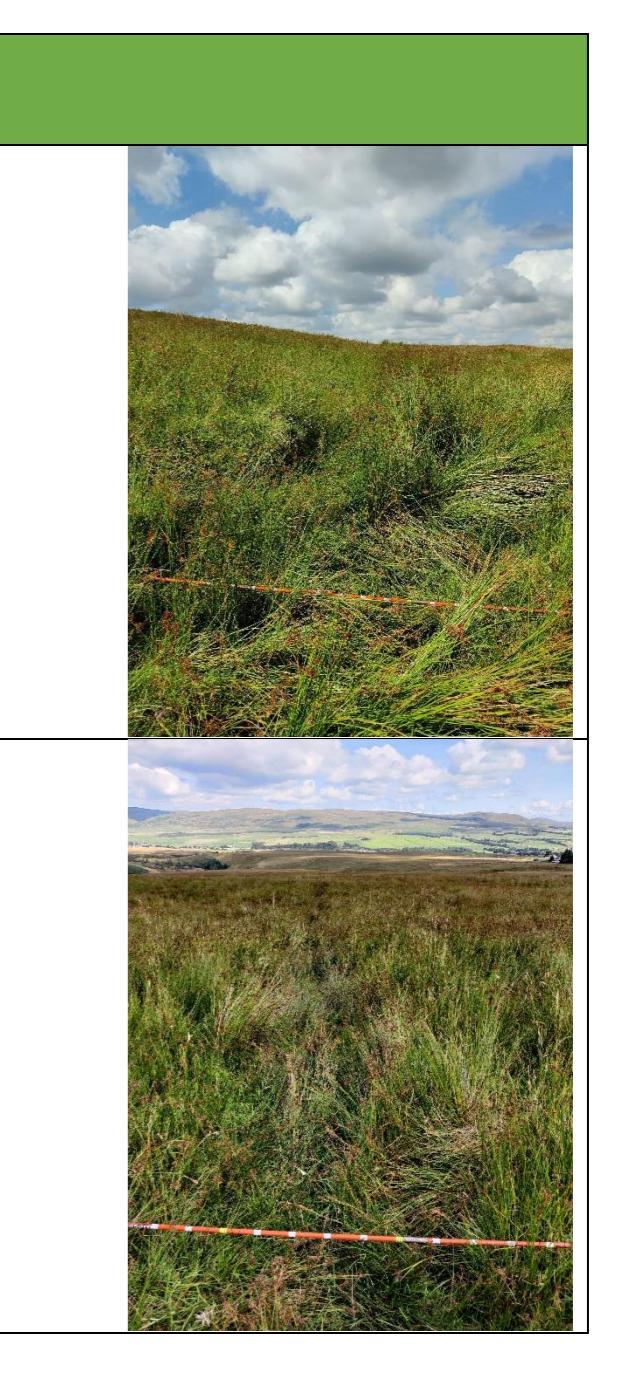
ID	Name	Easting	Northing	Width (m)	Sediment	Slope	Erosion	Crossing Type	Field Notes/ Comments	Catchment (km²)	Minor Watercourse (yes/no) ²	CAR Engineering Authorisation Required (yes/no)	Photo
7	Quintin's Burn	273112	608883	2.0	Silt/soil	Moderate	None	New	Dry	<0.01	No	No	
8	Unnamed	273093	608998	1.5	Silt/soil	Gentle	None	New	Dry drain	<0.01	Yes	No

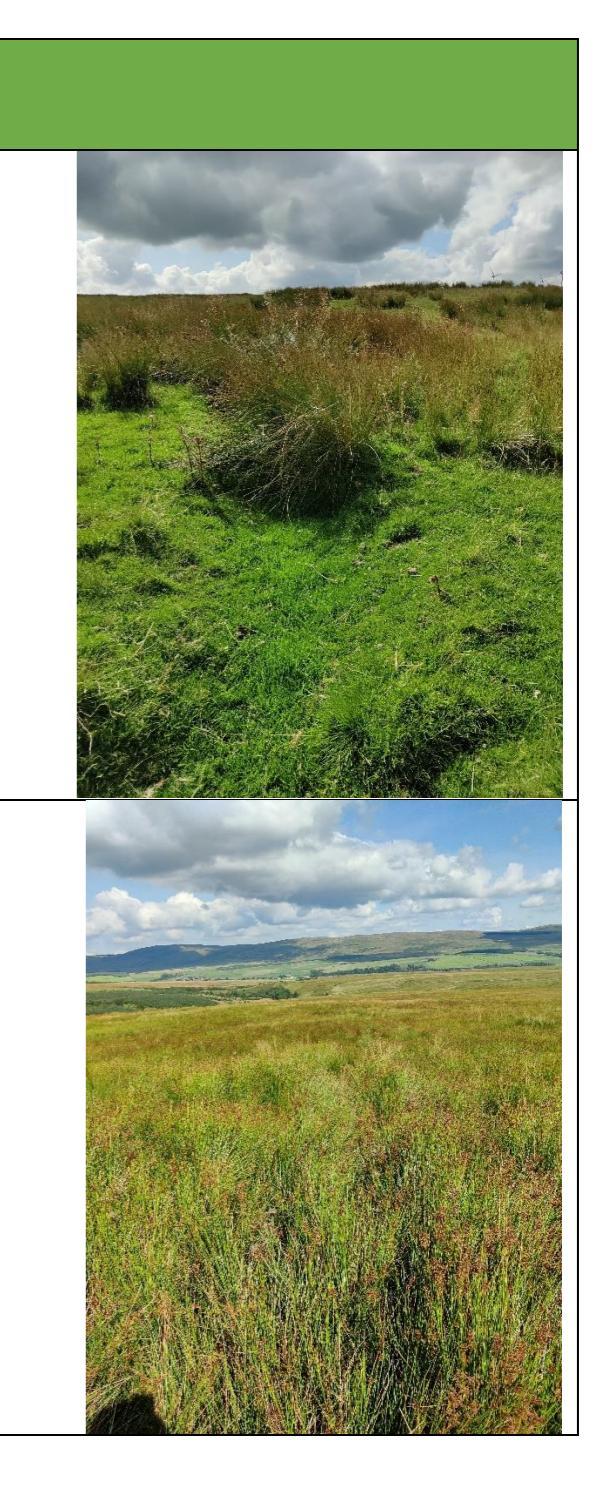
ID	Name	Easting	Northing	Width (m)	Sediment	Slope	Erosion	Crossing Type	Field Notes/ Comments	Catchment (km²)	Minor Watercourse (yes/no) ²	CAR Engineering Authorisation Required (yes/no)	Photo
9	Unnamed	273076	609101	1.5	Dry drain	Moderate	None	New	Dry drain	0.01	Yes	No	
10	Unnamed	273068	609144	1.0	Silt/soil	Moderate	None	New	Dry drain	<0.01	Yes	No

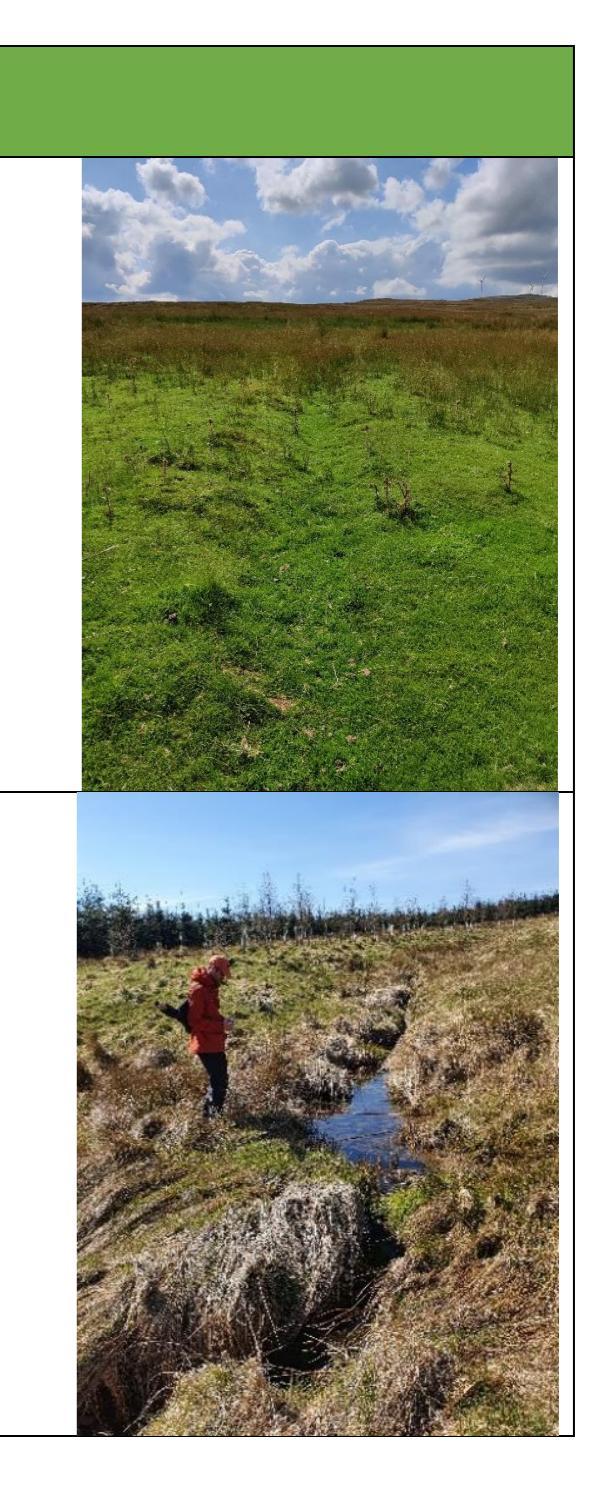
ID	Name	Easting	Northing	Width (m)	Sediment	Slope	Erosion	Crossing Type	Field Notes/ Comments	Catchment (km²)	Minor Watercourse (yes/no)²	CAR Engineering Authorisation Required (yes/no)	Photo
11	Unnamed	273057	609213	1.0	Sand/silt	Moderate	None	New	Drain	<0.01	Yes	No	
12	Unnamed	272717	609702	1.7	Pebble to Cobble/ Rock	Gentle	None	New	Forded channel	0.04	No	No

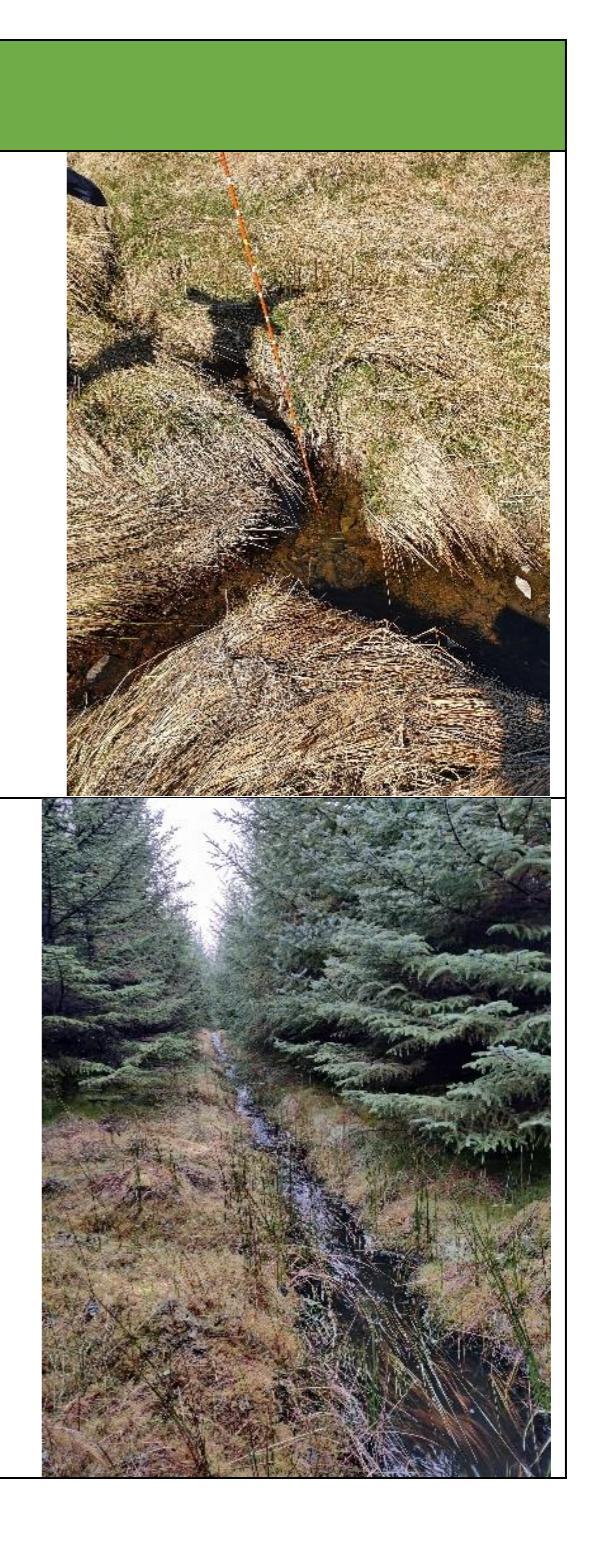
ID	Name	Easting	Northing	Width (m)	Sediment	Slope	Erosion	Crossing Type	Field Notes/ Comments	Catchment (km²)	Minor Watercourse (yes/no) ²	CAR Engineering Authorisation Required (yes/no)	Photo
18	Unnamed	272030	610138	0.6	Silt/soil	Gentle	None	New	Confluence of small channel with evidence of out of bank flow	0.35	No	No	
23	Unnamed	271470	610426	1.2	Silt/soil	Gentle	Not observed	New	Forest drainage channel	<0.01	Yes	No

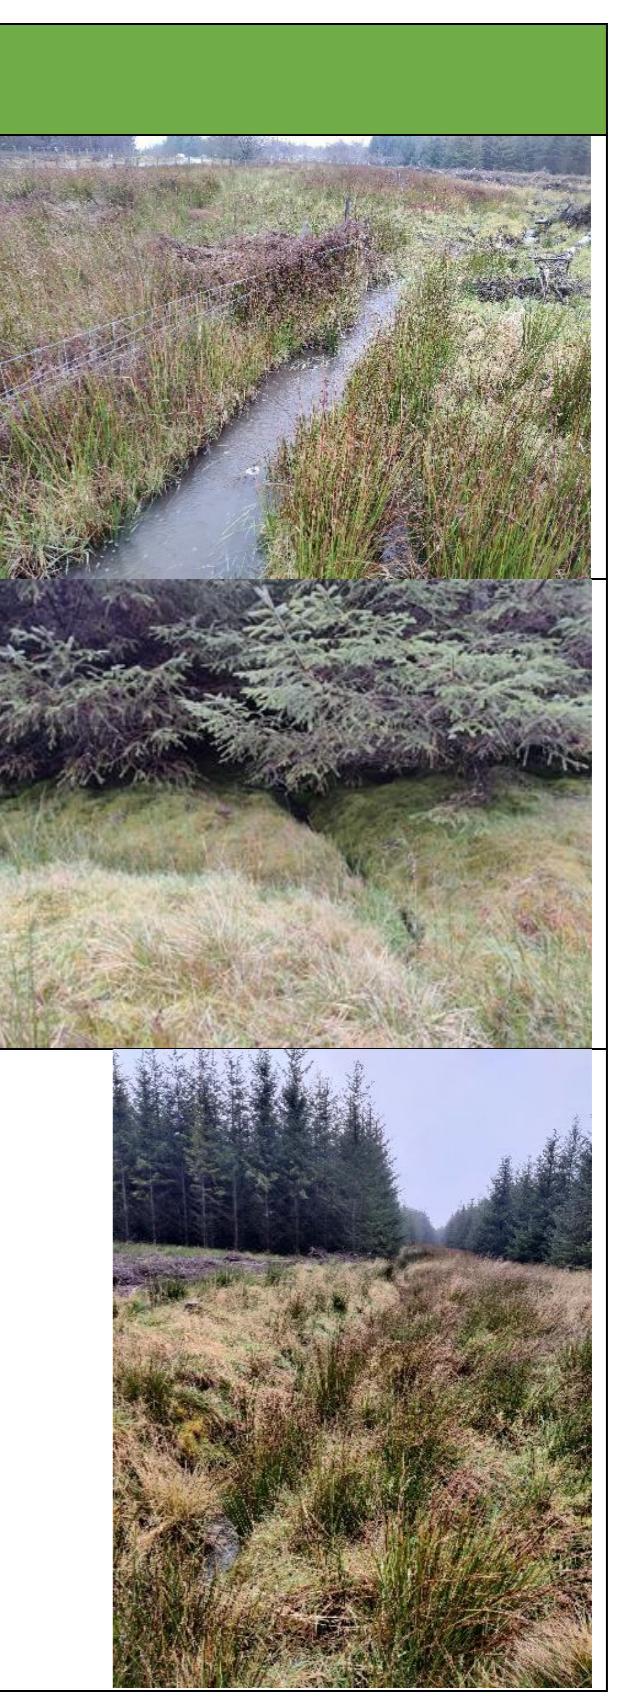
ID	Name	Easting	Northing	Width (m)	Sediment	Slope	Erosion	Crossing Type	Field Notes/ Comments	Catchment (km²)	Minor Watercourse (yes/no)²	CAR Engineering Authorisation Required (ves/no)	Photo
25	Unnamed	271515	611094	2.5	Silt/soil	Gentle	Not observed	New	Forest drainage channel	<0.01	Yes	No	
26	Unnamed	271141	611095	1.1	Silt/soil	Gentle	Not observed	New	Three channels merge immediately upstream of crossing. Forest drainage channel	0.06	Yes	No	
27	Unnamed	271502	611095	0.8	Silt/soil	Gentle	Not observed	New	Forest drainage channel	<0.01	Yes	No

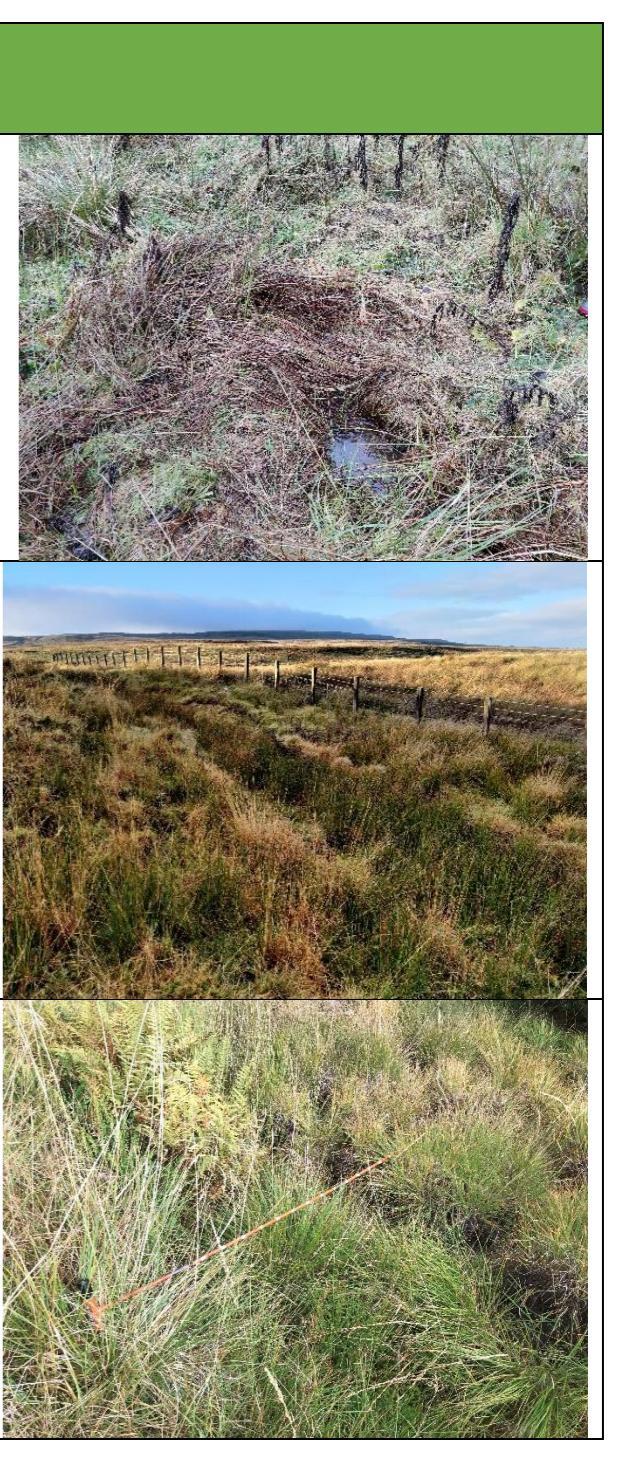
ID	Name	Easting	Northing	Width (m)	Sediment	Slope	Erosion	Crossing Type	Field Notes/ Comments	Catchment (km²)	Minor Watercourse (yes/no) ²	CAR Engineering Authorisation Required (yes/no)	Photo
28	Unnamed	271033	611379	0.4	Silt/soil	Moderate	Not observed	New	Drains area that is forested. Likely disrupted upstream	0.03	Yes	No	
30	Unnamed	270579	611644	2.3	Silt/soil	Gentle	Bank erosion	New	Peat drain	<0.01	Yes	No	
36	Unnamed	271199	613982	0.9	Sand/Silt	Gentle	None	New	-	0.03	Yes	No

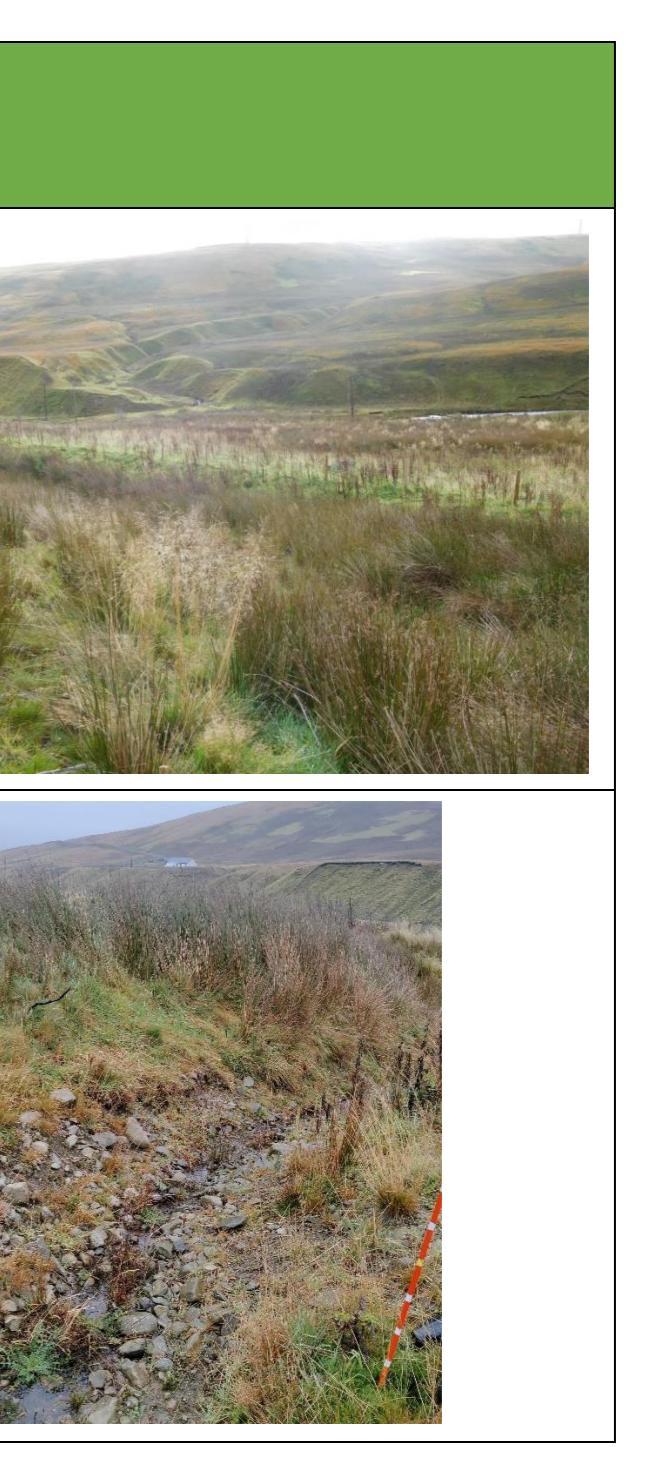
ID	Name	Width of watercourse (top of bank)	Watercourse Description	Infrastructure and Ancillary Works Description	Temporary or Permanent	Width of buffer strip achieved	Water feature upgradient or downgradient of proposed infrastructure	Potential Effect/ Comment	Additional Mitigation	Photo
A	Unnamed	0.4m	Artificial drainage ditch associated with Glenglass substation	T1 working area T1	Temporary Permanent	10m 14m	Slightly upgradient	This is an artificial drainage diversion ditch to divert natural drainage round Glenglass substation. It discharges to the Euchan Water Embedded mitigation (i.e. SuDS) around the construction area will be included in the design. Buffer width is considered adequate for size of water feature.	Additional mitigation (e.g. silt fences, settlement ponds) will be installed between the working area and the ditch to reduce the risk of sediment/silt run-off to the ditch during construction

В	Unnamed	1.0m	Small watercourse/ drain through heavily modified forestry.	T2 working area T3 working area T3 Access track to T3	Temporary Temporary Permanent Temporary	38m 15m 36m 20m	Upgradient Downgradient Downgradient Downgradient	Embedded mitigation (i.e. SuDS) around the construction area will be included in the design. Buffer width is considered adequate for size of water feature.	Additional mitigation (e.g. silt fences, settlement ponds) will be installed between the working area and the drain to reduce the risk of sediment/silt run-off during construction

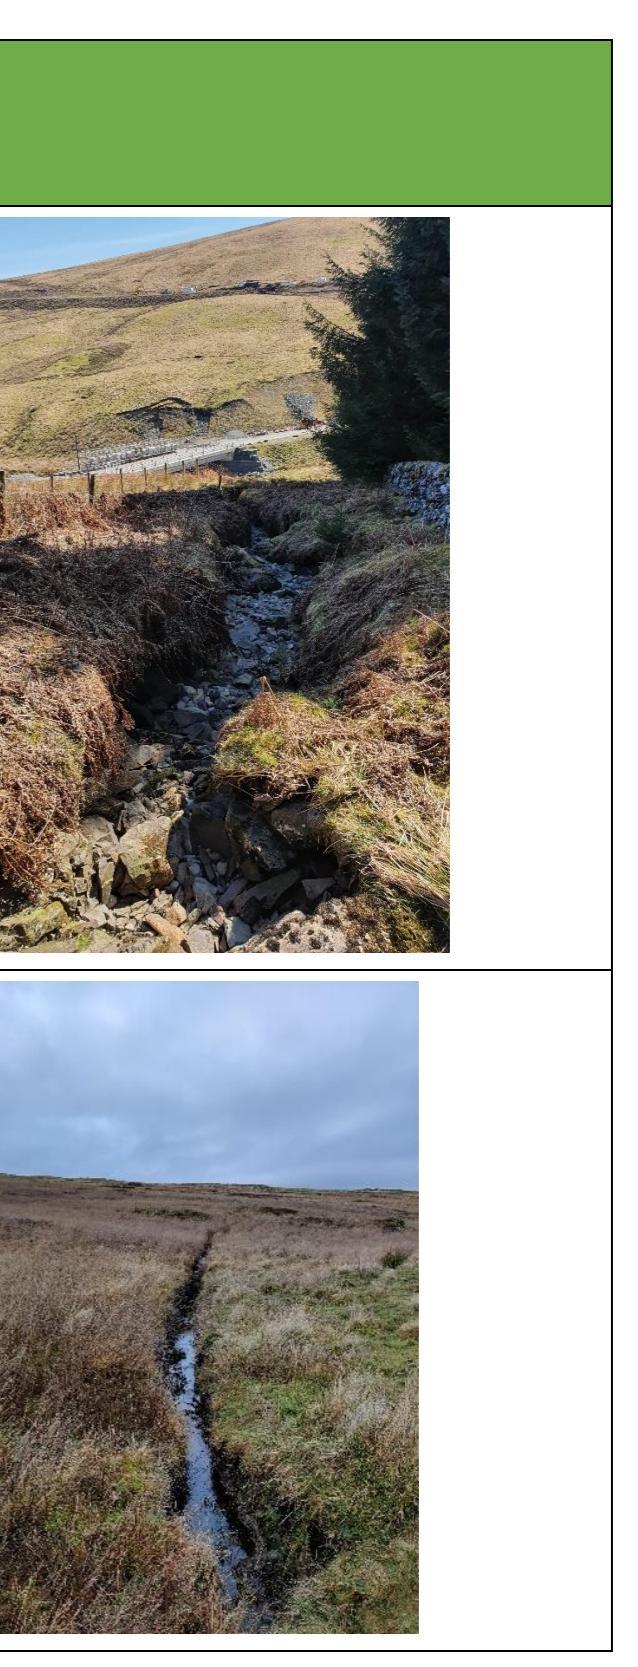
ID	Name	Width of watercourse (top of bank)	Watercourse Description	Infrastructure and Ancillary Works Description	Temporary or Permanent	Width of buffer strip achieved	Water feature upgradient or downgradient of proposed infrastructure	Potential Effect/ Comment	Additional Mitigation	Photo
с	Unnamed	1.3m	Small tributary of Euchan Water	T4 working area	Temporary	46m	Downgradient	Embedded mitigation (i.e. SuDS) around the construction area will be included in the design. Buffer width is considered adequate for size of water feature.	None	
D	Unnamed	0.6m	Artificial drains	T5 working area T5 Access track to T5	Temporary Permanent Temporary	10m 15m 10m	Upgradient	Limited effect as artificial drainage and upgradient of infrastructure. Embedded mitigation (i.e. SuDS) around the construction area will be included in the design. Buffer width is considered adequate for size of water feature.	None
