Appendix 7.1

Watercourse Crossings and Buffers

Appendix 7.1: Glenmuckloch to Glenglass Reinforcement Project (GGRP) Watercourse Crossings and Buffers

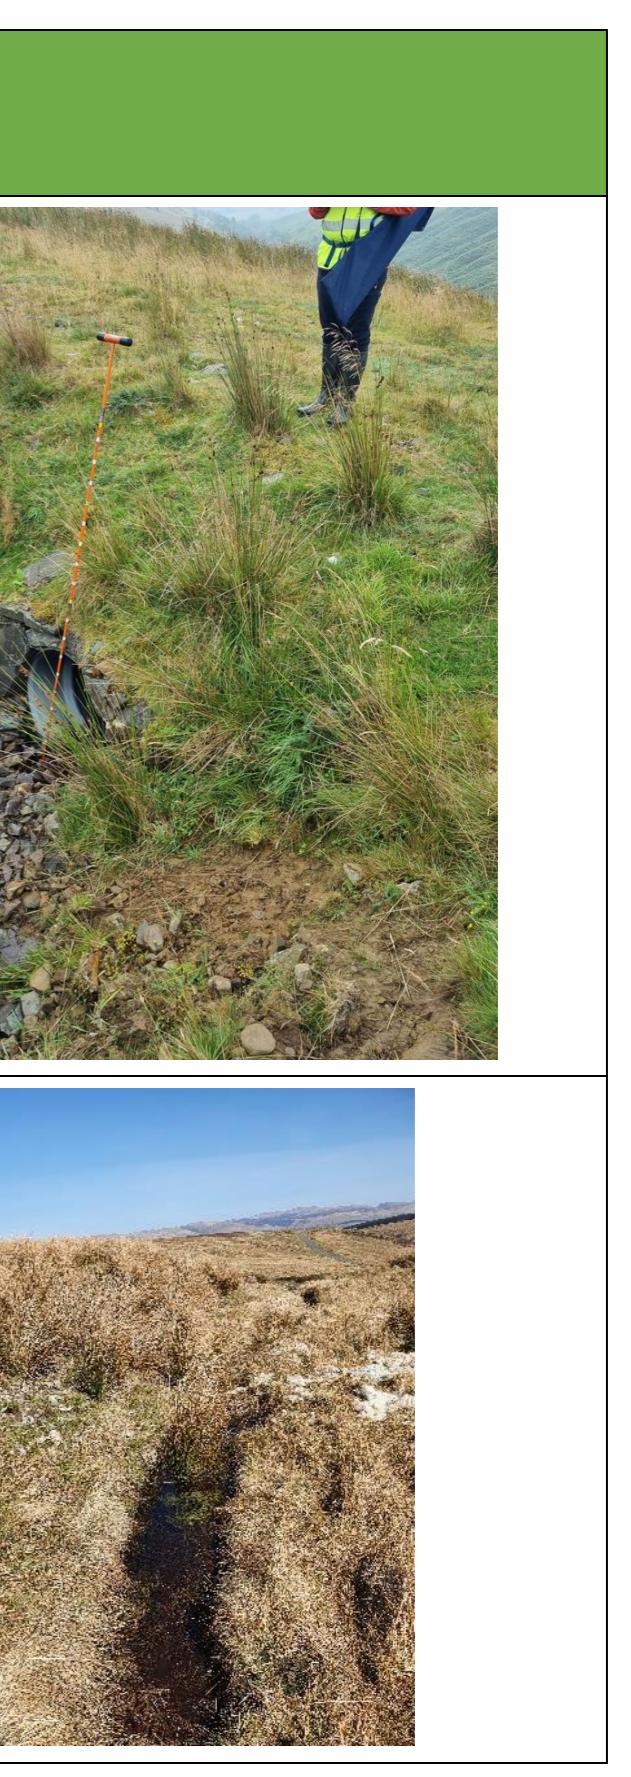
ID	Name	Width of watercourse (top of bank)	Watercourse Description	Infrastructure and Ancillary Works Description	Temporary or Permanent	Width of buffer strip achieved	Water feature upgradient or downgradient of proposed infrastructure	Potential Effect/ Comment	Additional Mitigation	Photo
E	Unnamed	0.45m	Artificial drains	T6 working area T6 laydown area	Temporary Temporary	33m 30m	Upgradient Downgradient	Limited effect as artificial drainage and upgradient of infrastructure. Embedded mitigation (i.e. SuDS) around the construction area will be included in the design. Buffer width is considered adequate for size of water feature.	None	
EE	Unnamed	<1m	Drain	Access track to T7	Temporary	36m	Downgradient	Embedded mitigation (i.e. SuDS) around the access track will be included in the design. Buffer width is considered adequate for size of water feature.	None

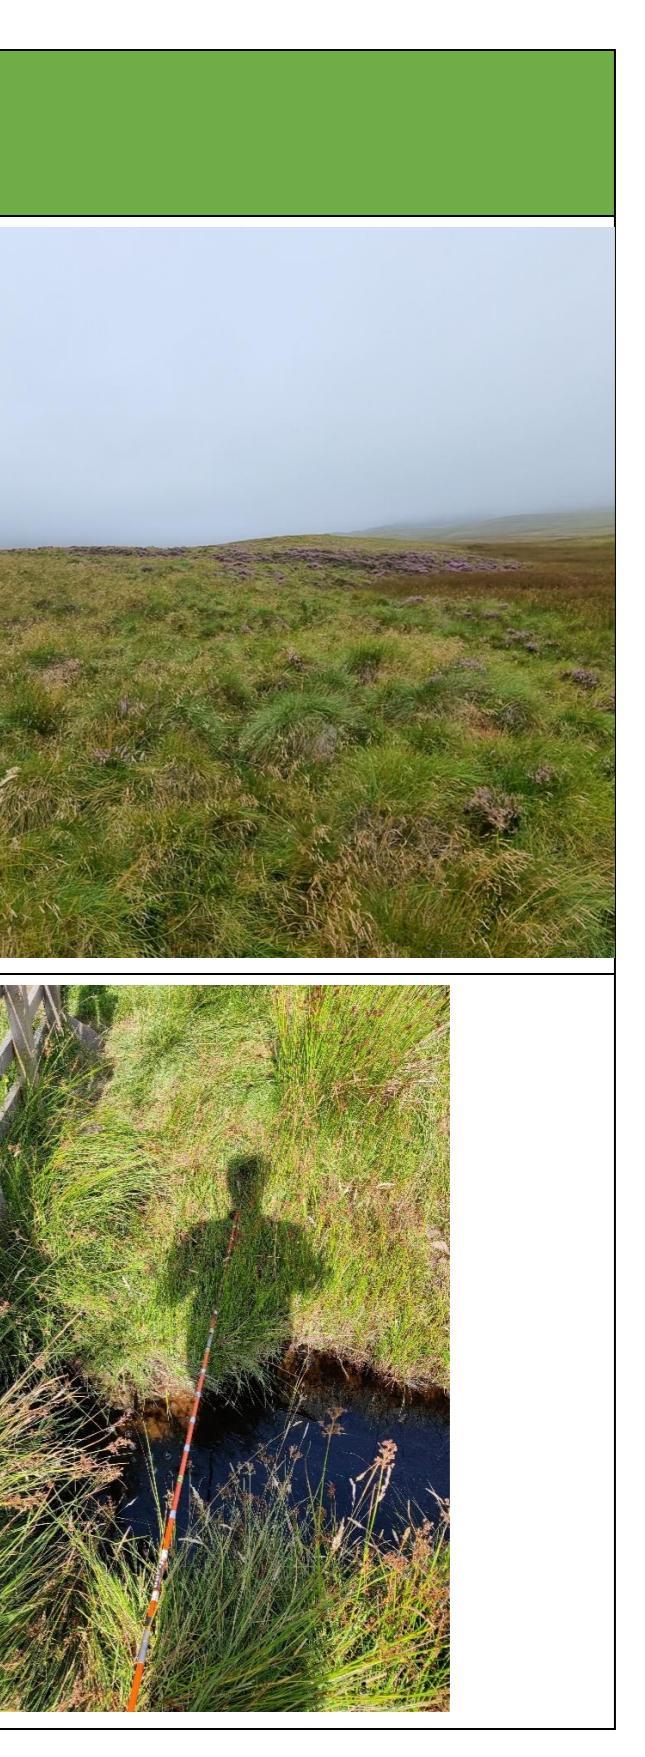
ID	Name	Width of watercourse (top of bank)	Watercourse Description	Infrastructure and Ancillary Works Description	Temporary or Permanent	Width of buffer strip achieved	Water feature upgradient or downgradient of proposed infrastructure	Potential Effect/ Comment	Additional Mitigation	Photo
F	Barr Burn	~10m wide marshy channel area	Upstream reach of Barr Burn. There is no defined channel, but a wider marshy area within peatland.	T9 working areas T9	Temporary Permanent	25m 45m	Downgradient	Proposed tower/working area is on higher ground (~4m higher than the burn). The tower is at location of surveyor in photo, which shows the marshy channel on right side of photo. There is a very small catchment upstream and the tower is not predicted to be at flood risk. Embedded mitigation (i.e. SuDS) around the construction area will be included in the design. Buffer width is considered adequate for size of water feature.	Additional mitigation (e.g. silt fences, settlement ponds) will be installed between the working area and the burn to reduce the risk of sediment/silt run-off to the burn during construction.

G	Thwarter Burn	1.3m	Thwarter Burn	T12 working area	Temporary	23m	Downgradient	The edge of the working area is ~5m higher than the burn and is not considered to be at flood risk. Embedded mitigation (i.e. SuDS) around the construction area will be included in the design. Buffer width is considered adequate for size of water feature.	Additional mitigation (e.g. silt fences, settlement ponds) will be installed between the working area and the burn to reduce the risk of sediment/silt run-off to the burn during construction.

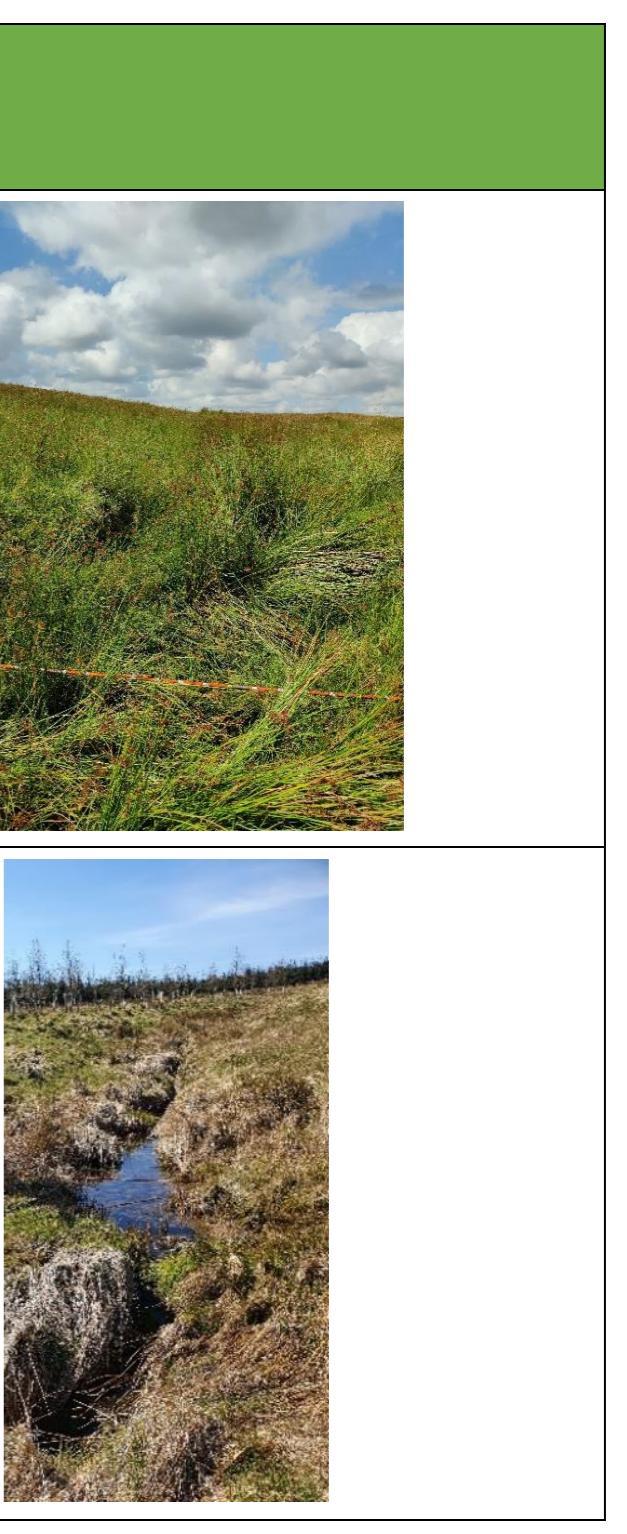
IC) Name	Width of watercourse (top of bank)	Watercourse Description	Infrastructure and Ancillary Works Description	Temporary or Permanent	Width of buffer strip achieved	Water feature upgradient or downgradient of proposed infrastructure	Potential Effect/ Comment	Additional Mitigation	Photo
F	Quintin's Burn	2.0m	Quintin's Burn	T14 working area	Temporary	45m	Downgradient	The edge of the working area is ~4m higher than the burn and is not considered to be at flood risk. Embedded mitigation (i.e. SuDS) around the construction area will be included in the design. Buffer width is considered adequate for size of water feature.	Additional mitigation (e.g. silt fences, settlement ponds) will be installed between the working area and the burn to reduce the risk of sediment/silt run-off to the burn during construction.	
1	Unnamed	1.7m	Unnamed tributary of Kello Water	T17 working area	Temporary	41m	Downgradient	The edge of the working area is over 5m higher and 41m away from the watercourse and is not considered to be at flood risk. Embedded mitigation (i.e. SuDS) around the construction area will be included in the design. Buffer width is considered adequate for size of water feature.	None

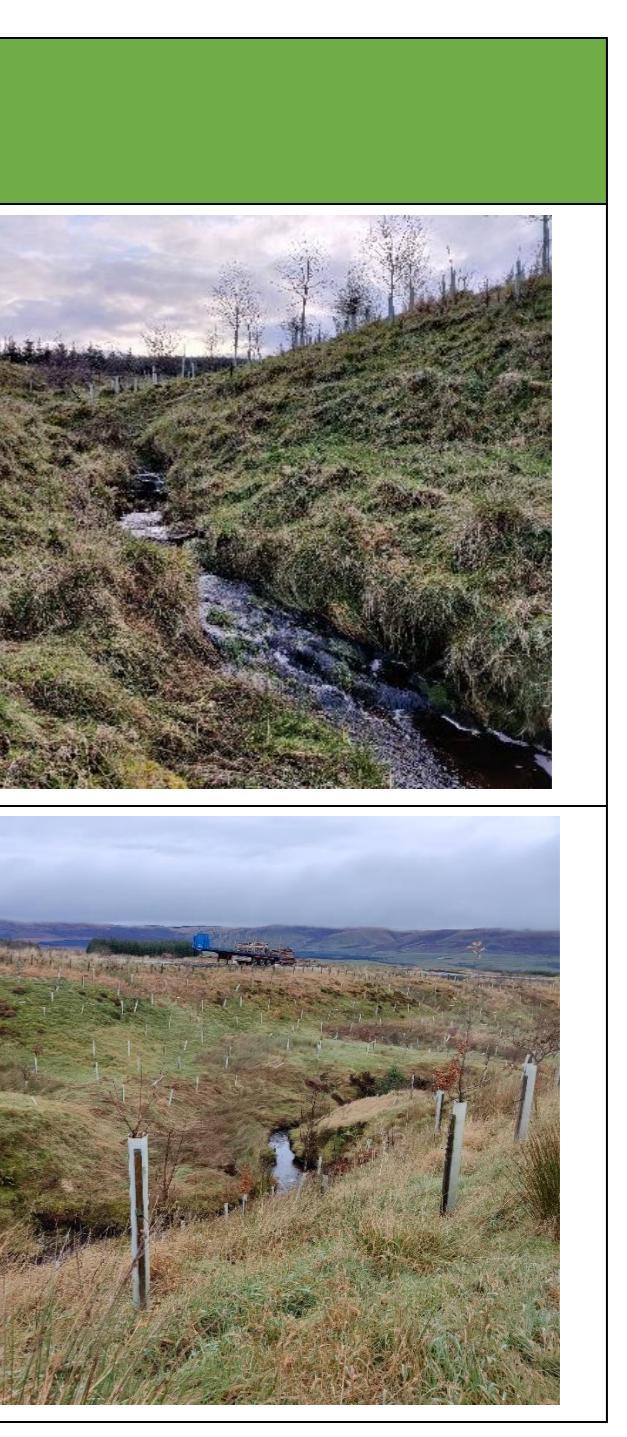
ID	Name	Width of watercourse (top of bank)	Watercourse Description	Infrastructure and Ancillary Works Description	Temporary or Permanent	Width of buffer strip achieved	Water feature upgradient or downgradient of proposed infrastructure	Potential Effect/ Comment	Additional Mitigation	Photo
J	Guttie Burn	1.3m	The small active channel is ~1.3m wide and set within a wider incised valley of 15-20m wide.	T21 working area T21 Access track to T21	Temporary Permanent Temporary	15m 24m 10m	Downgradient	The tower and working areas are outside of the wider valley and ~2m higher than the active channel. Embedded mitigation (i.e. SuDS) around the construction area will be included in the design. Buffer width is considered adequate for size of water feature.	Additional mitigation (e.g. silt fences, settlement ponds) will be installed between the working area/ temporary access track and the burn to reduce the risk of sediment/silt run-off to the burn during construction.

к	Unnamed	1.6m	Unnamed watercourse	Access track to T22	Temporary	10m	Downgradient	Access is upstream of the upstream reach of a small watercourse. Embedded mitigation (i.e. SuDS) around the construction area will be included in the design. Buffer width is considered adequate for size of water feature.	Additional mitigation (e.g. silt fences, settlement ponds) will be installed between the temporary access and the watercourse to reduce the risk of sediment/silt run-off to the burn during construction

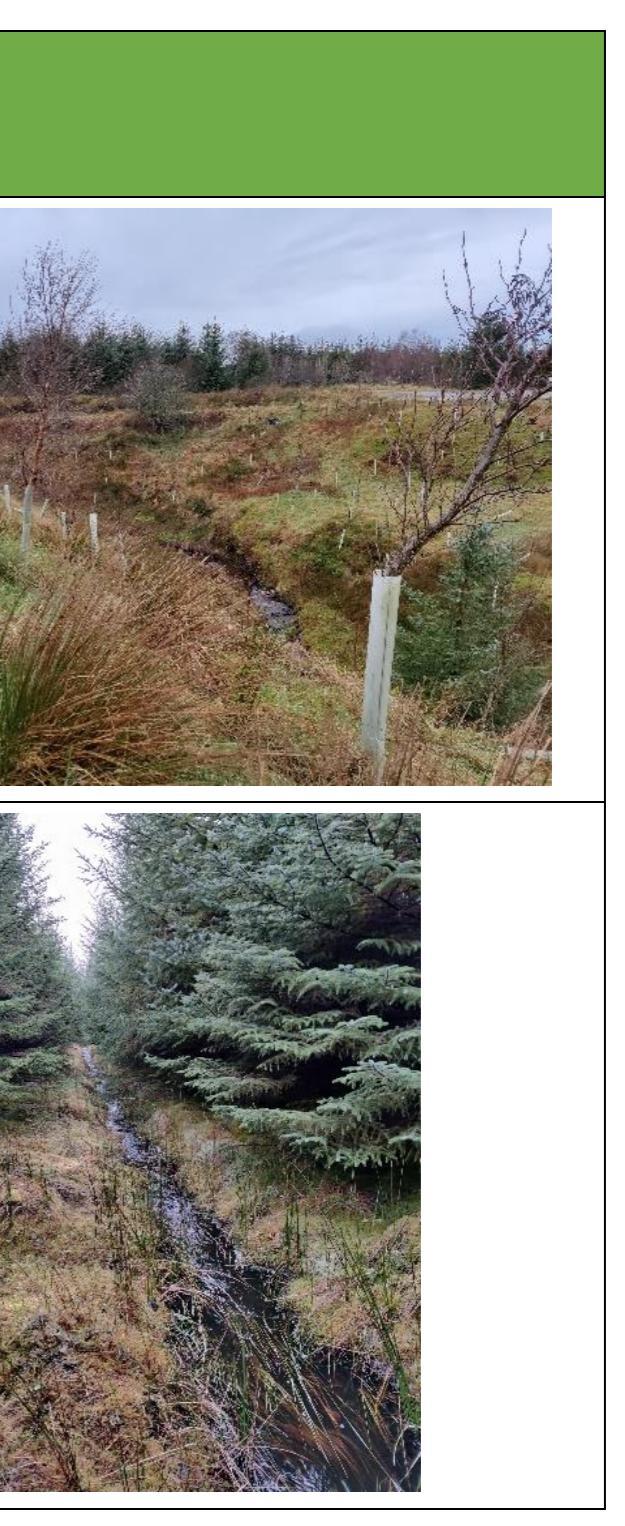
ID	Name	Width of watercourse (top of bank)	Watercourse Description	Infrastructure and Ancillary Works Description	Temporary or Permanent	Width of buffer strip achieved	Water feature upgradient or downgradient of proposed infrastructure	Potential Effect/ Comment	Additional Mitigation	Photo
L	Polbroc Burn	1.5m	The active channel is ~1.5m wide and set within a wider incised valley (~30m wide and ~11m deep).	Access track to T22 Scaffolding required for OHL stringing across public road	Temporary Temporary	27m 12m	Downgradient.	The access track is set outside the valley banks and is ~11m higher than the burn level and 27m away. Embedded mitigation (i.e. SuDS) around the track and scaffolding works will be included in the design. Buffer width is considered adequate for size of water feature.	Additional mitigation (e.g. silt fences, settlement ponds) will be installed between the scaffolding works and the burn to reduce the risk of sediment/silt run-off to the burn during construction

м	Unnamed	1.2m	Drainage ditches within Libry Moor forestry	T23 T23 working areas and access tracks	Permanent Temporary	17m 10m	Downgradient	Embedded mitigation (i.e. SuDS) around the construction area and access tracks will be included in the design. Buffer width is considered adequate for size of water feature.	Additional mitigation (e.g. silt fences, settlement ponds) will be installed between the working area and accesses and the drains to reduce the risk of sediment/silt run-off during construction

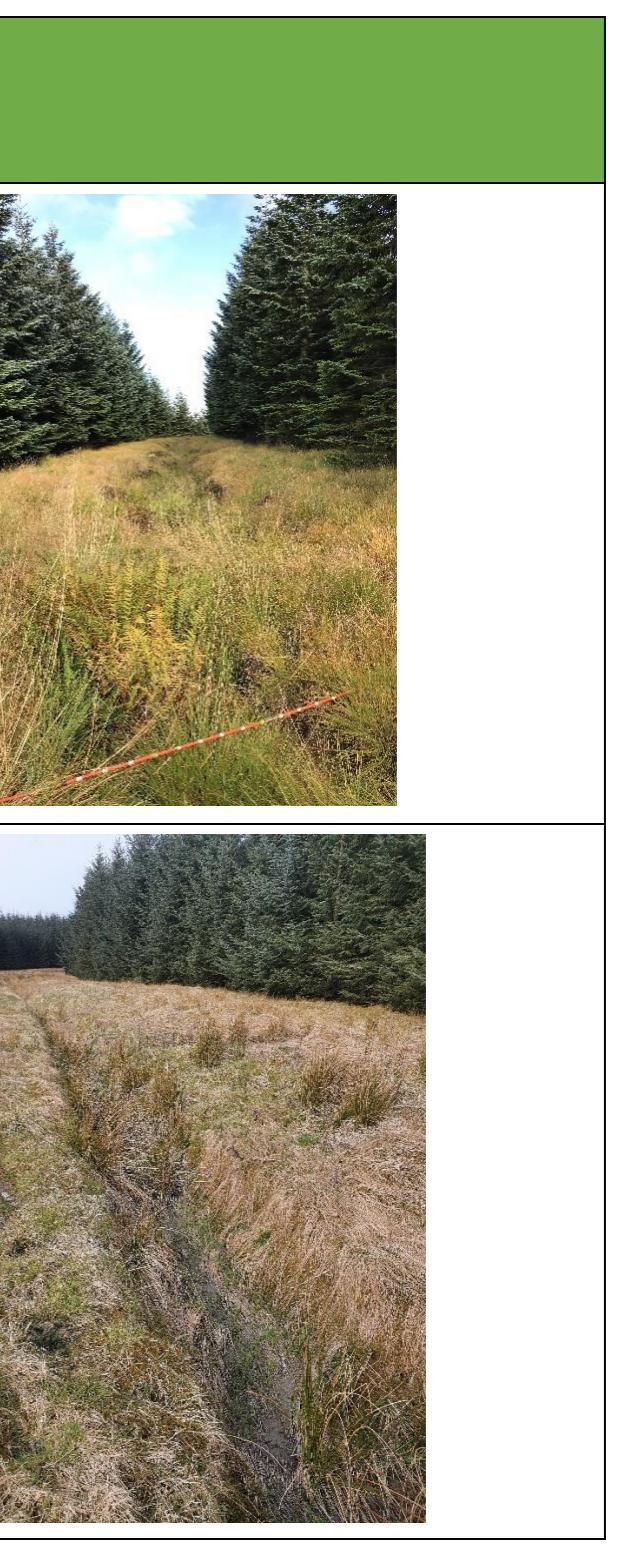
ID	Name	Width of watercourse (top of bank)	Watercourse Description	Infrastructure and Ancillary Works Description	Temporary or Permanent	Width of buffer strip achieved	Water feature upgradient or downgradient of proposed infrastructure	Potential Effect/ Comment	Additional Mitigation	Photo
Ν	Unnamed	1.0m	Two drainage ditches within Libry Moor forestry. The ditches are ~20m apart.	T24 T24 working areas and access track	Permanent Temporary	17m 10m	Downgradient	Embedded mitigation (i.e. SuDS) around the construction area and access tracks will be included in the design. Buffer width is considered adequate for size of water feature.	Additional mitigation (e.g. silt fences, settlement ponds) will be installed between the working area and accesses and the drains to reduce the risk of sediment/silt run-off during construction.	
0	Unnamed	0.5m	Roadside drainage ditch within Libry Moor forestry	T25 T25 working area	Permanent Temporary	22m 16m	Upgradient	Ditch is on opposite side of public road from infrastructure Embedded mitigation (i.e. SuDS) around the construction area and access tracks will be included in the design. Buffer width is considered adequate for size of water feature.	None

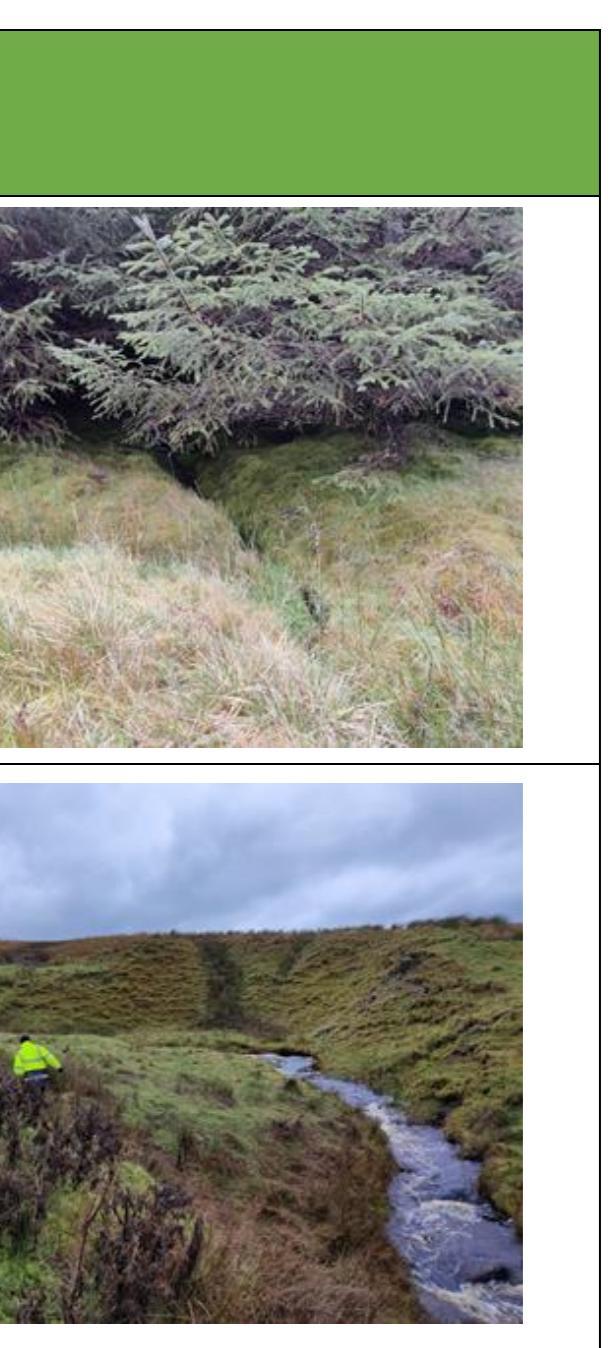
ID	Name	Width of watercourse (top of bank)	Watercourse Description	Infrastructure and Ancillary Works Description	Temporary or Permanent	Width of buffer strip achieved	Water feature upgradient or downgradient of proposed infrastructure	Potential Effect/ Comment	Additional Mitigation	Photo
P	Unnamed	0.95 to 1.1m	Drainage ditches within Libry Moor forestry	T26 T26 working area	Permanent Temporary	28m 10m	Downgradient	Embedded mitigation (i.e. SuDS) around the construction area and access tracks will be included in the design. Buffer width is considered adequate for size of water feature.	Additional mitigation (e.g. silt fences, settlement ponds) will be installed between the working area and the drains to reduce the risk of sediment/silt run-off during construction	
Q	Polmeur Burn	2.5m	The active channel is ~2.5m wide and set within a wider valley (~40m wide and ~10m deep)	T27 T27 working area Access track to T27	Permanent Temporary Temporary	34m 25m 10m	Downgradient.	The tower and access track are set above the wider valley banks and are ~10m and 5m higher than the burn level, respectively. They are not considered to be at flood risk. Embedded mitigation (i.e. SuDS) around the construction area and access tracks will be included in the design. Buffer width is considered adequate for size of water feature.	Additional mitigation (e.g. silt fences, settlement ponds) will be installed between the working area and accesses and the burn to reduce the risk of sediment/silt run-off during construction.

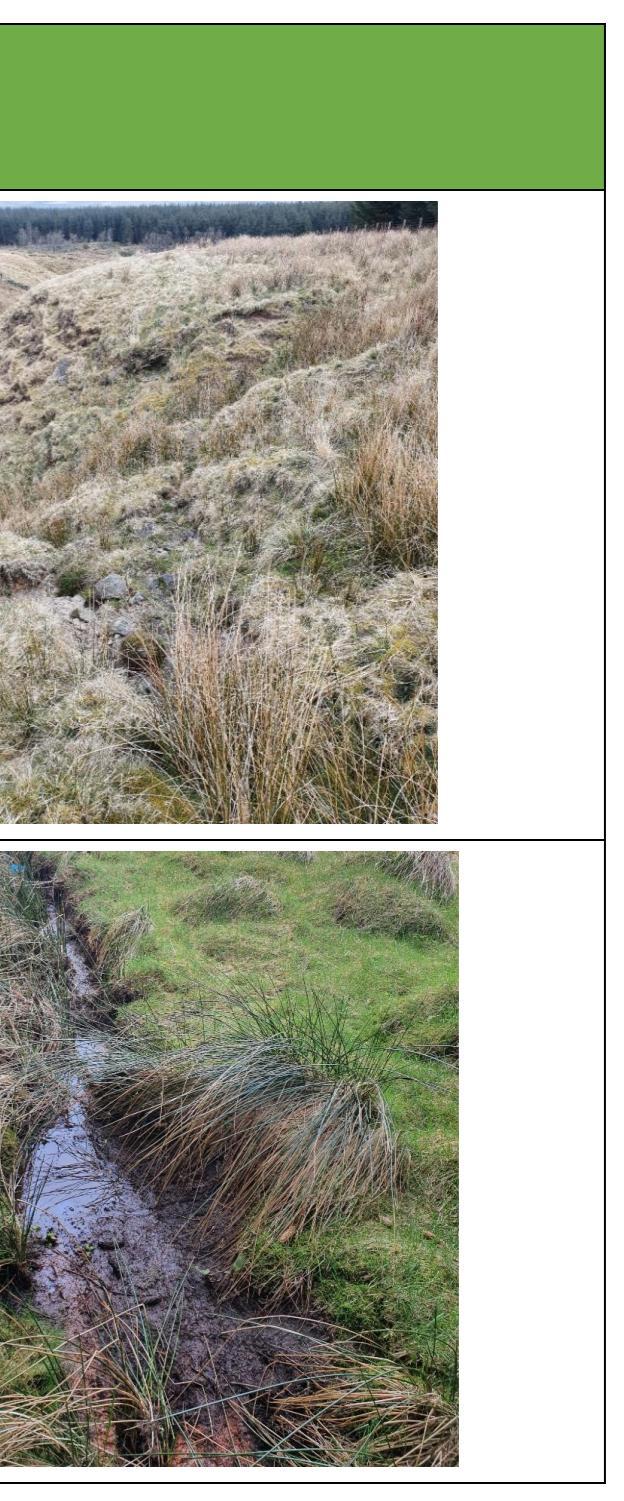
ID	Name	Width of watercourse (top of bank)	Watercourse Description	Infrastructure and Ancillary Works Description	Temporary or Permanent	Width of buffer strip achieved	Water feature upgradient or downgradient of proposed infrastructure	Potential Effect/ Comment	Additional Mitigation	Photo
R	Unnamed	<2m	Drainage ditches	T28 T28 working area	Permanent Temporary	31m 16m	Downgradient.	Embedded mitigation (i.e. SuDS) around the construction area and access tracks will be included in the design. Buffer width is considered adequate for size of water feature.	Additional mitigation (e.g. silt fences, settlement ponds) will be installed between the working area and the drains to reduce the risk of sediment/silt run-off during construction	
s	Unnamed	<0.8m	Unnamed tributary/ditch of Polmeur Burn	T30 working area Scaffolding required for OHL stringing across A76	Temporary Temporary	38m 20m	Downgradient.	Embedded mitigation (i.e. SuDS) around the construction area and scaffolding works will be included in the design. Buffer width is considered adequate for size of water feature.	Additional mitigation (e.g. silt fences, settlement ponds) will be installed between the scaffolding works and the watercourse to reduce the risk of sediment/silt run-off during construction

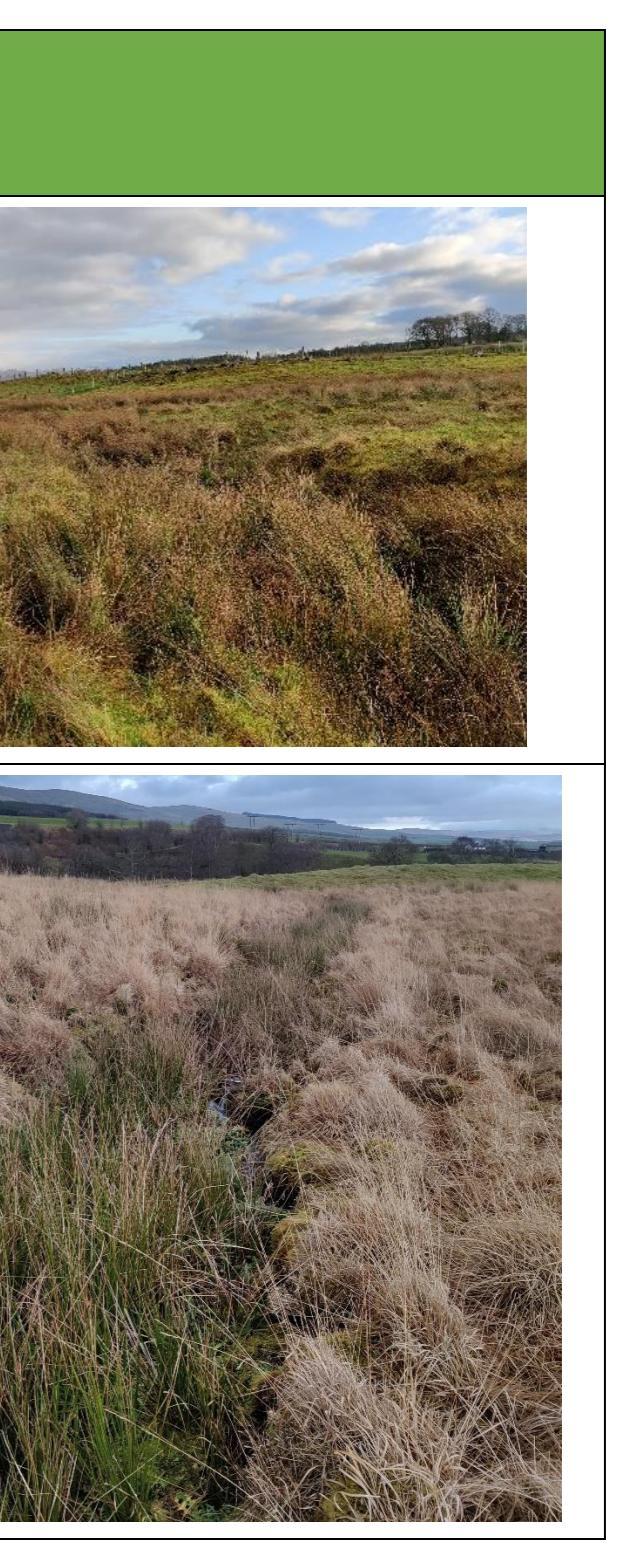
ID	Name	Width of watercourse (top of bank)	Watercourse Description	Infrastructure and Ancillary Works Description	Temporary or Permanent	Width of buffer strip achieved	Water feature upgradient or downgradient of proposed infrastructure	Potential Effect/ Comment	Additional Mitigation	Photo
Т	Birk Burn	2.2m	Small active channel sits in a much wider valley (~40m wide)	T33 working area Access track to T32	Temporary Temporary	36m 30m	Downgradient.	The T33 working area is over 1.5m higher than the active channel and is not considered to be at flood risk. The track is over 3m higher than the active channel and not at flood risk. Embedded mitigation (i.e. SuDS) around the construction area and will be included in the design. Buffer width is considered adequate for size of water feature.	Additional mitgation (e.g. silt fences, settlement ponds) will be installed between the working area and the watercourse to reduce the risk of sediment/silt run-off during construction

U	Unnamed	1.4m	Drainage ditch through localised area of peatland	T34 T34 working area	Permanent Temporary	25m 10m	Downgradient	Artificial drainage ditch. Embedded mitigation (i.e. SuDS) around the construction area and will be included in the design. Buffer width is considered adequate for size of water feature.	None

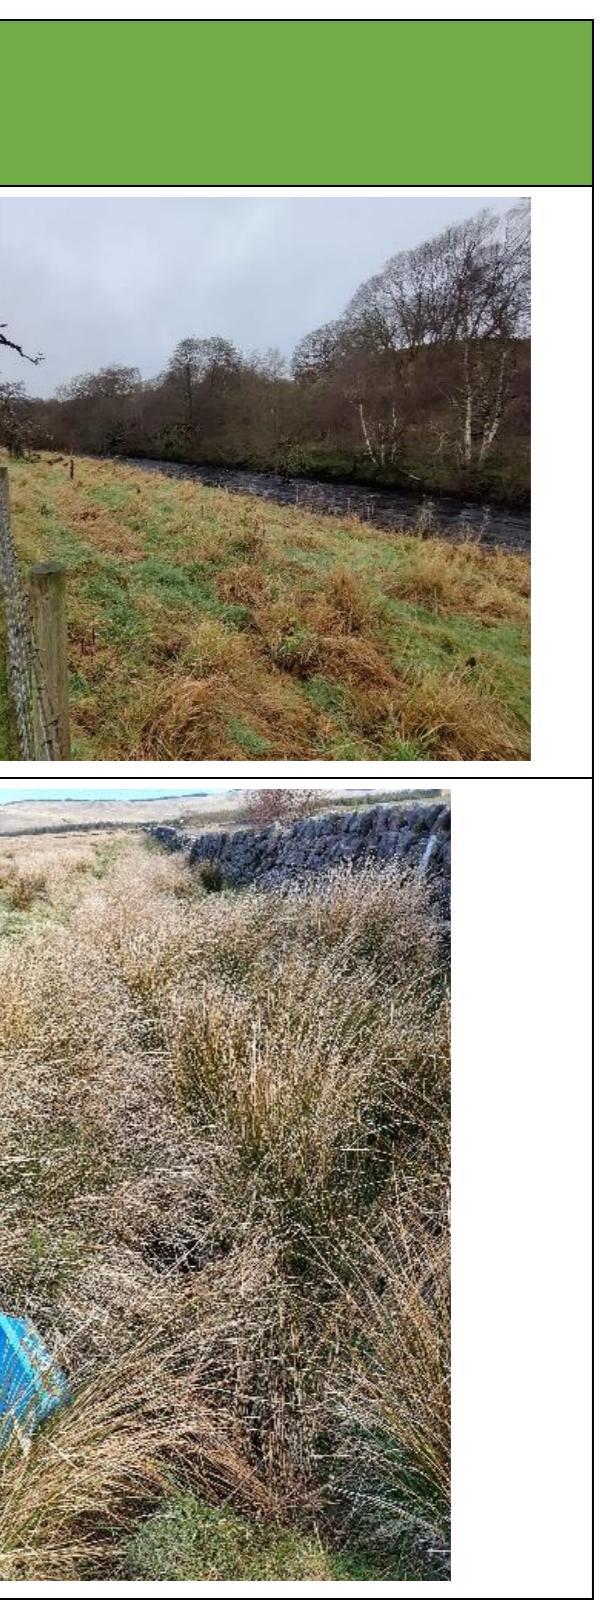
ID	Name	Width of watercourse (top of bank)	Watercourse Description	Infrastructure and Ancillary Works Description	Temporary or Permanent	Width of buffer strip achieved	Water feature upgradient or downgradient of proposed infrastructure	Potential Effect/ Comment	Additional Mitigation	Photo
v	River Nith	10m	River Nith	Scaffolding required for OHL stringing across River Nith	Temporary	35m	Downgradient	Embedded mitigation (i.e. SuDS) around the scaffolding works will be included in the design. Buffer width is considered adequate for size of water feature	Additional mitigation (e.g. silt fences) will be installed between the scaffoding working area and the watercourse to reduce the risk of sediment/silt run-off during construction	
w	Unnamed	2m	Unnamed tributary of River Nith	T35 working area	Temporary	31m	Downgradient	Working area is over 10m higher than the small watercourse and over 31m away. Embedded mitigation (i.e. SuDS) around the working area will be included in the design. Buffer width is considered adequate for size of water feature	None

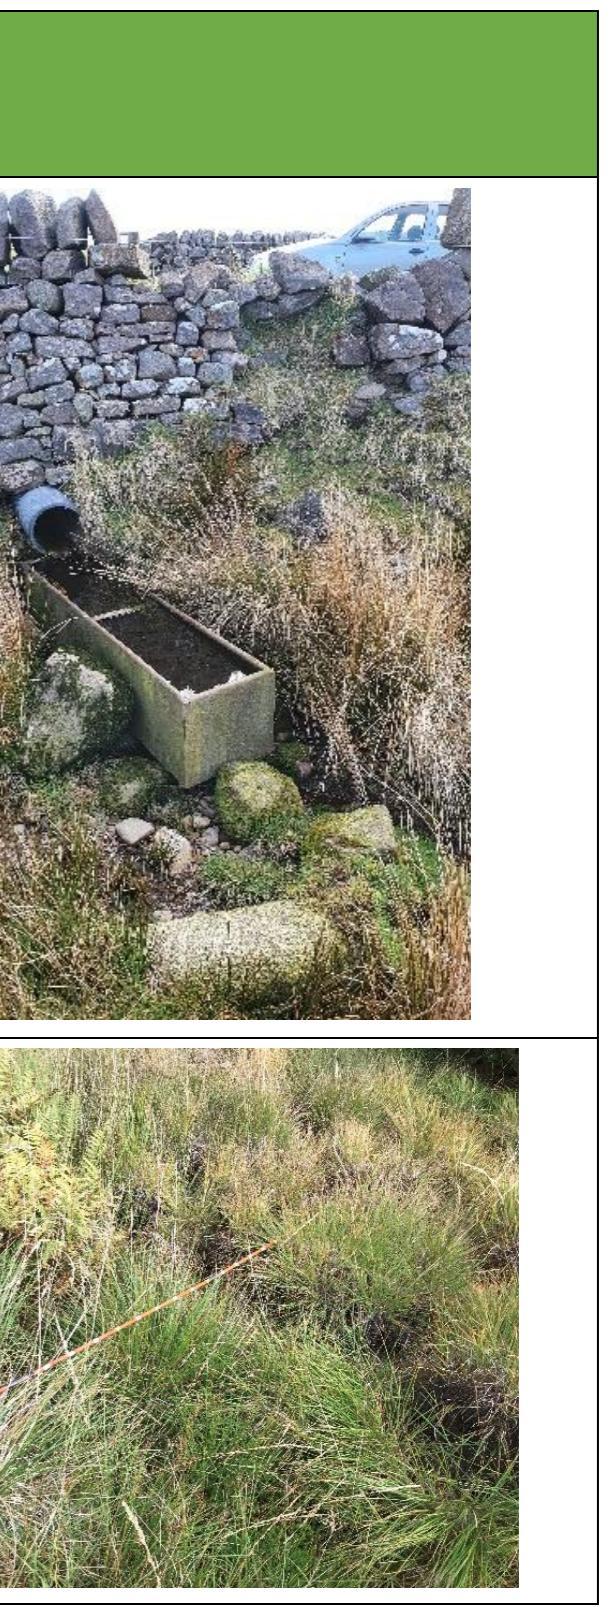
ID	Name	Width of watercourse (top of bank)	Watercourse Description	Infrastructure and Ancillary Works Description	Temporary or Permanent	Width of buffer strip achieved	Water feature upgradient or downgradient of proposed infrastructure	Potential Effect/ Comment	Additional Mitigation	Photo
x	Unnamed	2.0m	Unnamed tributary of River Nith. Field drainage ditch along north and then south side of public road. Passes under road via 250mm culvert. Ditch width varied from 0.3m at culvert under road to 2m downstream	T36 T36 working area T37 T37 working area T38 working area	Permanent Temporary Permanent Temporary Temporary	25m 15m 21m 12m 30m	Upgradient	Minor drainage ditch upgradient of proposed works. The public road is located between T38 and the ditch. Embedded construction SUDS will minimise any sedimentation/pollutio n runoff during construction.	None	
Y	Unnamed	0.9m	Unnamed tributary/ditch of River Nith within forestry	T39 T39 working area and access track	Permanent Temporary	13m 10m	Upgradient	Minor ditch within forestry slightly upgradient of proposed works Embedded mitigation (i.e. SuDS) around the working area will be included in the design. Buffer width is considered adequate for size of water feature	None

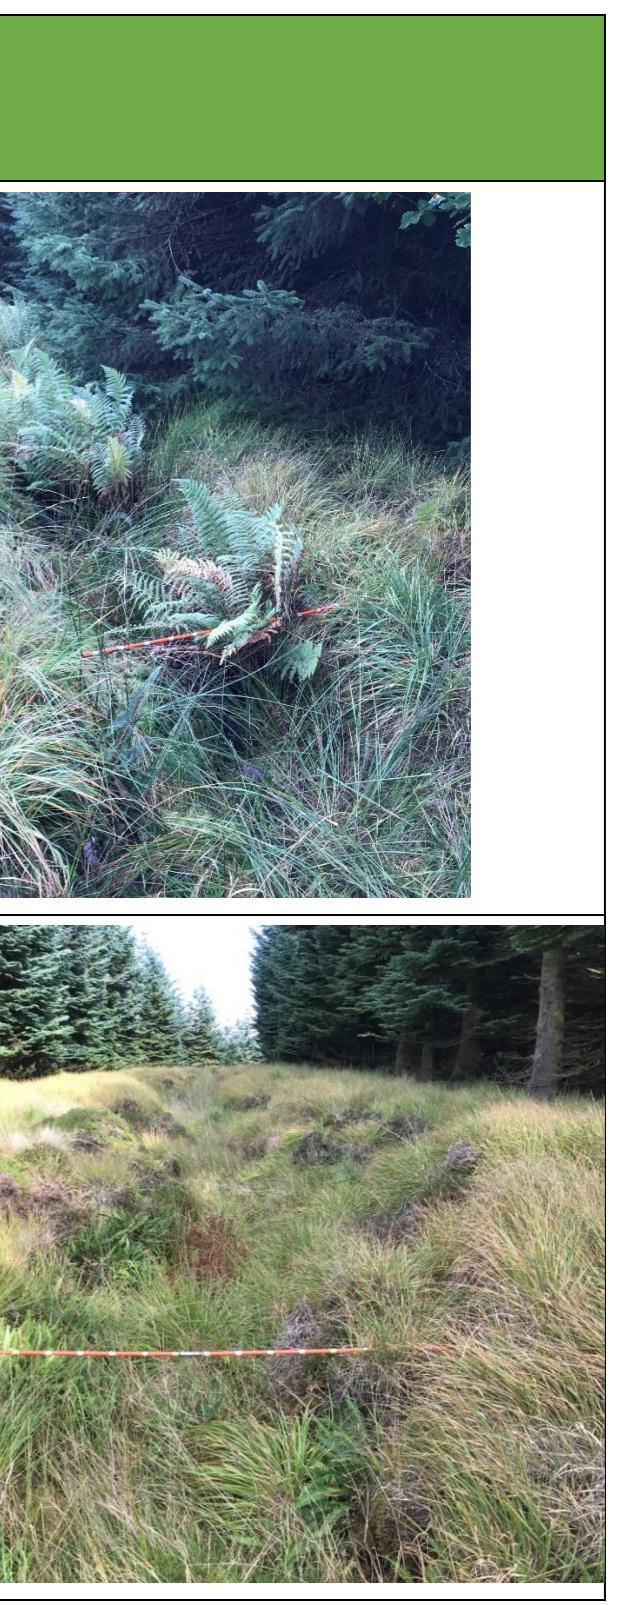
ID	Name	Width of watercourse (top of bank)	Watercourse Description	Infrastructure and Ancillary Works Description	Temporary or Permanent	Width of buffer strip achieved	Water feature upgradient or downgradient of proposed infrastructure	Potential Effect/ Comment	Additional Mitigation	Photo
Z	Stank Burn	1.0m	Upstream reach of Stank Burn	Access track to T40	Temporary	17m	Downgradient.	Embedded mitigation (i.e. SuDS) around the access tracks will be included in the design. Buffer width is considered adequate for size of water feature	Additional mitigation (e.g. silt fences) will be installed between the track and the watercourse to reduce the risk of sediment/silt run-off during construction	
AA	Unnamed	0.4m to 1.6m downstream	Unnamed watercourse within forestry fire break	Glenmuckloch Substation and access track to substation	Permanent	17m	Upgradient	The watercourse is small, with very little flow at time of survey. The proposed drainage layout for the substation does not drain to the watercourse, drainage is to tie into existing road drainage to the south. Embedded mitigation (i.e. SuDS) around the access tracks will be included in the design. Buffer width is considered adequate for size of water feature	Additional mitigation (e.g. silt fences, settlement ponds) will be installed between the substation and the watercourse to reduce the risk of sediment/silt run-off during construction
